# VEHICLE INSPECTION REPORT

**NA25VFU**

## Mercedes-Benz Sprinter 315 CDI

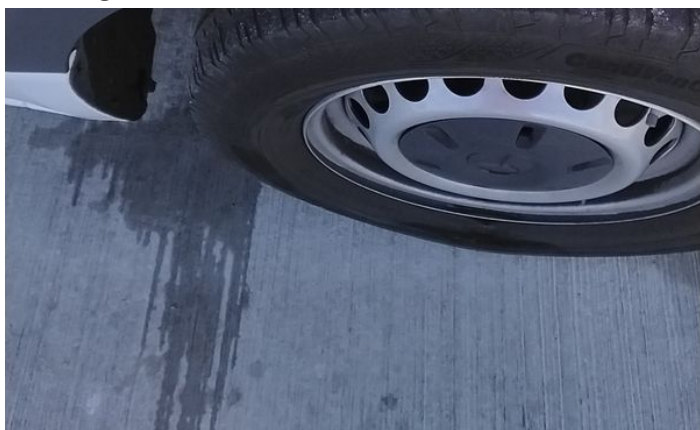
1: Wing osf  
Scratched  
Over 25mm Thru Paint

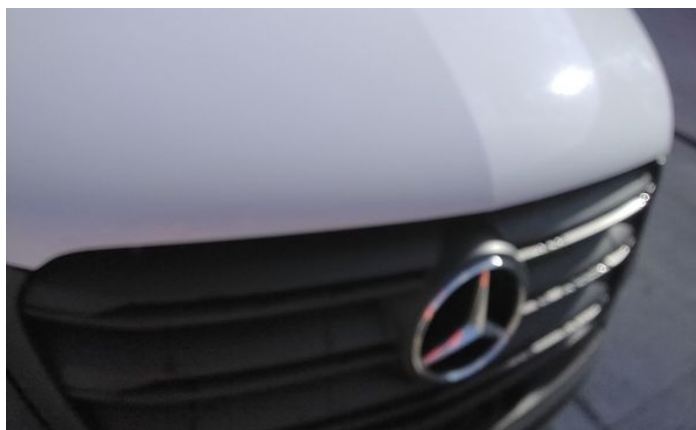
2: Bonnet  
Chipped  
Multiple Chips

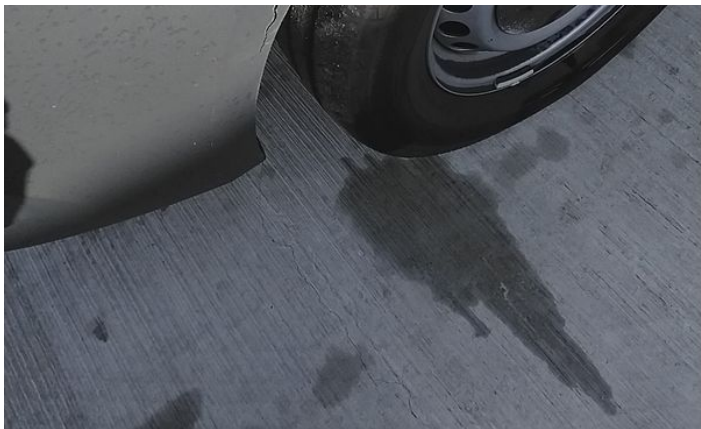
3: Bumper Front  
Cracked  
Over 25mm

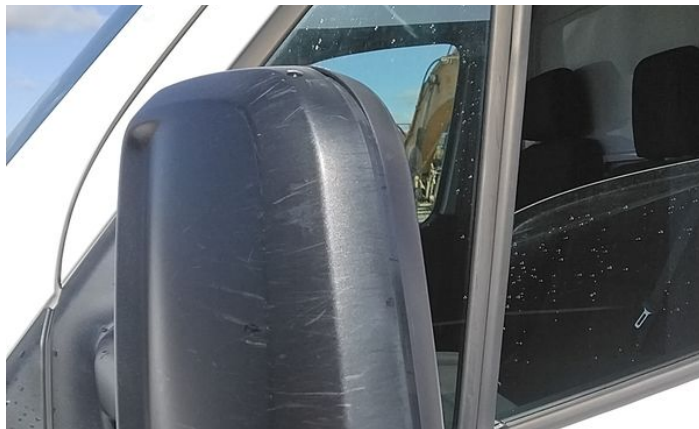
4: Door Mirror Assy nsf  
Broken  
Replace

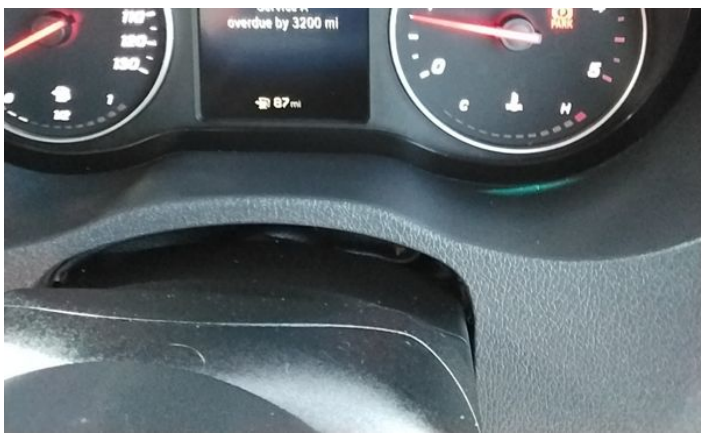
\*WARNING LIGHTS ON DASH\* AD-BLUE, E/ MIRRORS

5: Dash Warning Lights  
Displayed  
No Action
