# VEHICLE INSPECTION REPORT

**HX73YPE**

## Mercedes-Benz Atego 816

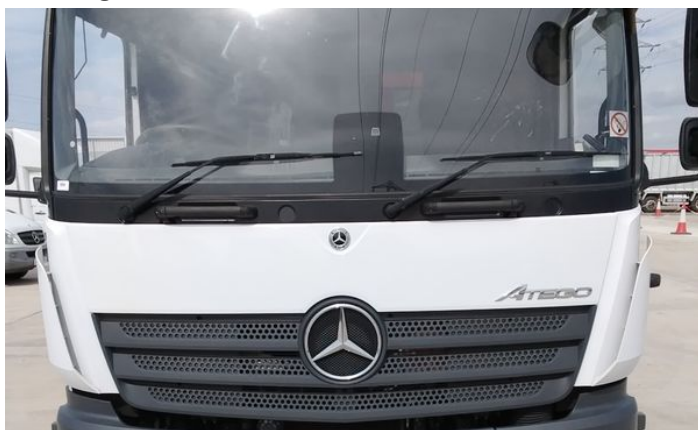
1: Bonnet  
Chipped  
Multiple Chips

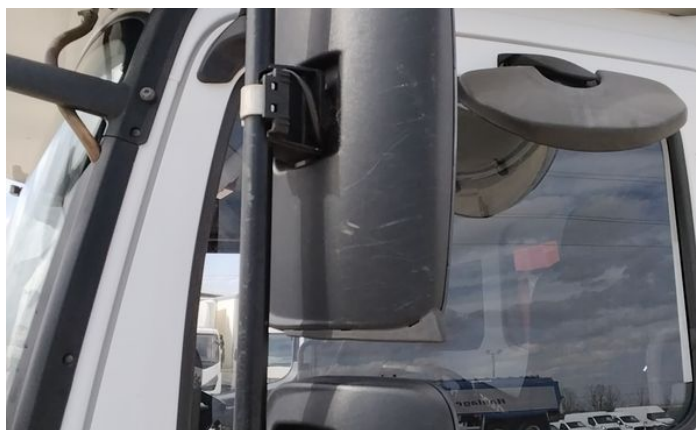
2: Door Mirror Assy nsf  
Scuffed (Unpainted)  
Over 100mm

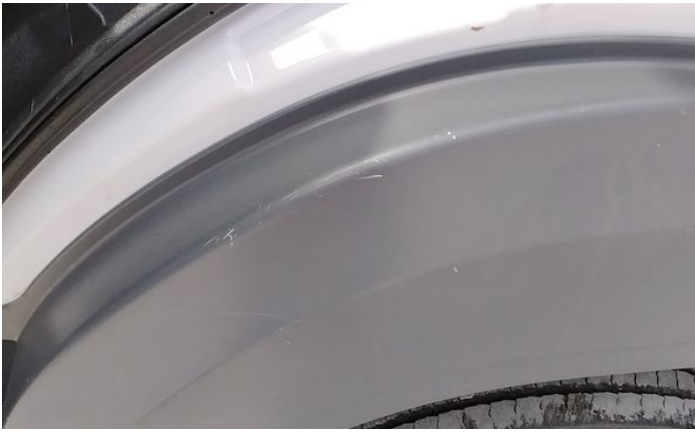
3: Wing Front Arch Extension ns  
Scratched (Painted)  
Over 25mm Thru Paint

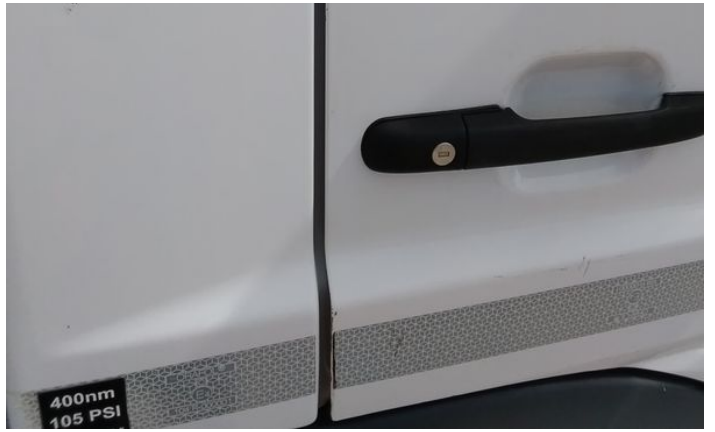
4: Door of  
Chipped  
Multiple Chips

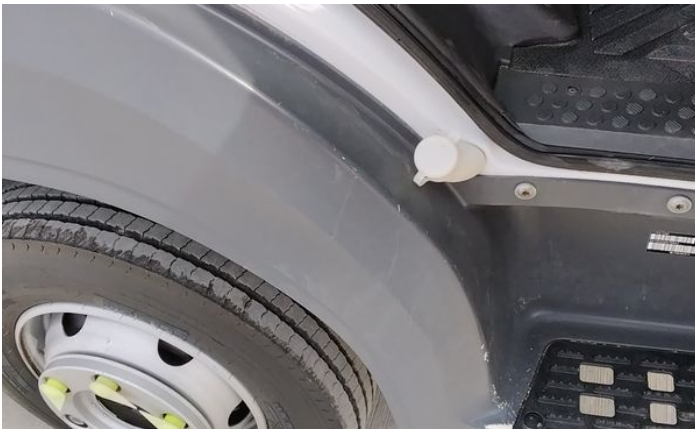
5: Wing Front Arch Extension of  
Scratched (Painted)  
Over 25mm Thru Paint

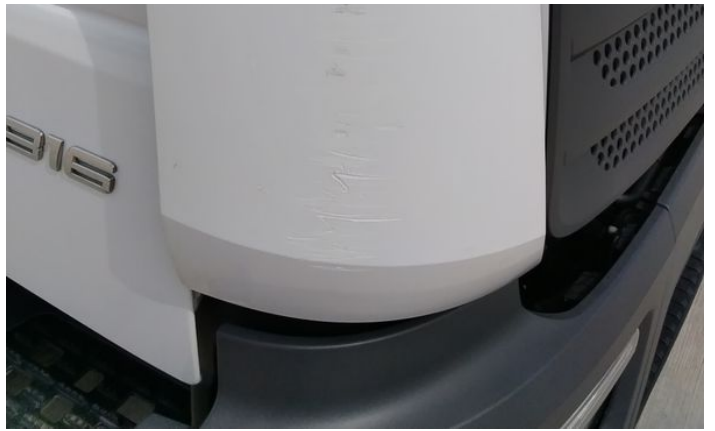
6: Moulding of Wing  
Scratched (Painted)  
Over 25mm Thru Paint

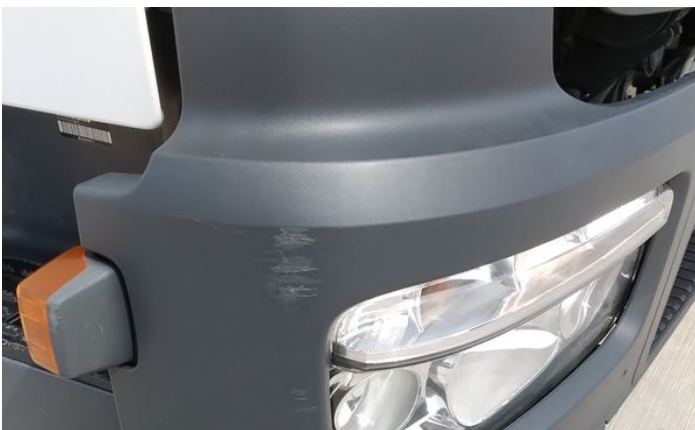
7: Bumper Front  
Scratched  
Over 100mm Thru Paint

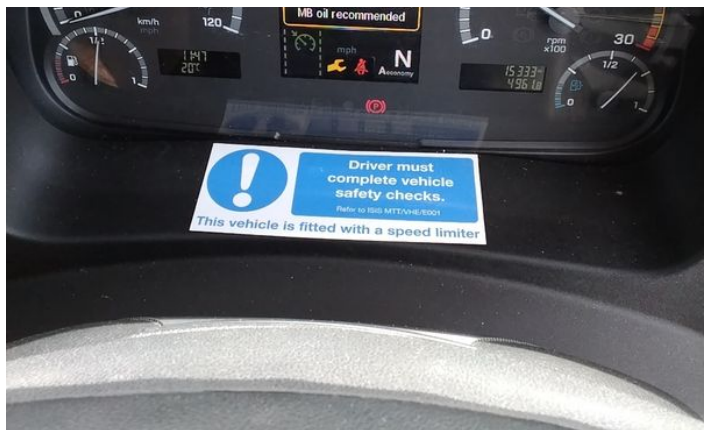
8: Dash Warning Lights  
Displayed  
No Action
