## VEHICLE INSPECTION REPORT

**HX73YSD**

### Mercedes-Benz Atego 816

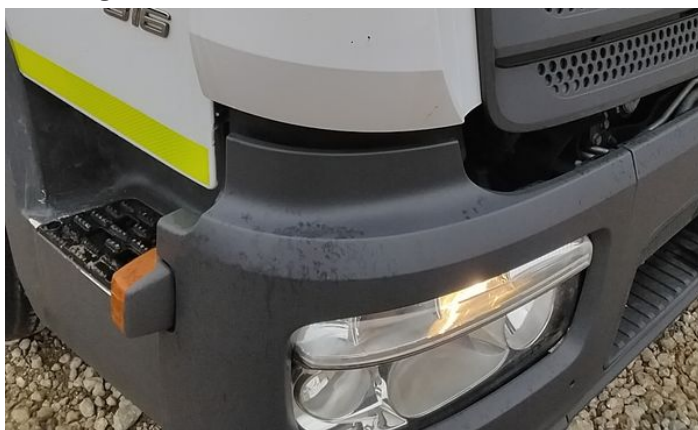
1: Wing of  
Scratched  
Up To 25mm Not Thru Paint

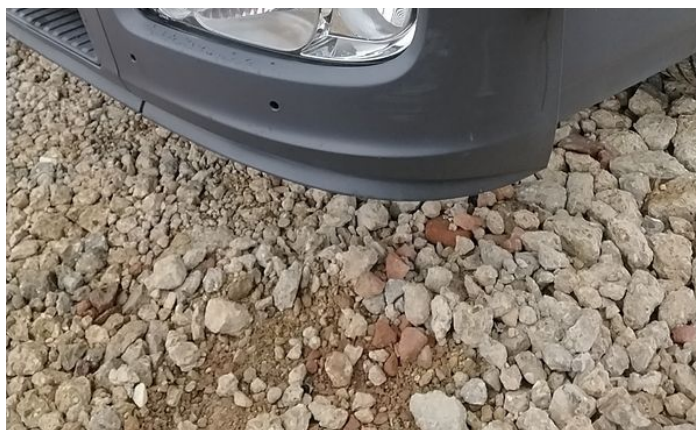
2: Bumper Front Moulding  
Scuffed (Unpainted)  
Over 100mm

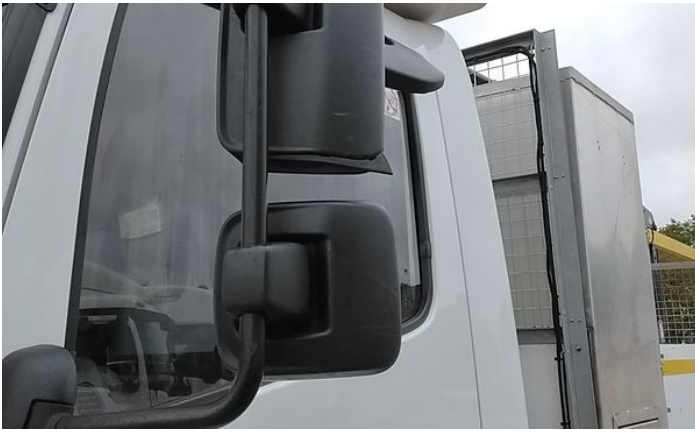
3: Door Mirror Assy nsf  
Scuffed (Unpainted)  
Over 100mm

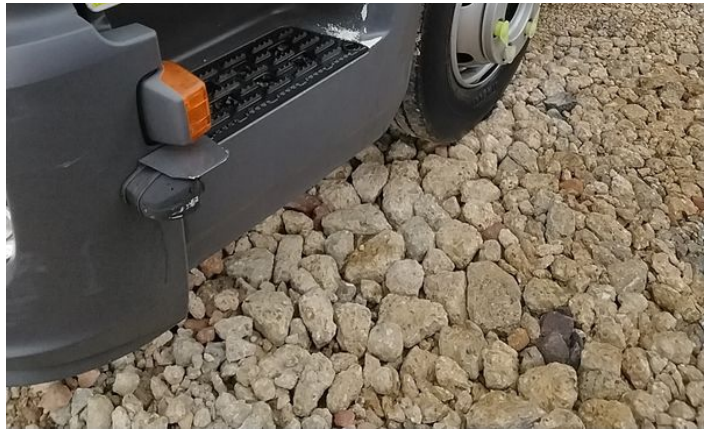
4: Wing Front Arch Extension ns  
Scuffed (Unpainted)  
Over 100mm

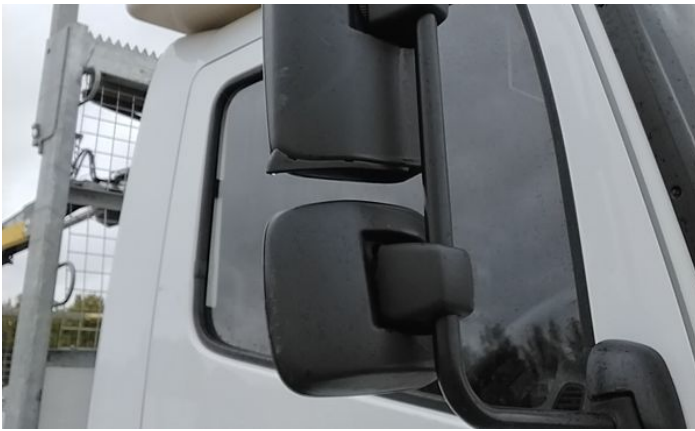
5: Door Mirror Assy osf  
Scuffed (Unpainted)  
Over 100mm

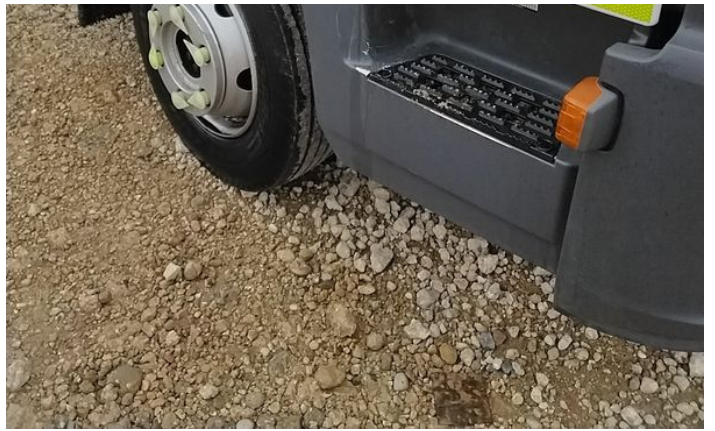
6: Wing Front Arch Extension os  
Scuffed (Unpainted)  
Over 100mm
