## VEHICLE INSPECTION REPORT

**OY18LPN**

### Daf CF 450

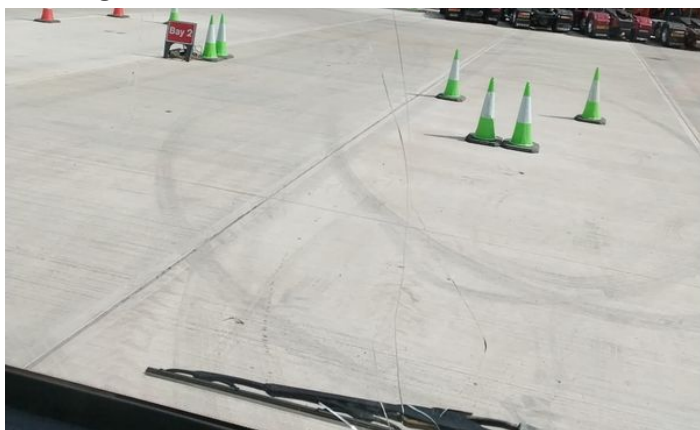
1: Screen Front  
Cracked  
Replace

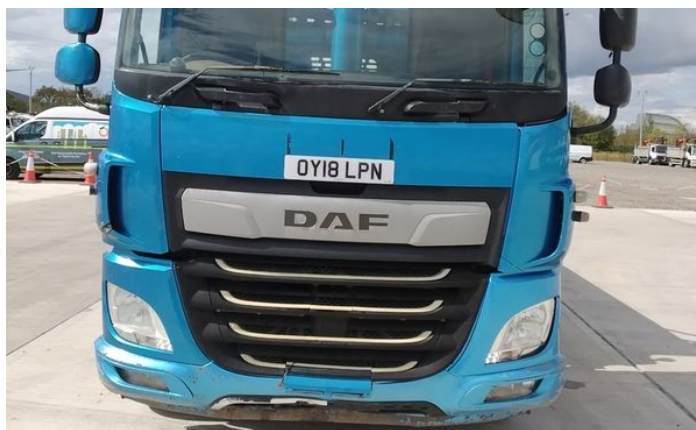
2: Bonnet  
Chipped  
Multiple Chips

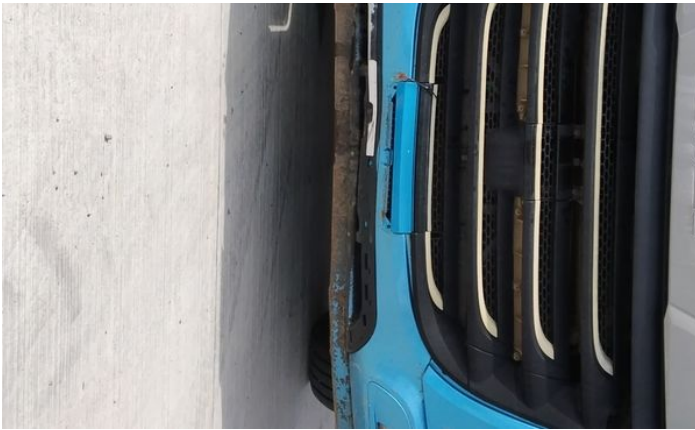
3: Bumper Front  
Dented  
With Paint Damage

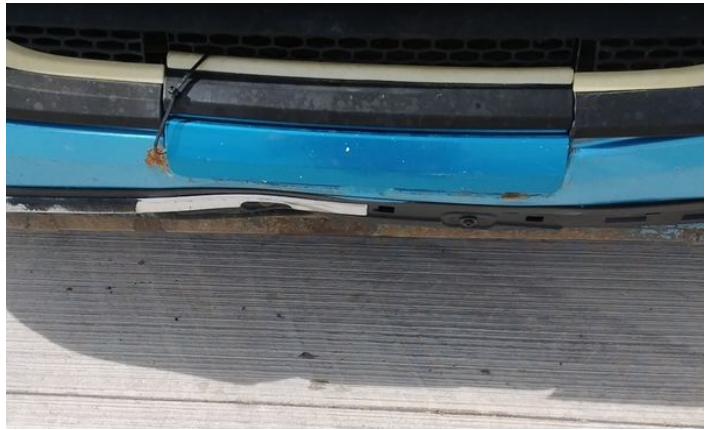
4: Bumper Front Grill  
Broken  
Replace

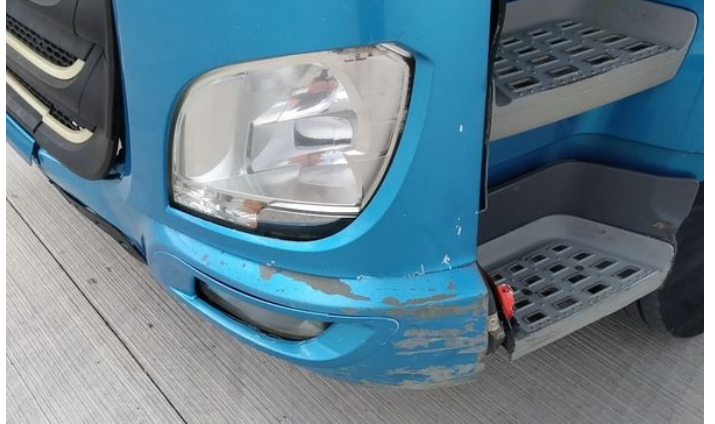
6: Bumper Front  
Scratched  
Over 100mm Thru Paint

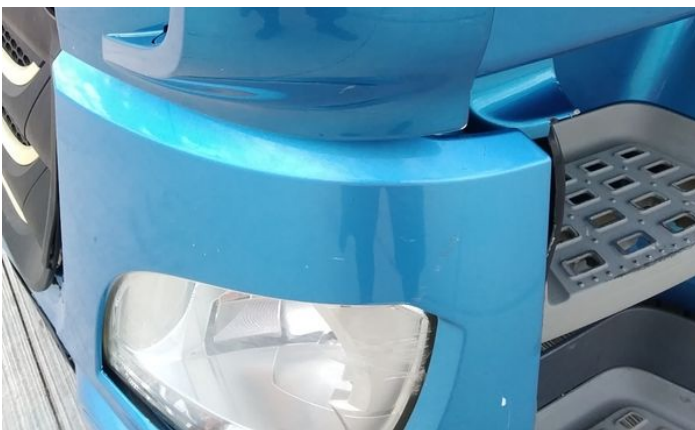
7: Moulding nsf Wing  
Scratched (Painted)  
Over 25mm Thru Paint

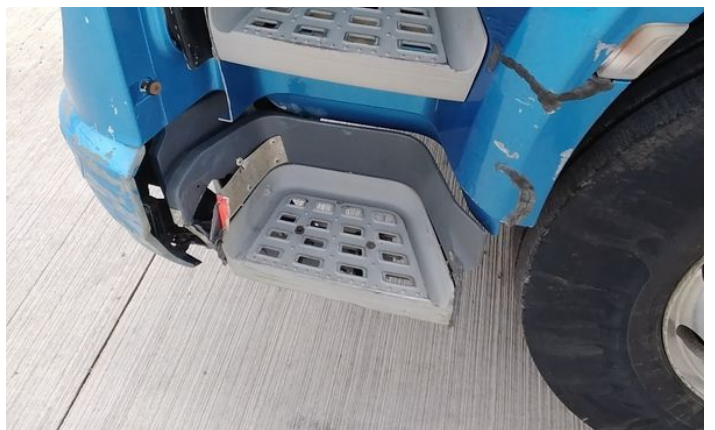
8: Wing nsf  
Cracked  
Replace

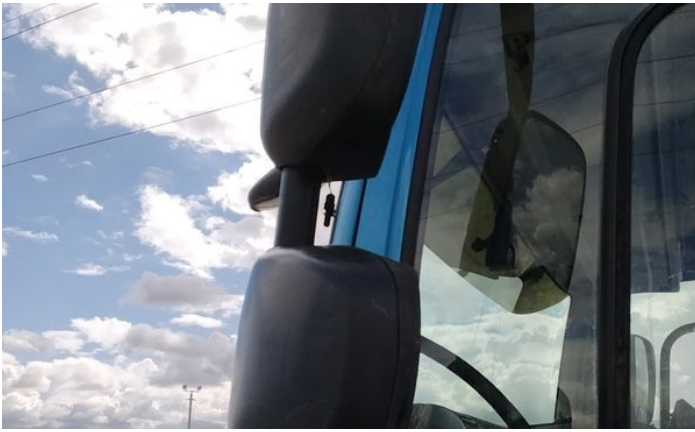
9: Door Mirror Assy nsf  
Scratched (Painted)  
Over 25mm Thru Paint

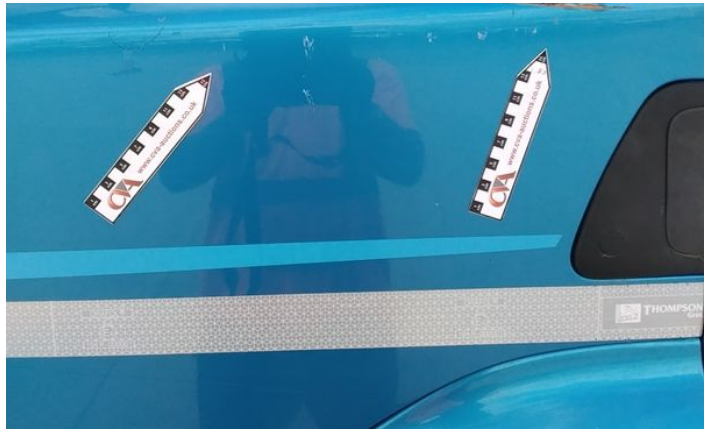
10: Door nsf  
Scratched  
Over 25mm Thru Paint

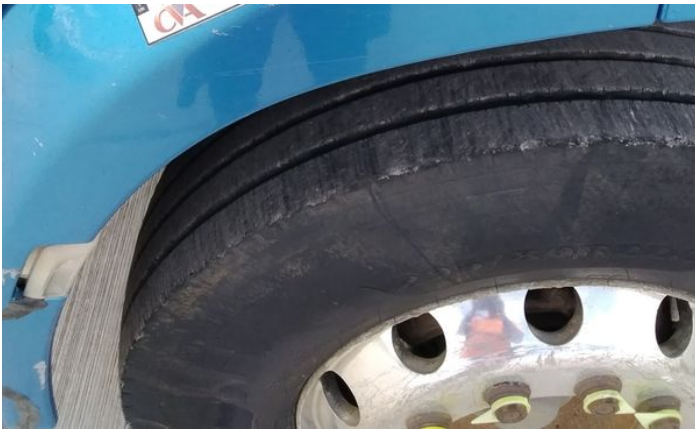
11: Wing Front Arch Extension ns  
Scratched (Painted)  
Over 25mm Thru Paint

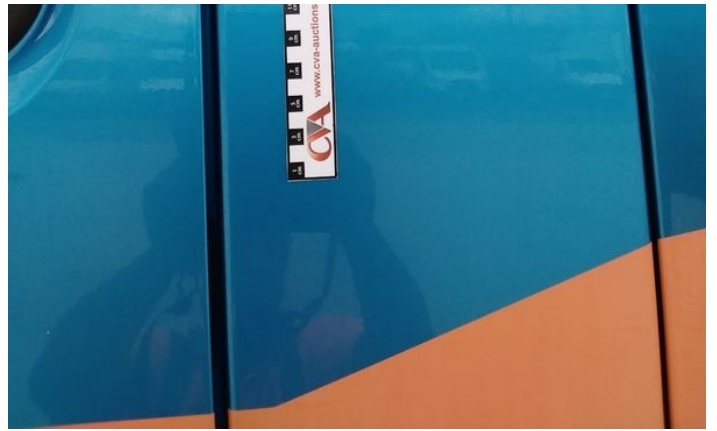
12: Qtr Panel nsr  
Scratched  
Rusted

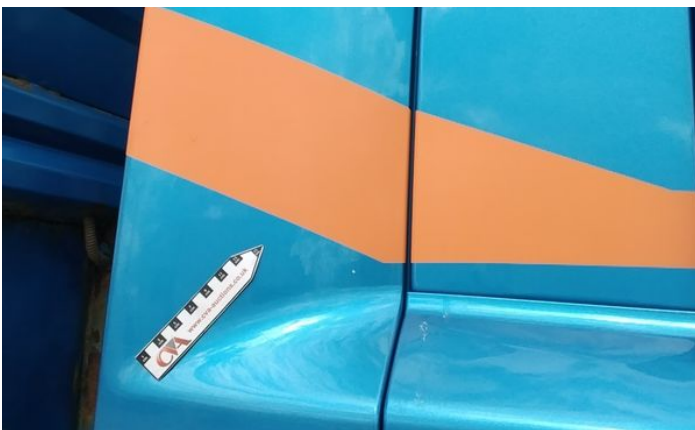
13: Qtr Panel osr  
Chipped  
Multiple Chips

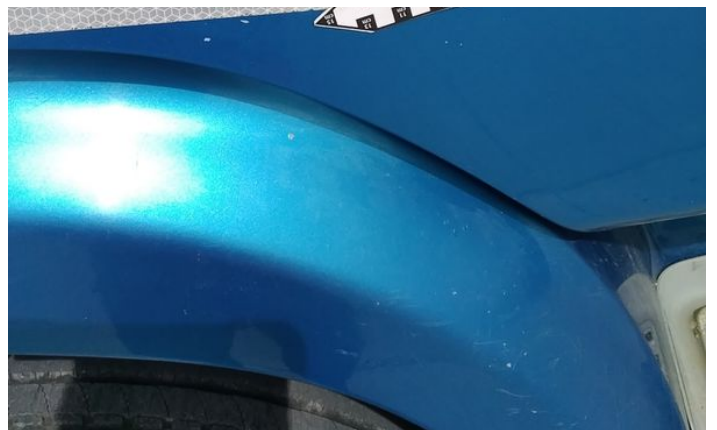
14: Door osf  
Chipped  
Multiple Chips

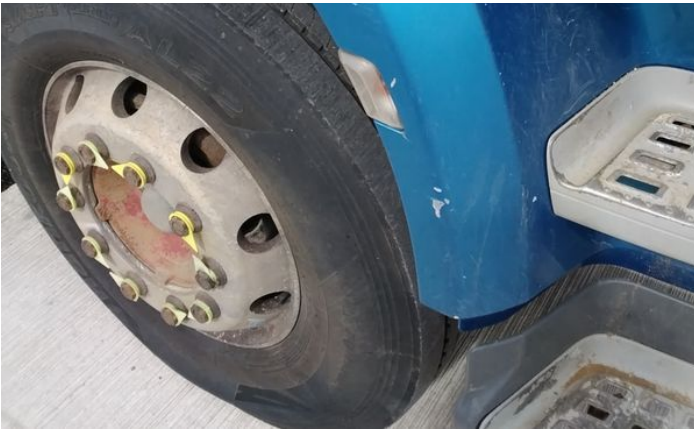
15: Wing Front Arch Extension os  
Scratched (Painted)  
Over 25mm Thru Paint

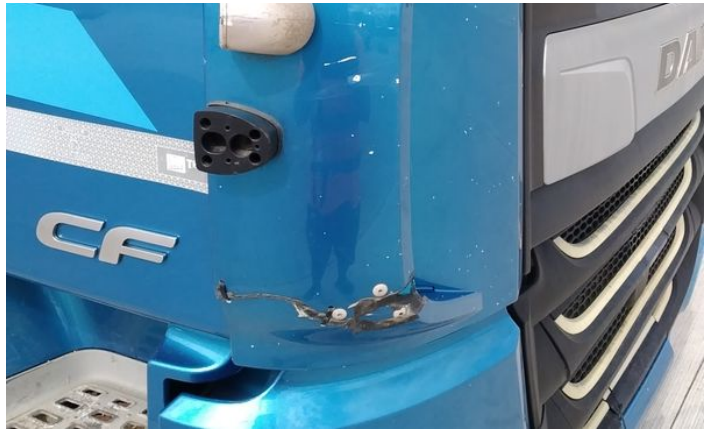
16: Moulding osf Wing  
Broken  
Replace

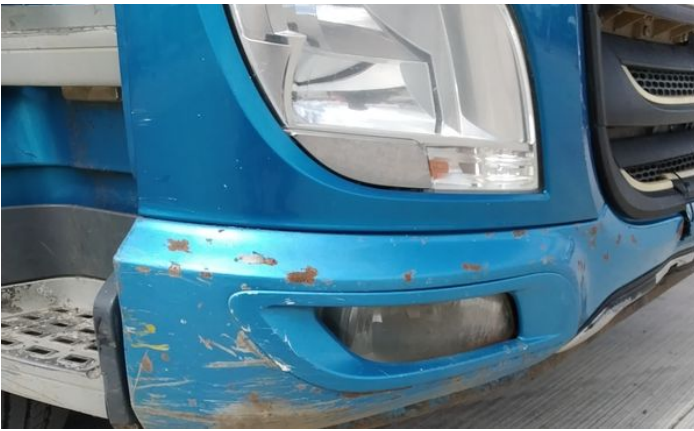
17: Bumper Front  
Scratched  
Over 100mm Thru Paint

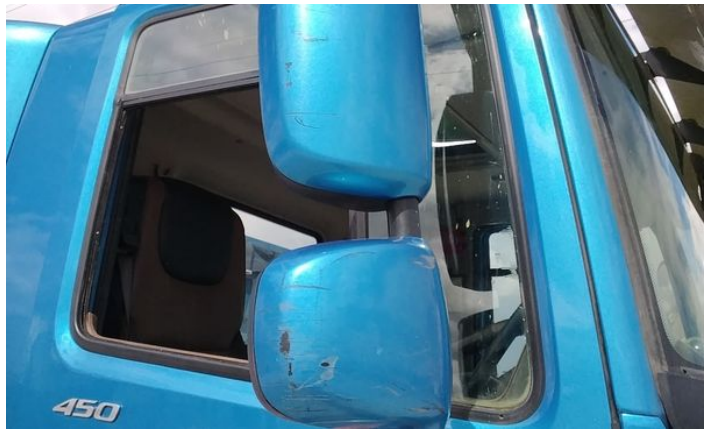
18: Door Mirror Assy osf  
Scratched (Painted)  
Over 25mm Thru Paint

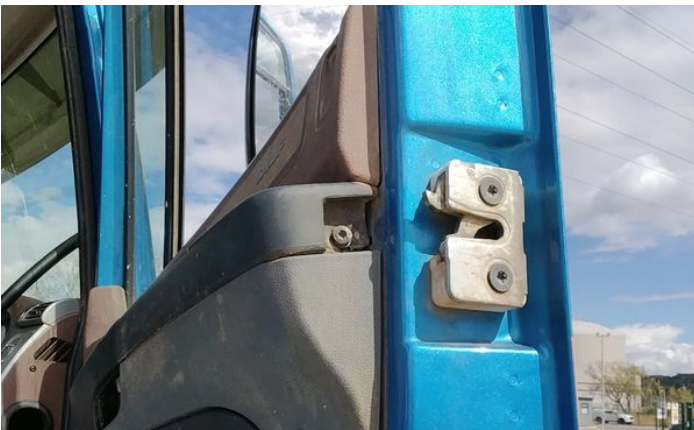
19: Door Pad osf  
Broken  
Replace

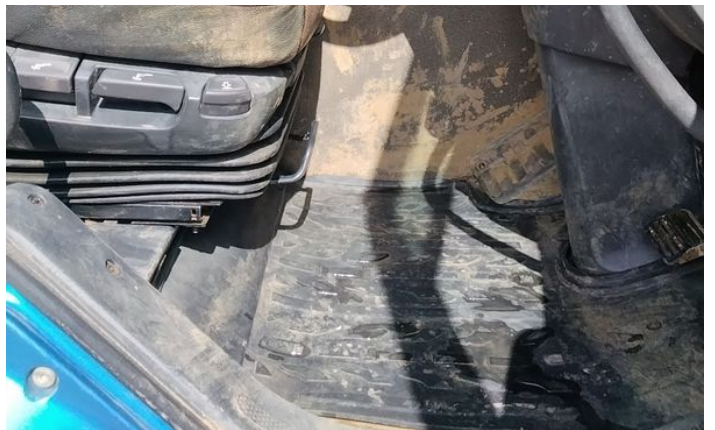
20: General Interior  
Soiled  
Light

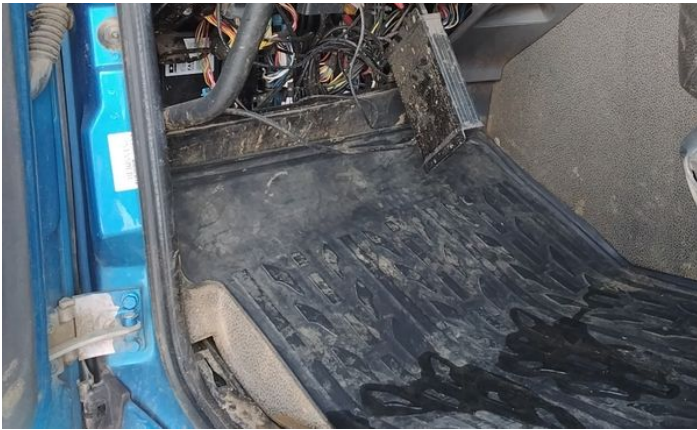
21: Fascia Panel  
Broken  
Replace

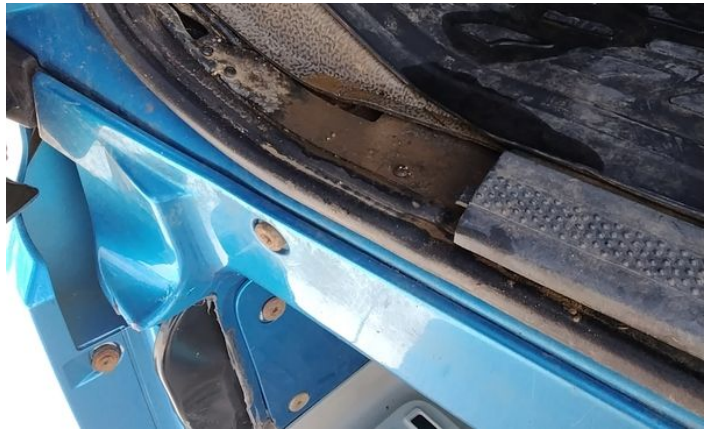
22: Fascia Trim  
Missing  
Replace

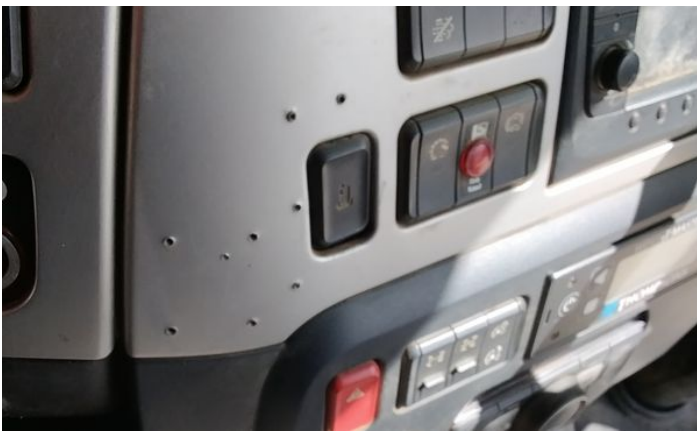
23: Centre Console Front  
Holed  
Over 3mm

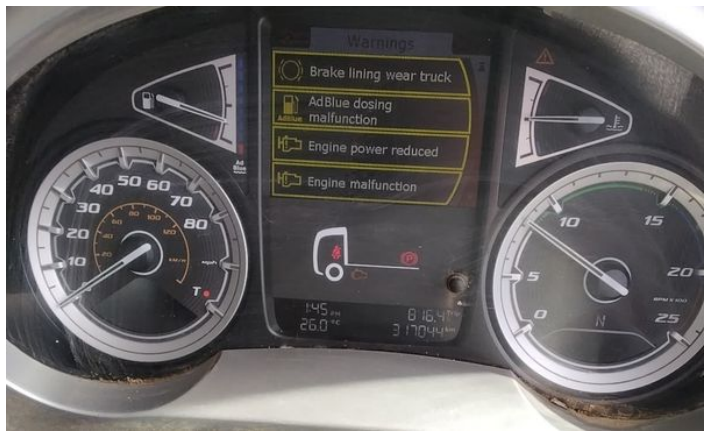
24: Dash Warning Lights  
Displayed  
No Action

| Carpet Condition | Average | Upholstery Condition | Average |
|---|---|---|---|
| EML light illuminated | Fault | DPF light illuminated | OK |
