## VEHICLE INSPECTION REPORT

**YP16AXM**

### Fiat Ducato Maxi 35 2.3 Multijet Tipper 150

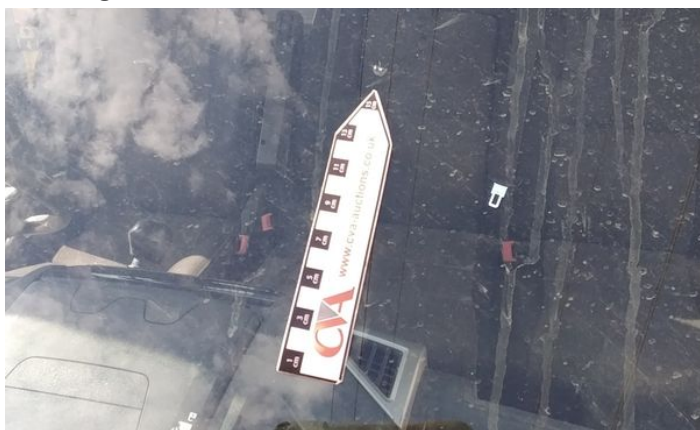
1: Screen Front  
Cracked  
Replace

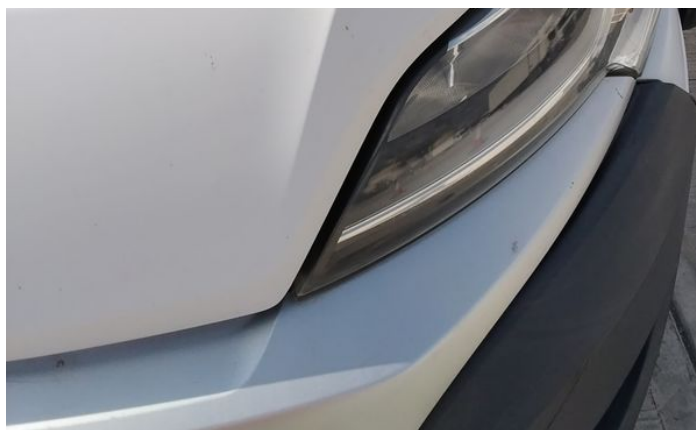
2: Bonnet  
Dented  
Hail - Severe

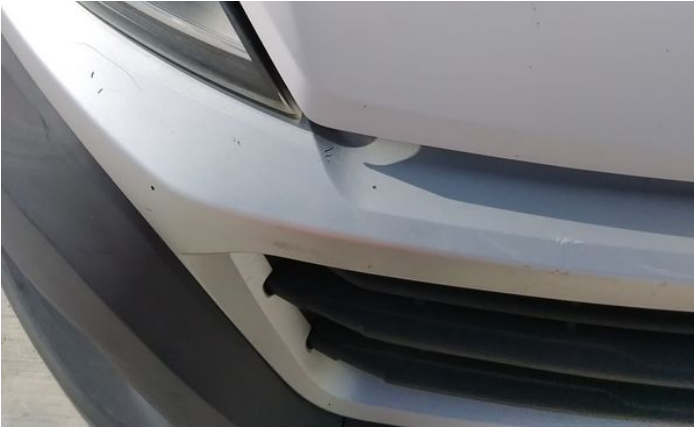
3: Bonnet  
Scratched  
Over 25mm Thru Paint

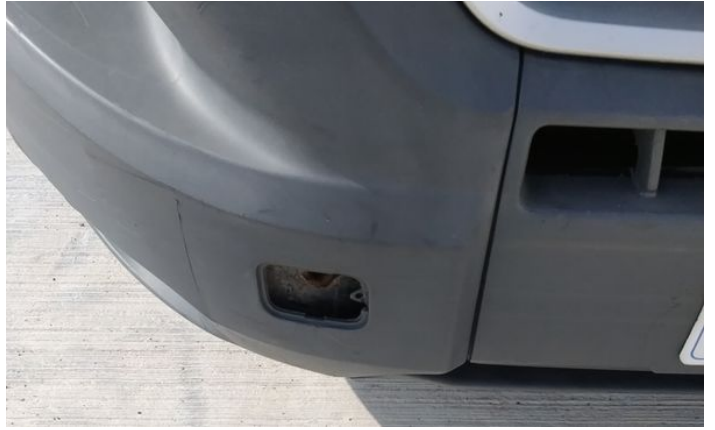
4: Front TowEye Cvr  
Missing  
Replace

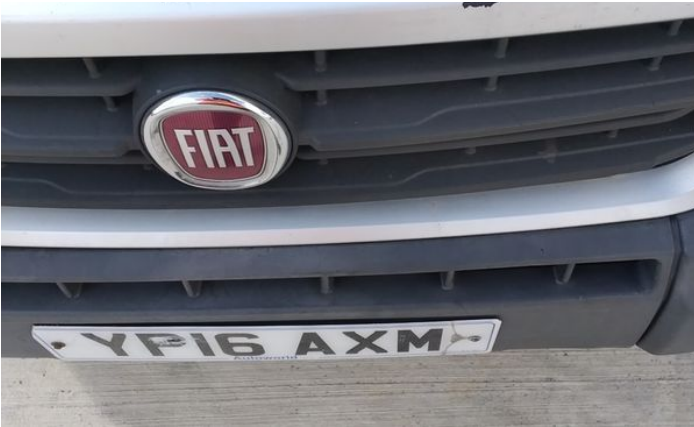
5: Bumper Front Grill  
Broken  
Replace

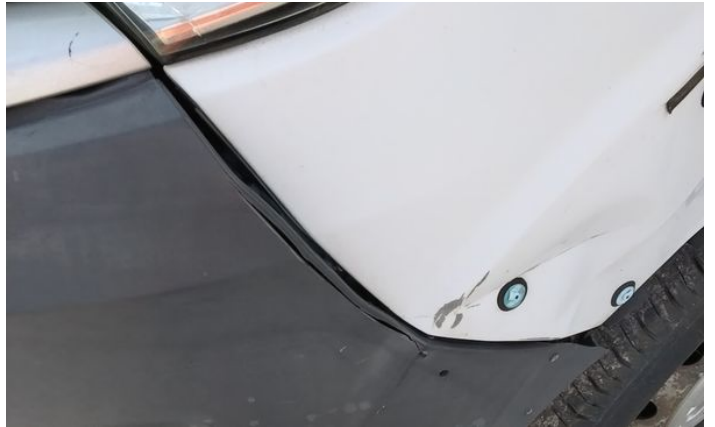
6: Bumper Front  
Insecure  
Action Required

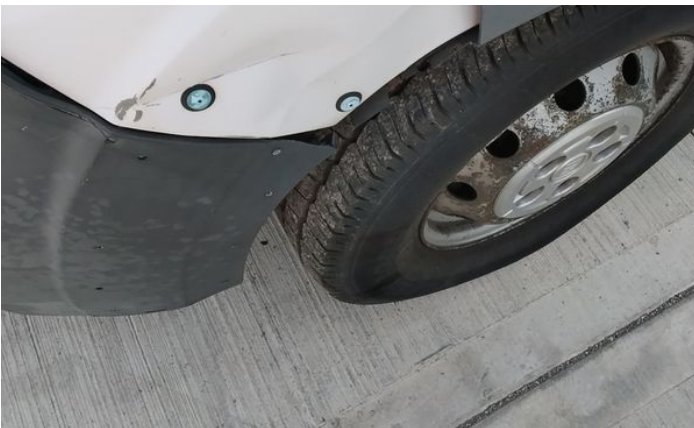
7: Moulding of Wing  
Broken  
Replace

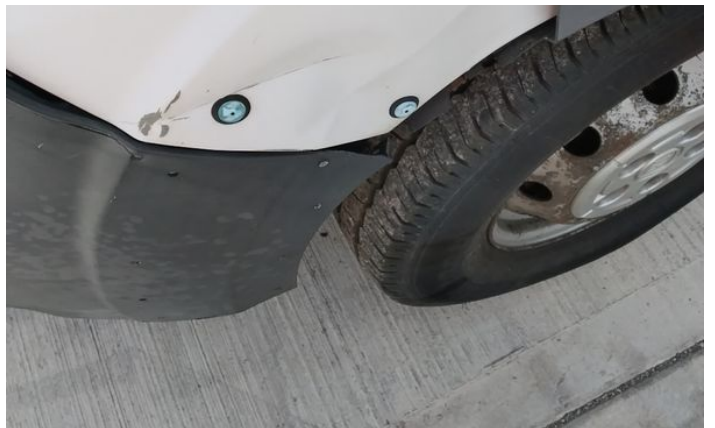
8: Wing not  
Dented  
Hail - Severe

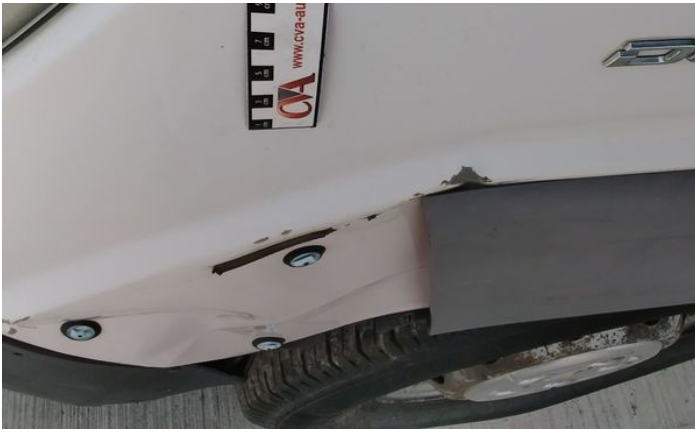
9: Wing nsf  
Scratched  
Over 25mm Thru Paint

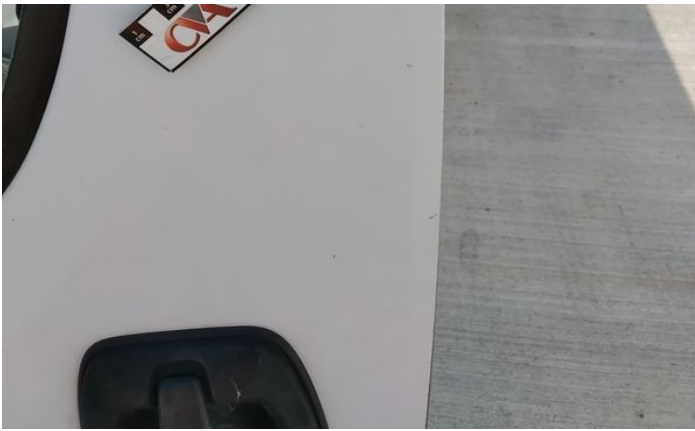
11: Door nsf  
Scratched  
Over 25mm Thru Paint

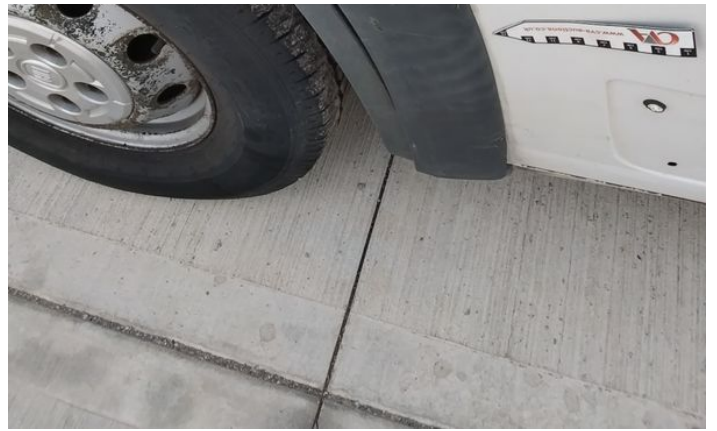
12: Wing Front Arch Extension ns  
Broken  
Replace

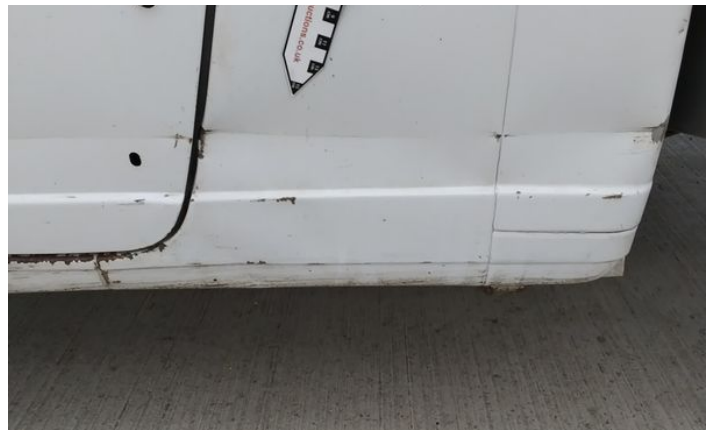
14: B Post ns  
Dented  
With Paint Damage

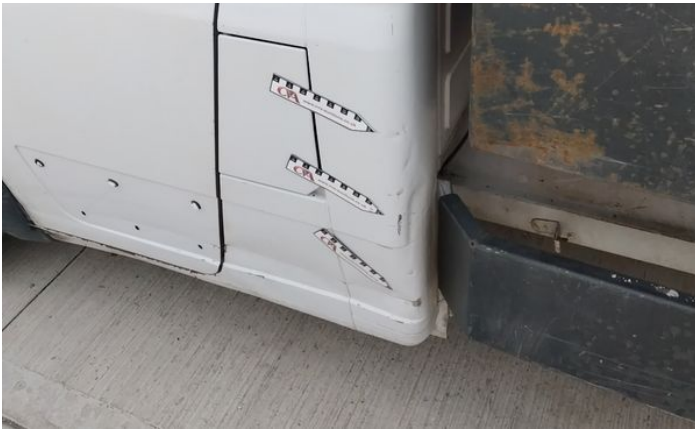
15: Qtr Panel nsr  
Dented  
With Paint Damage

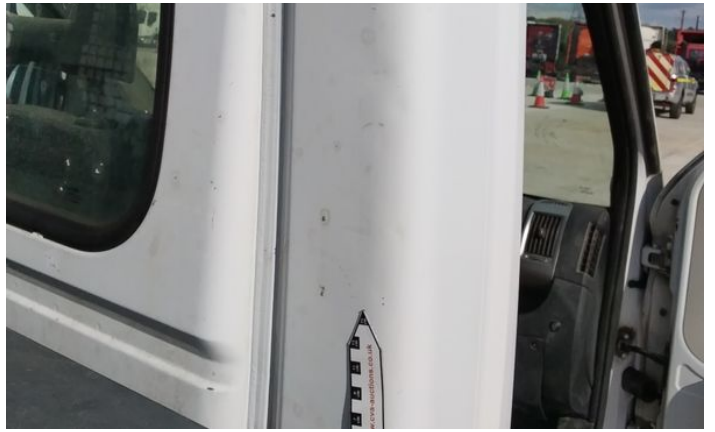
16: Panel Rear  
Dented  
With Paint Damage

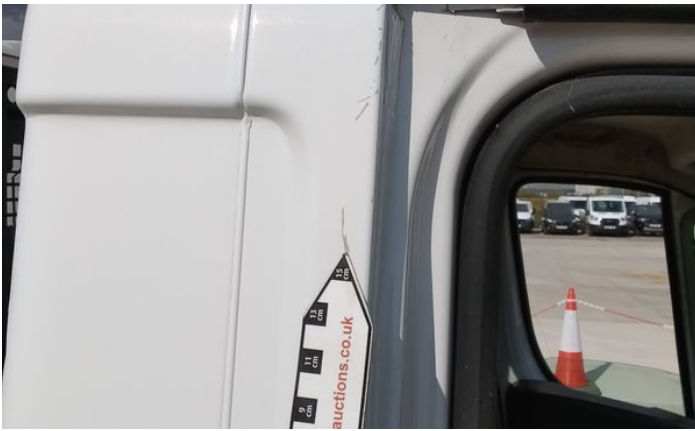
17: B Post os  
Scratched  
Over 25mm Thru Paint

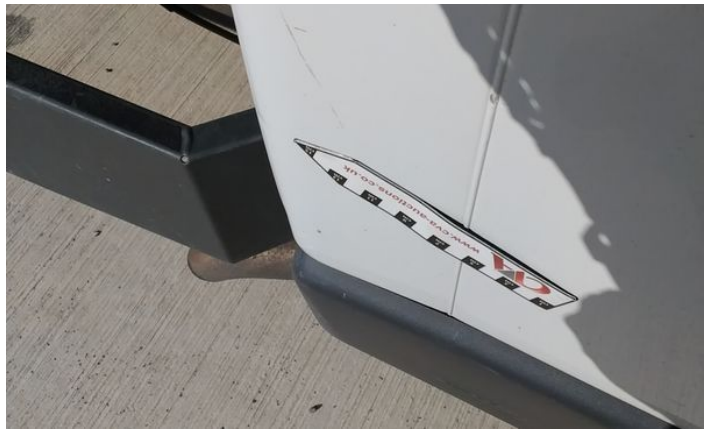
18: Qtr Panel osr  
Dented  
With Paint Damage

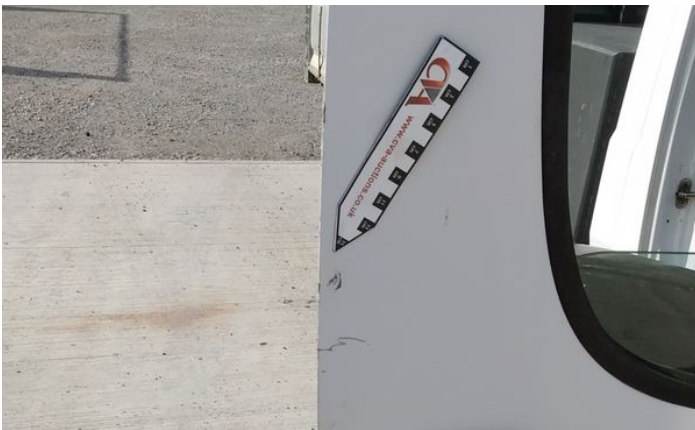
19: Door osf  
Scratched  
Over 25mm Thru Paint

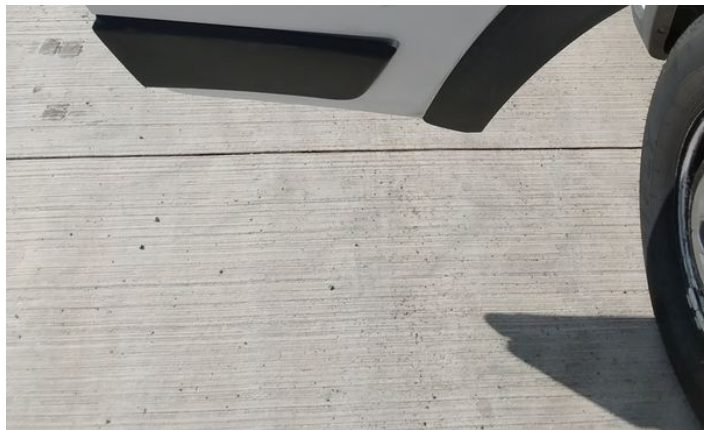
20: Door osf  
Dented  
With Paint Damage

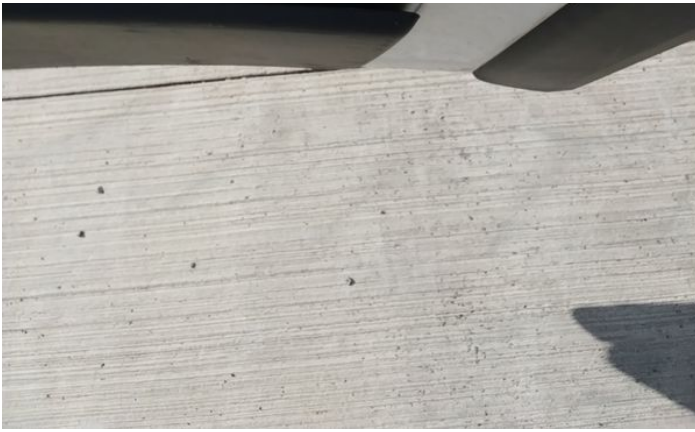
21: Door Moulding osf  
Broken  
Replace

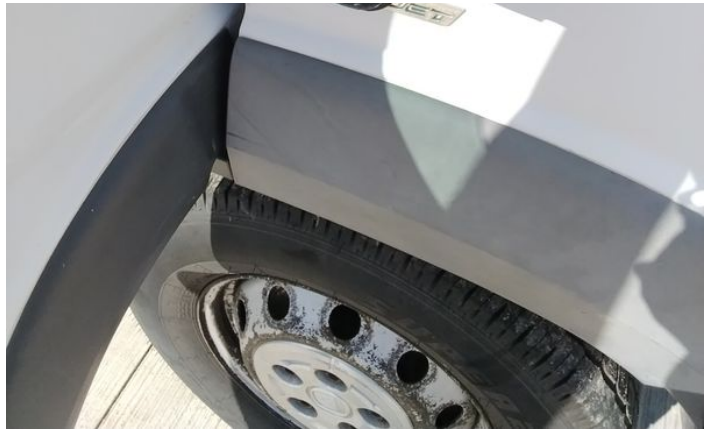
22: Door Mirror Assy osf  
Broken  
Replace

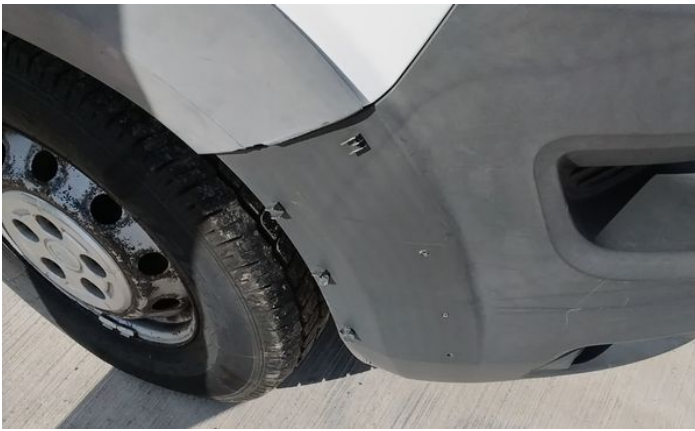
23: Bumper Front  
Insecure  
Action Required

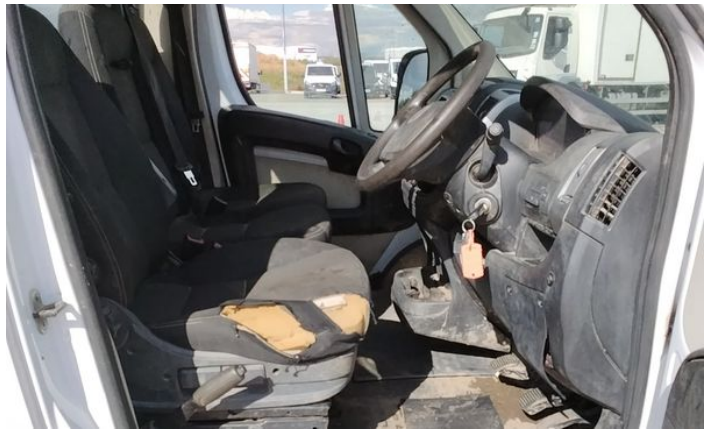
24: General Interior  
Soiled  
Light

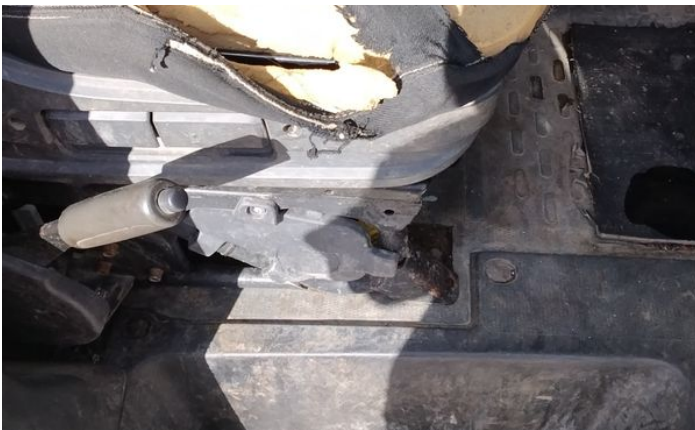
25: Seat Base Cover osf  
Holed  
Over 3mm

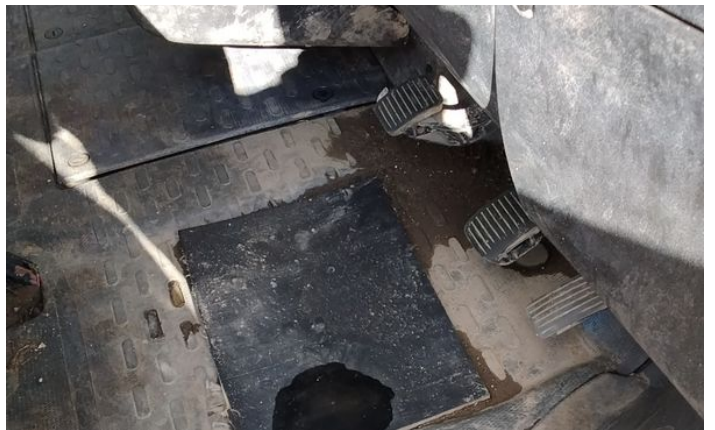
26: Carpets Front  
Broken  
Replace

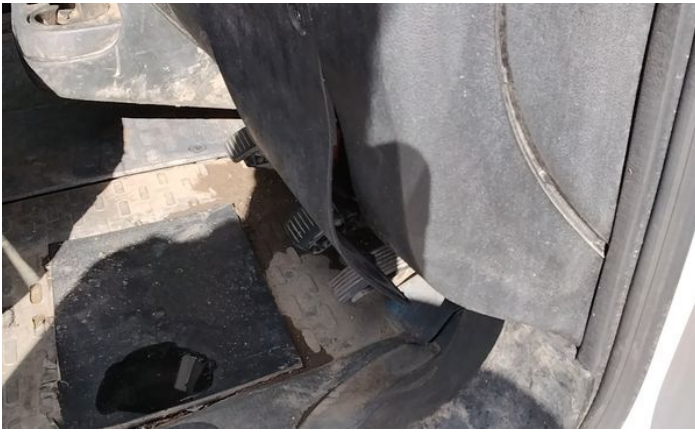
27: Fascia Trim  
Damaged  
Replace

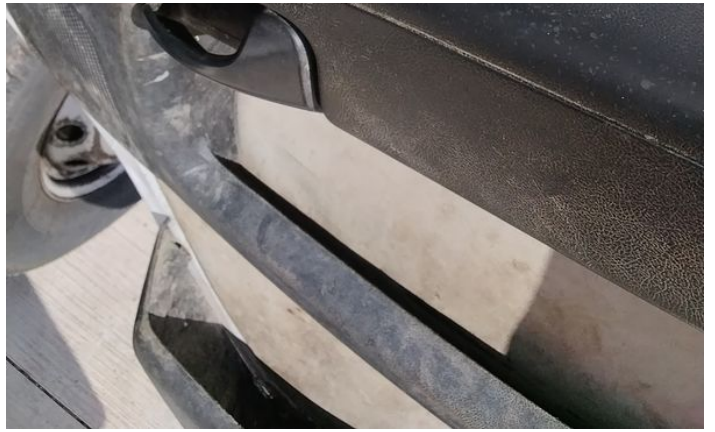
28: Fascia Trim  
Damaged  
Replace

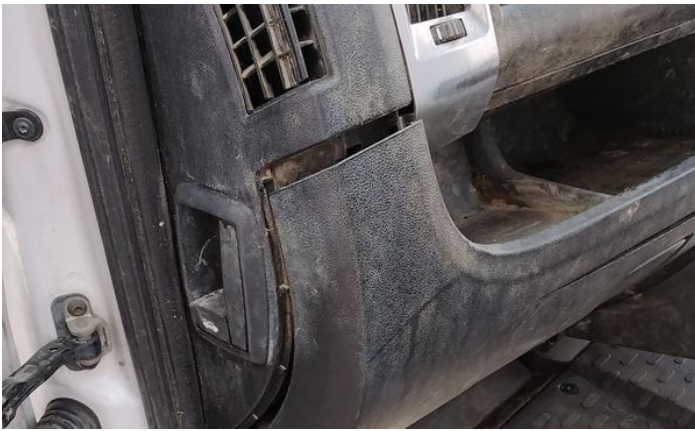
29: Fascia Trim  
Damaged  
Replace

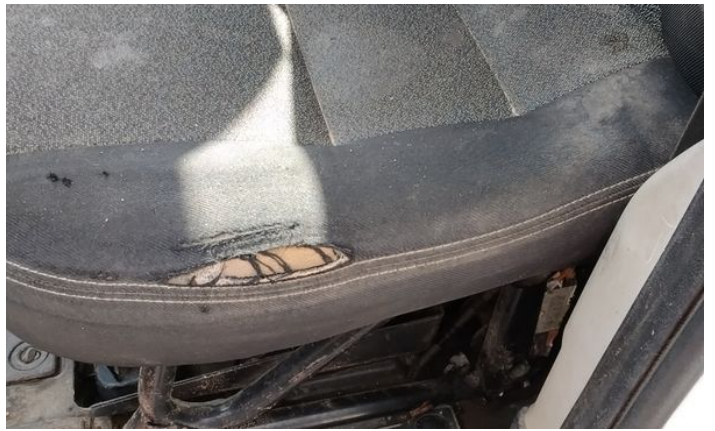
30: Seat Base Cover nsf  
Holed  
Over 3mm

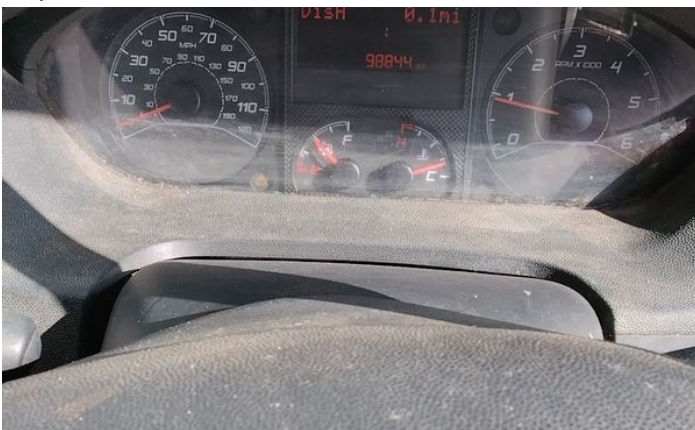
31: Dash Warning Lights  
Displayed  
No Action
