# VEHICLE INSPECTION REPORT

**WS19ACY**

## Fiat Ducato 35 2.3 Multijet II 130PS

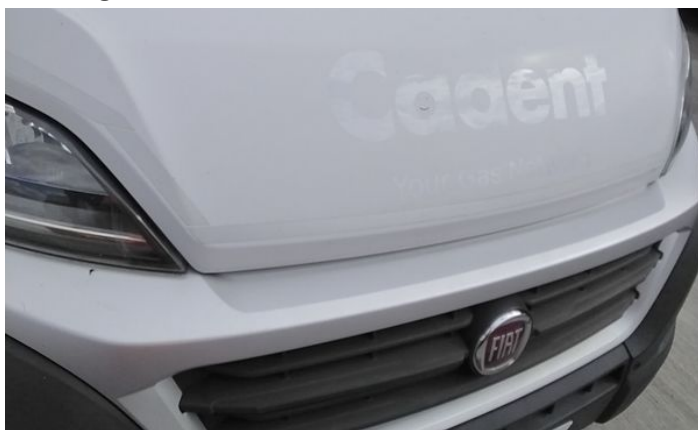
1: Bonnet  
Chipped  
Multiple Chips

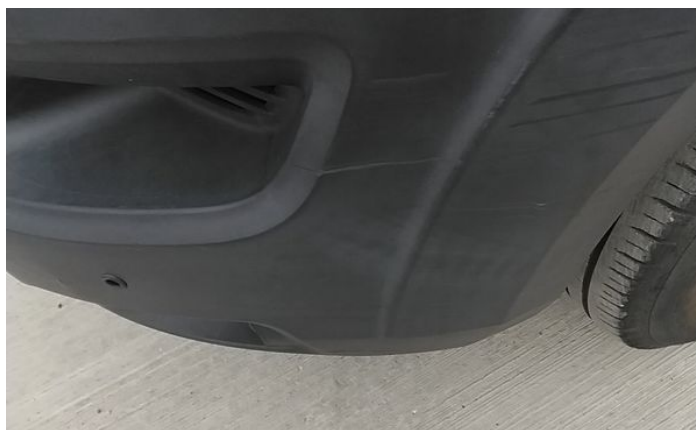
2: Bumper Front  
Scratched  
Over 100mm Thru Paint

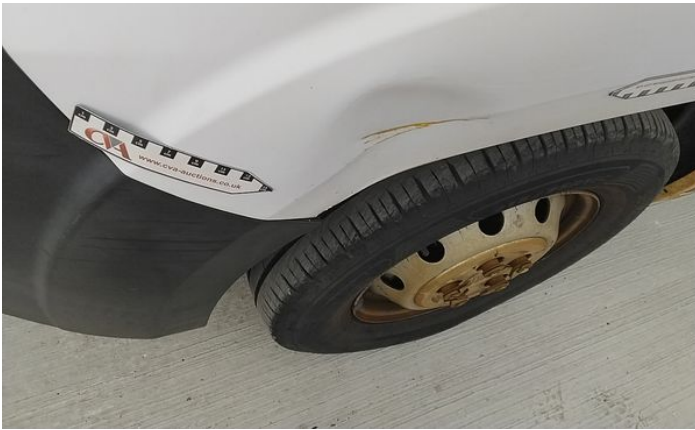
3: Wing nsf  
Dented  
With Paint Damage

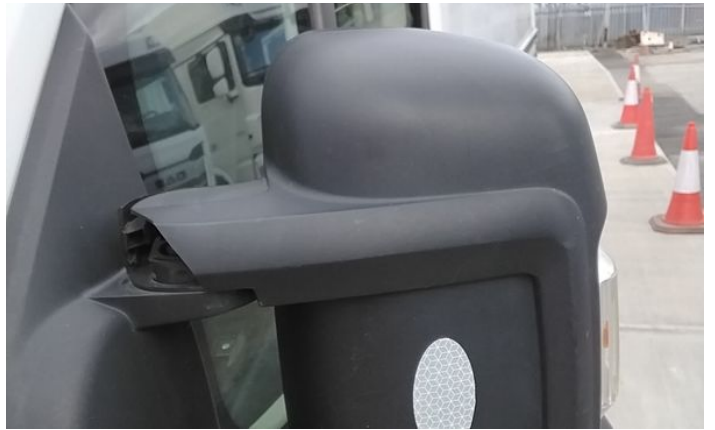
4: Door Mirror Assy nsf  
Broken  
Replace

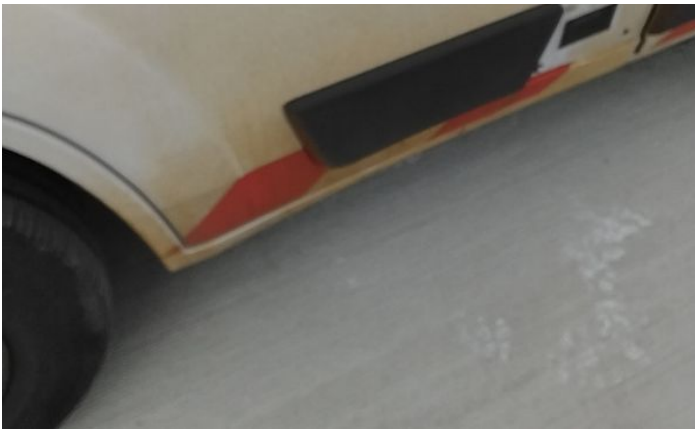
5: Door nsf  
Chipped  
Multiple Chips

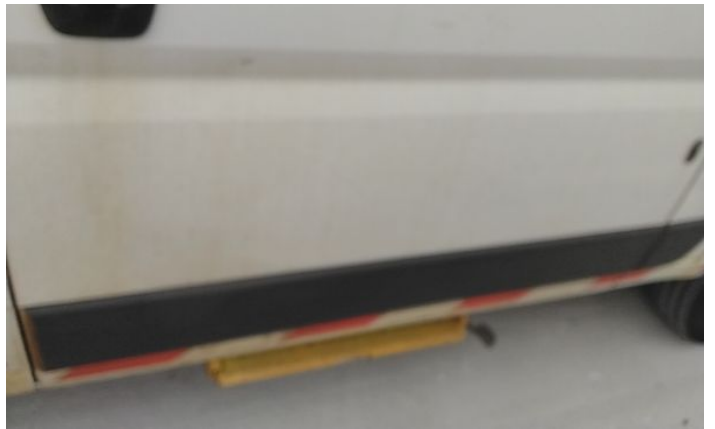
6: Qtr Panel nsr  
Chipped  
Multiple Chips

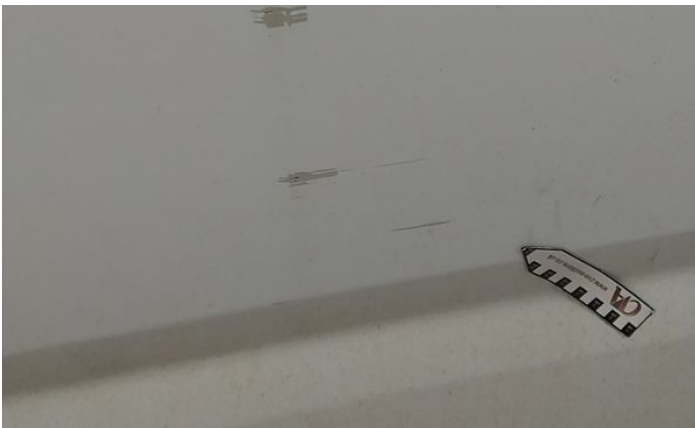
7: Qtr Panel nsr  
Dented  
With Paint Damage

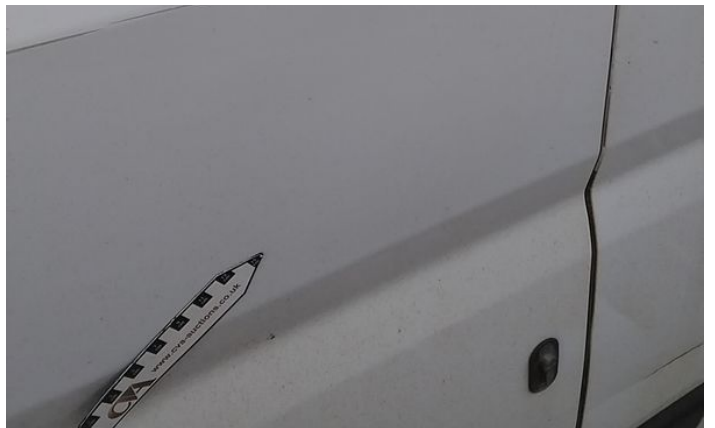
8: Qtr Panel nsr  
Dented  
Over 30mm

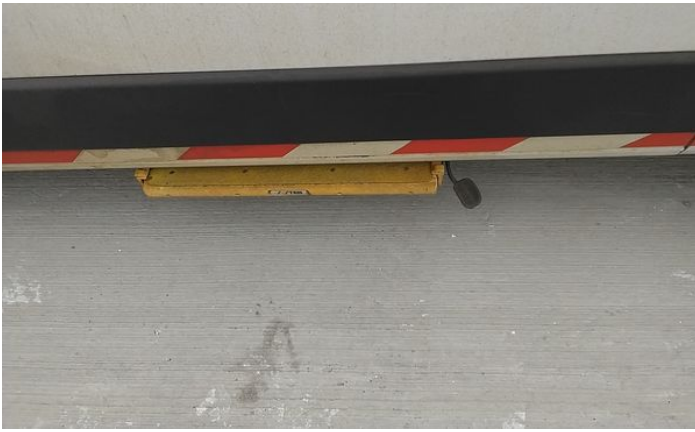
9: Qtr Panel Moulding ns  
Scuffed (Unpainted)  
Over 100mm

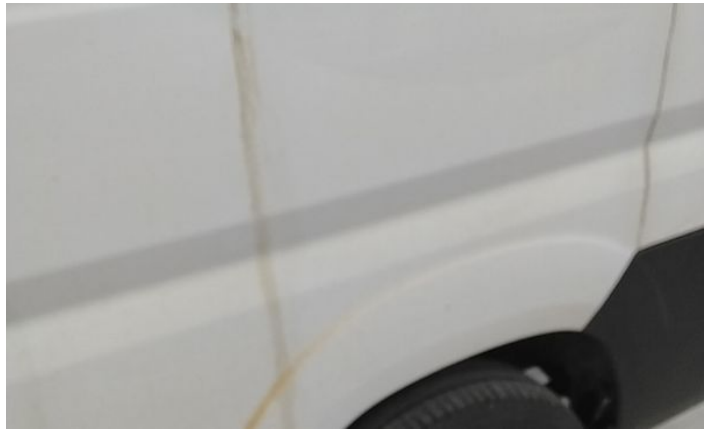
10: Qtr Panel nsr  
Chipped  
Multiple Chips

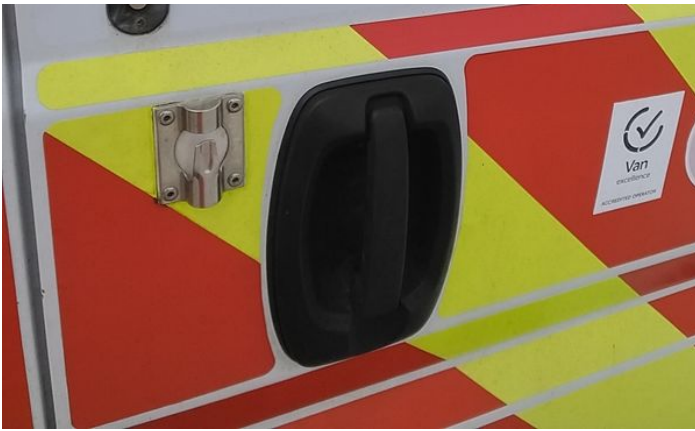
11: Door osr  
Chipped  
Over 5mm

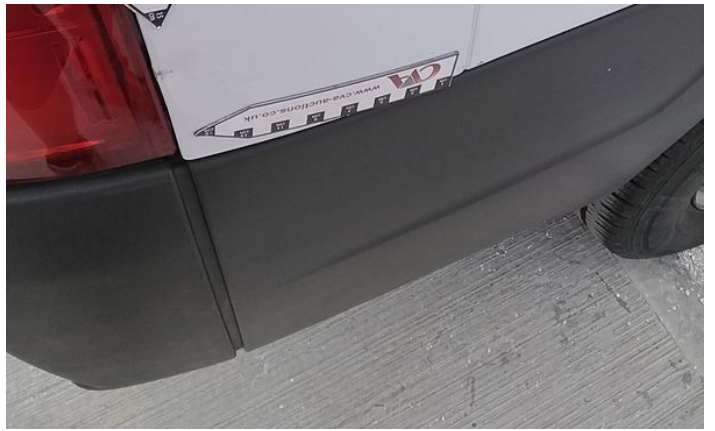
12: C Post os  
Dented  
With Paint Damage

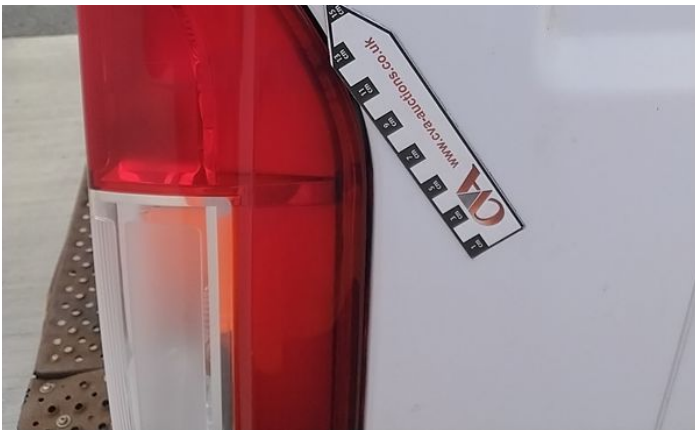
13: C Post os  
Dented  
With Paint Damage

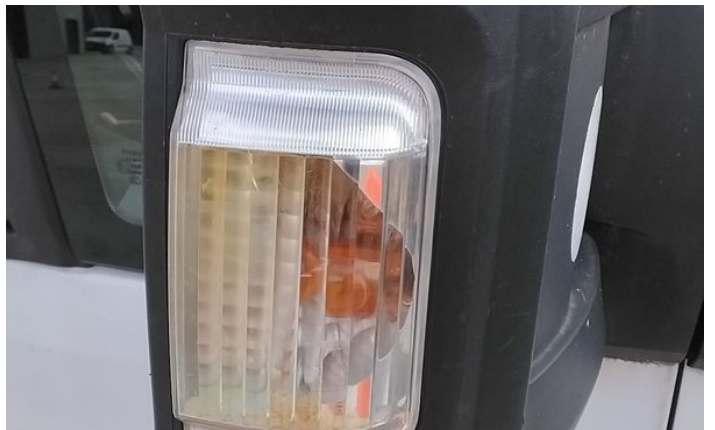
14: Door Mirror Assy osf  
Scuffed (Unpainted)  
UpTo 100mm

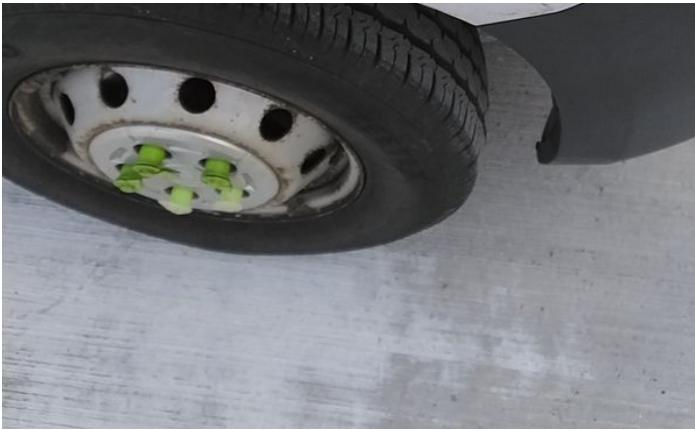
15: Wing osf  
Dented  
With Paint Damage

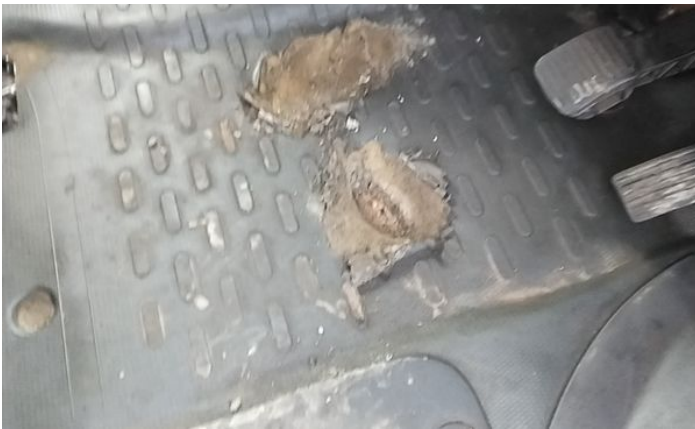
17: Carpets Front  
Holed  
Over 3mm

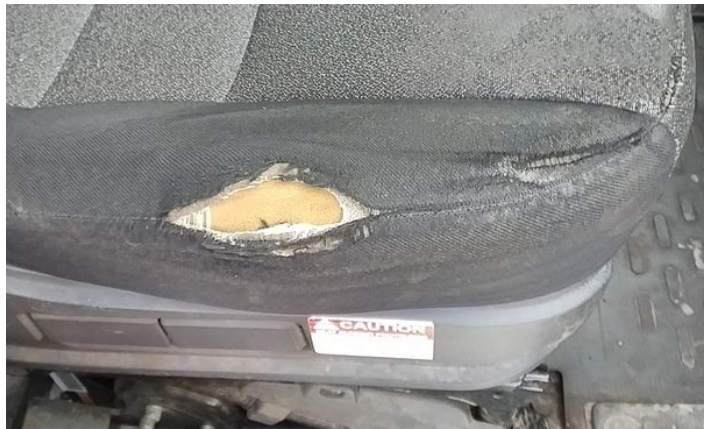
18: Seat Base Cover osf  
Holed  
Over 3mm

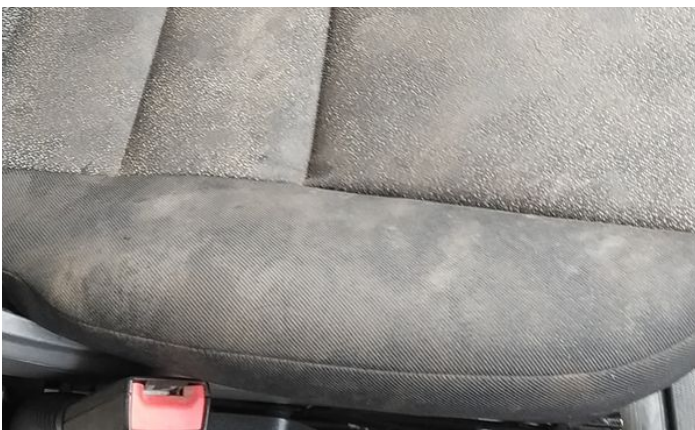
19: Seat Base Cover nsf  
Soiled  
Heavy

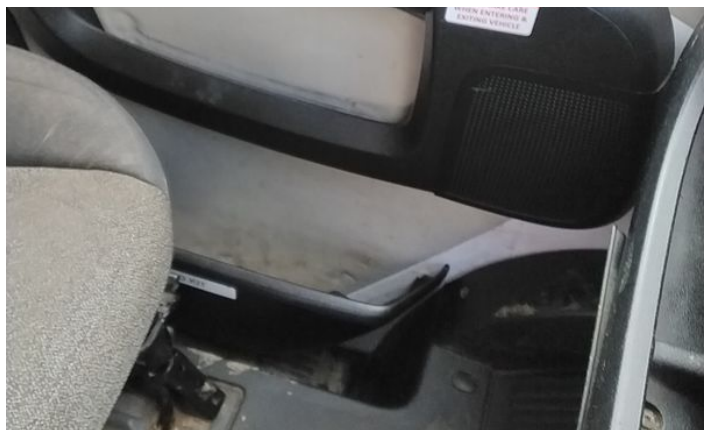
20: Door Pad nsf  
Soiled  
Heavy
