# VEHICLE INSPECTION REPORT

**WX20KME**

## Fiat Ducato 35 2.3 Multijet I 140PS

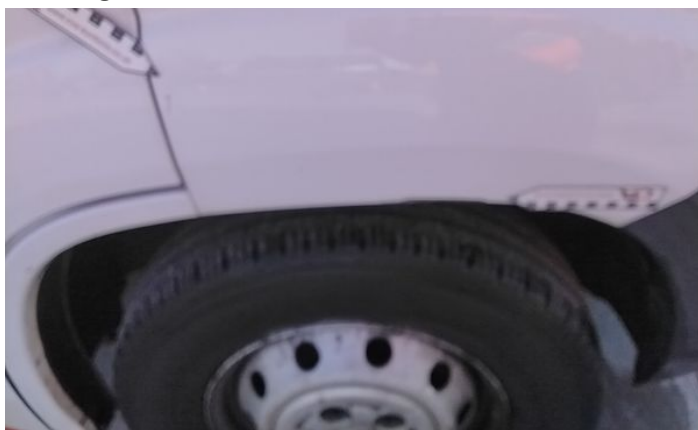
1: Wing osf  
Scratched  
Over 25mm Thru Paint

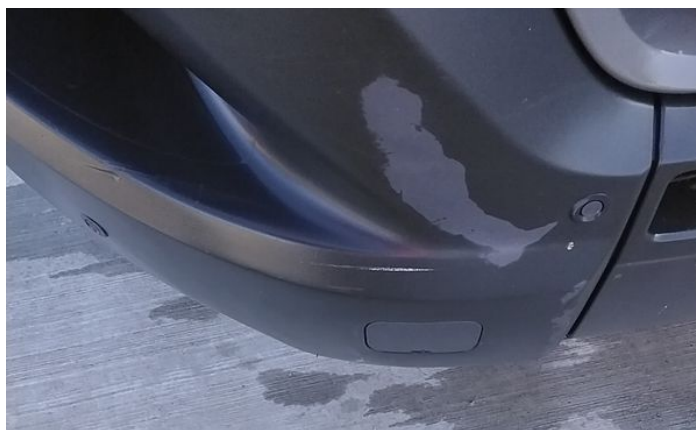
2: Bumper Front  
Scratched  
25 to 100mm Thru Paint

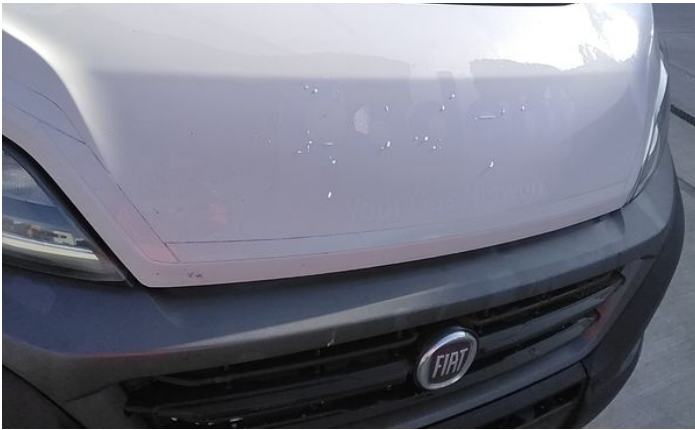
3: Bonnet  
Chipped  
Multiple Chips

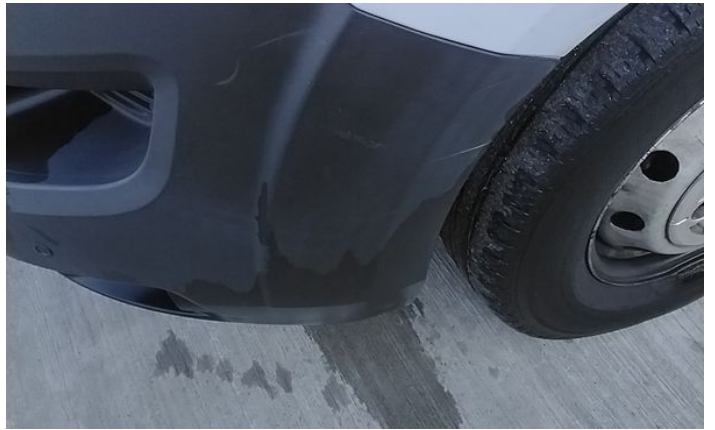
4: Bumper Front  
Scratched  
Over 100mm Thru Paint

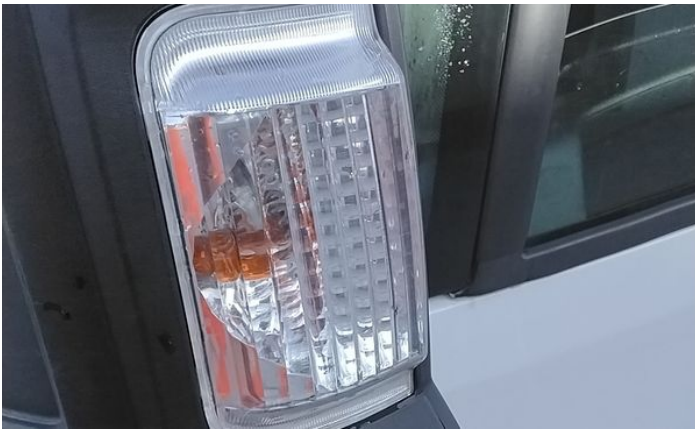
5: Door Mirror Assy nsf  
Scuffed (Unpainted)  
UpTo 100mm

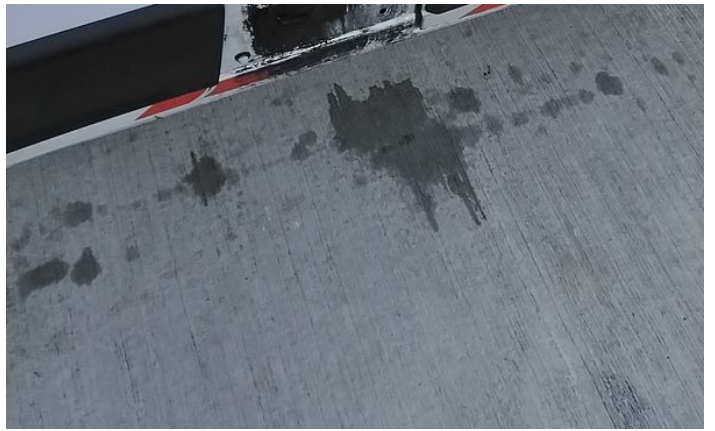
6: Door Moulding nsf  
Missing  
Replace

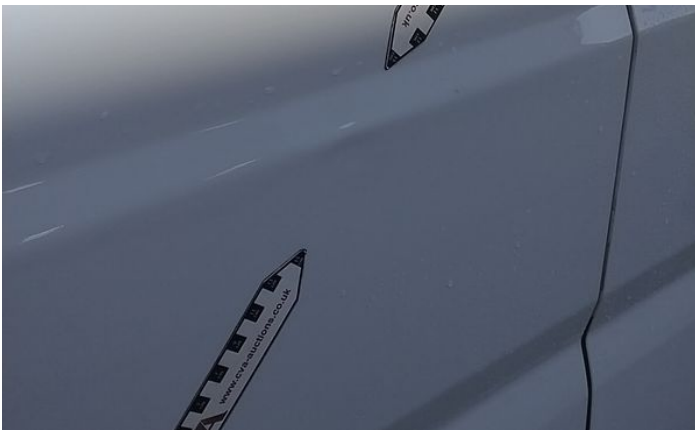
7: Qtr Panel nsr  
Dented  
Over 30mm

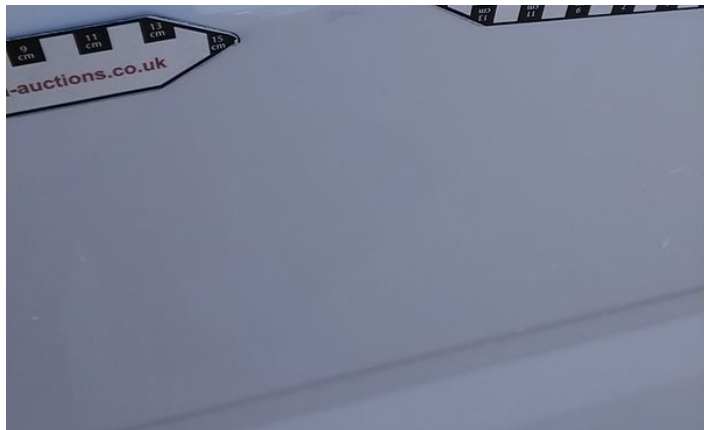
8: Qtr Panel osr  
Dented  
Over 30mm

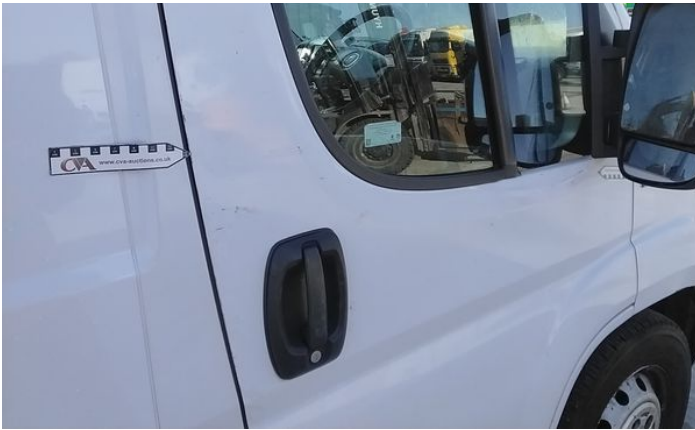
9: Door osf  
Scratched  
Over 25mm Thru Paint

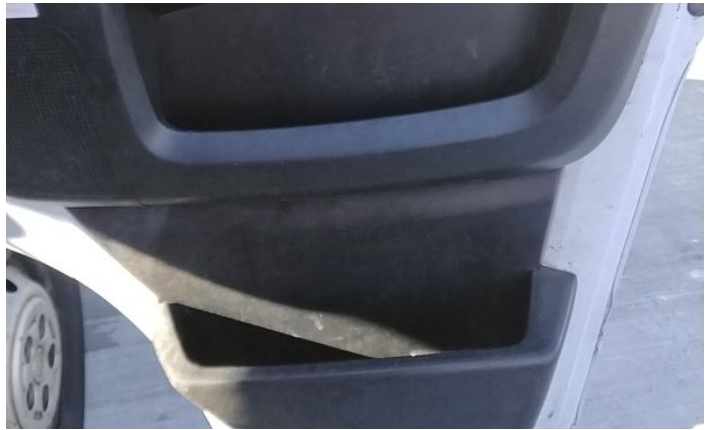
10: Door Pad osf  
Soiled  
Heavy

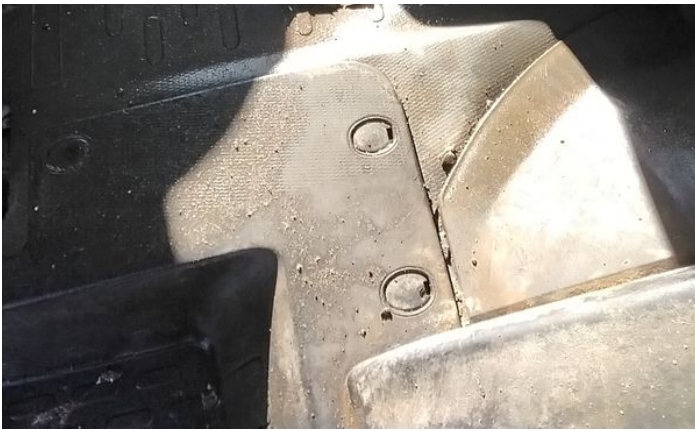
11: Carpets Front  
Holed  
Over 3mm

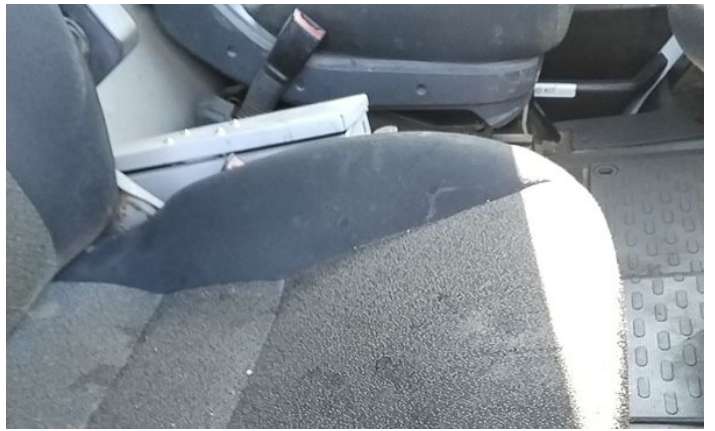
12: Seat Base Cover osf  
Torn  
Over 3mm

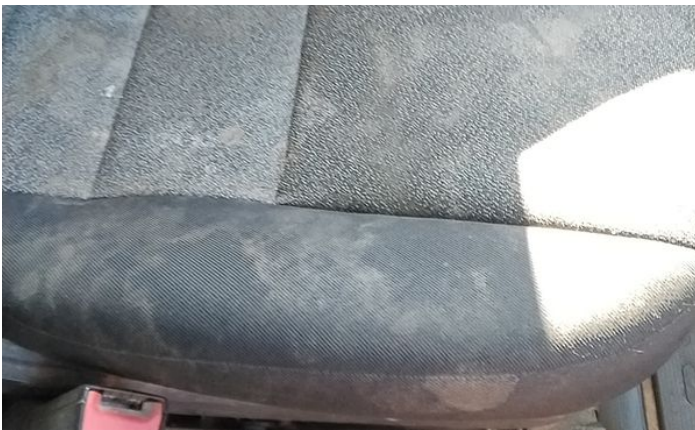
13: Seat Base Cover nsf  
Soiled  
Heavy

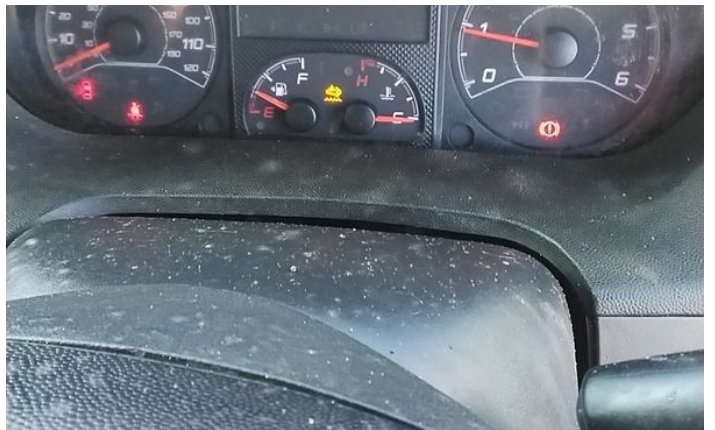
14: Dash Warning Lights  
Displayed  
No Action
