# VEHICLE INSPECTION REPORT

**KU68BAV**

## Daf LF 230

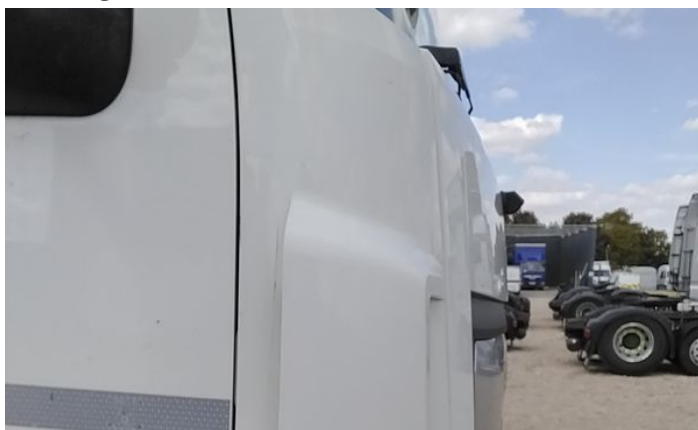
1: Wing osf  
Scratched  
Over 25mm Thru Paint

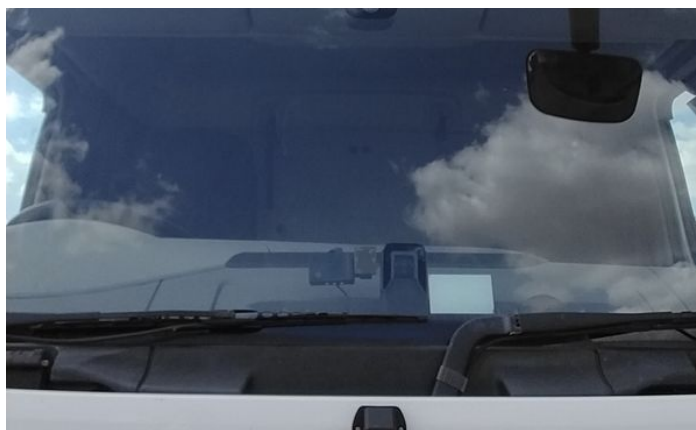
2: Screen Front  
Chipped  
UpTo 10mm

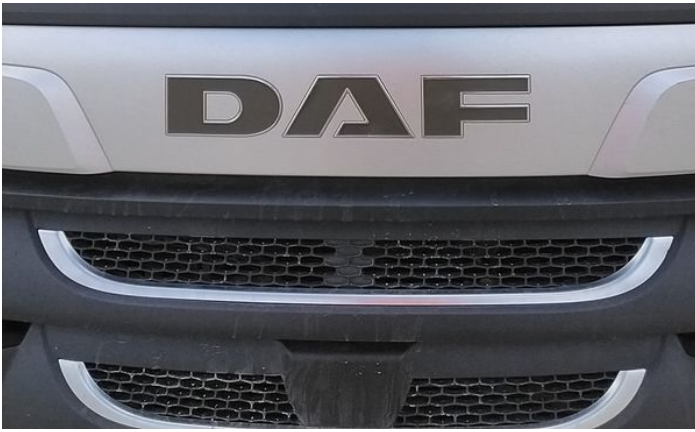
3: Bonnet  
Cracked  
Replace

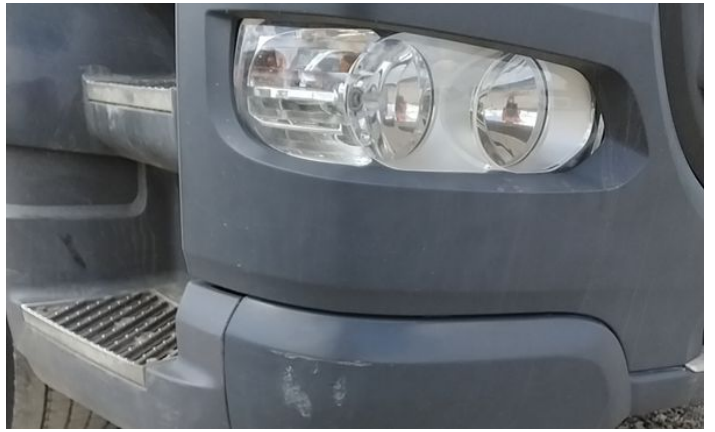
4: Bumper Front  
Scratched  
25 to 100mm Thru Paint

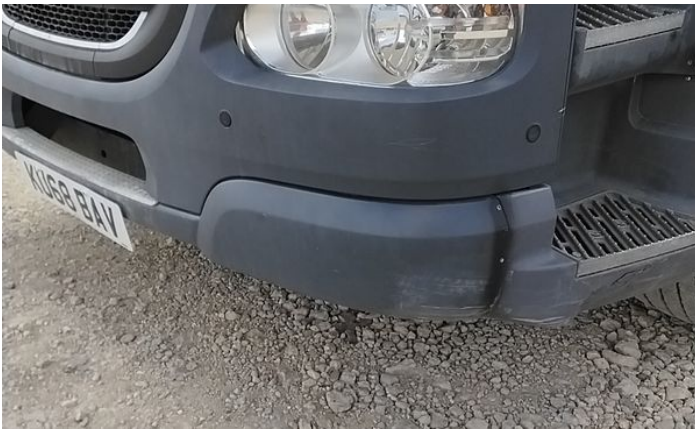
5: Bumper Front  
Scratched  
25 to 100mm Thru Paint

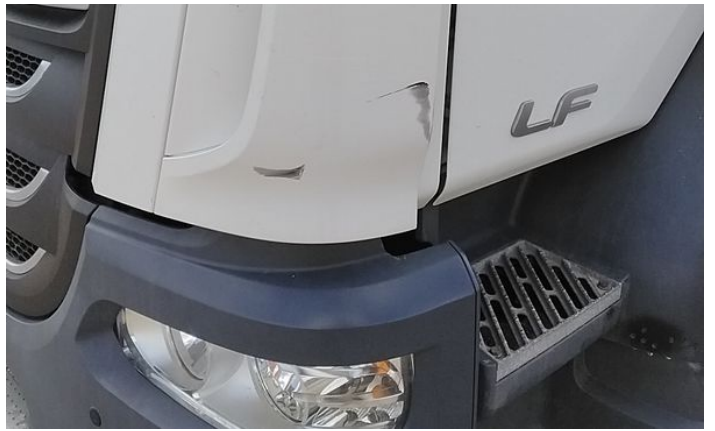
6: Wing nsf  
Scratched  
Over 25mm Not Thru Paint

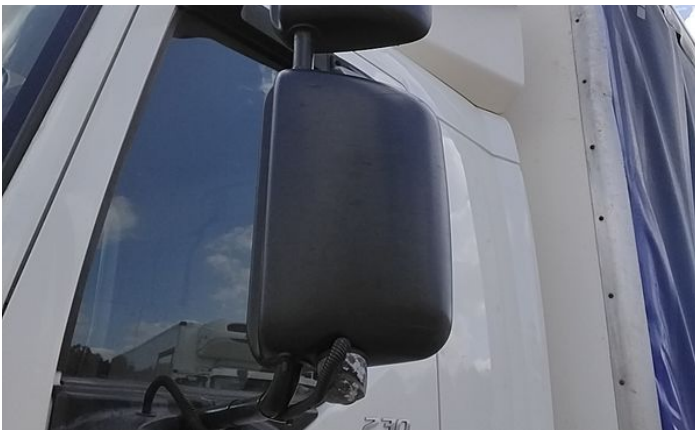
7: Door Mirror Assy nsf  
Scuffed (Unpainted)  
UpTo 100mm

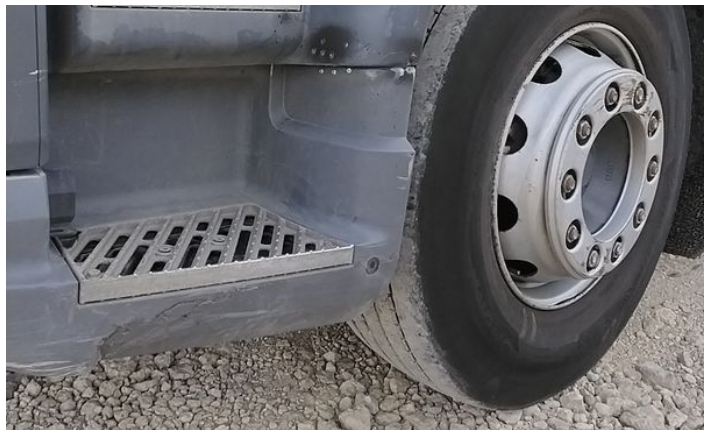
8: Wing Front Arch Extension ns  
Broken  
Replace

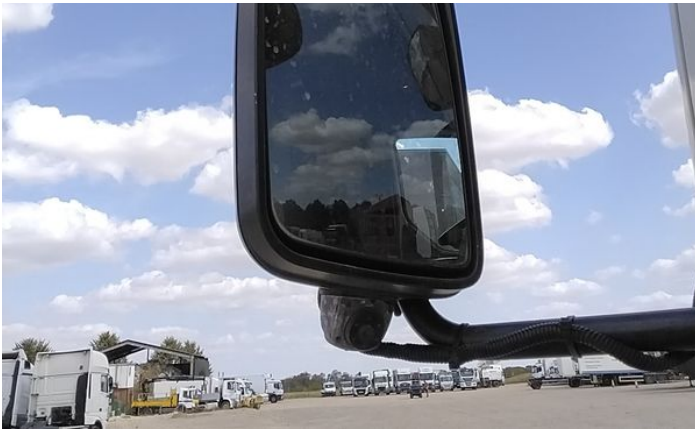
9: Door Mirror Glass ns  
Broken  
Replace

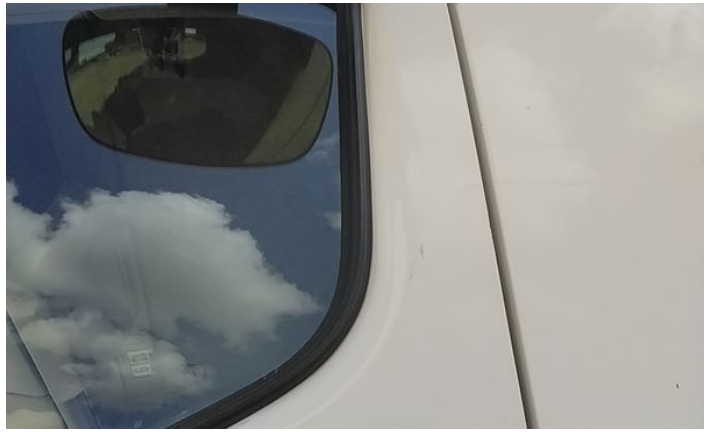
10: Door nsf  
Scratched  
Over 25mm Not Thru Paint

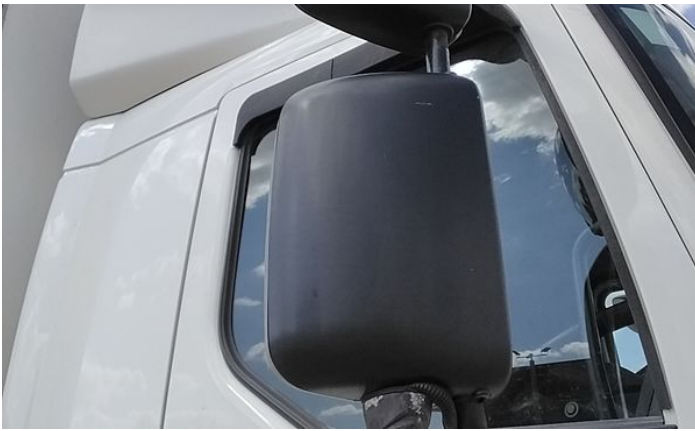
11: Door Mirror Assy osf  
Scuffed (Unpainted)  
UpTo 100mm

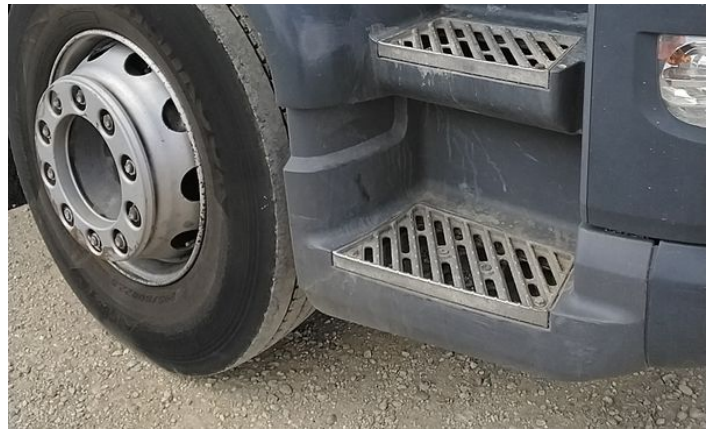
12: Wing Front Arch Extension os  
Scuffed (Unpainted)  
Over 100mm

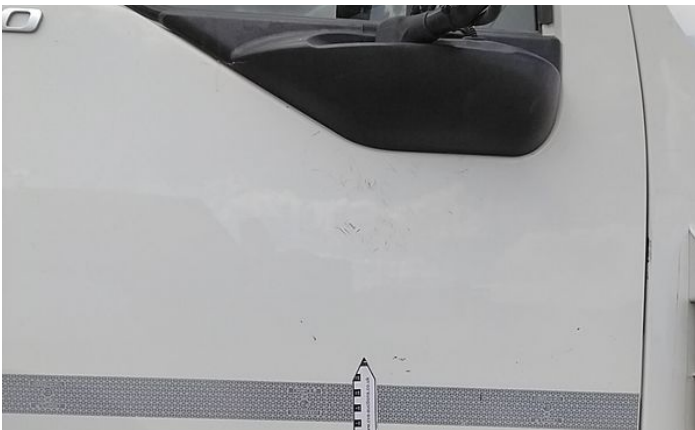
13: Door osf  
Scratched  
Over 25mm Not Thru Paint

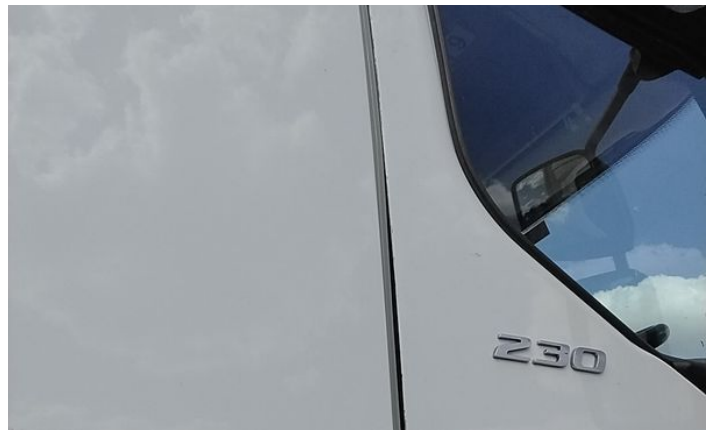
14: Door osf  
Chipped  
Edge Chip
