# VEHICLE INSPECTION REPORT

**KR68PZN**

## Daf LF 230

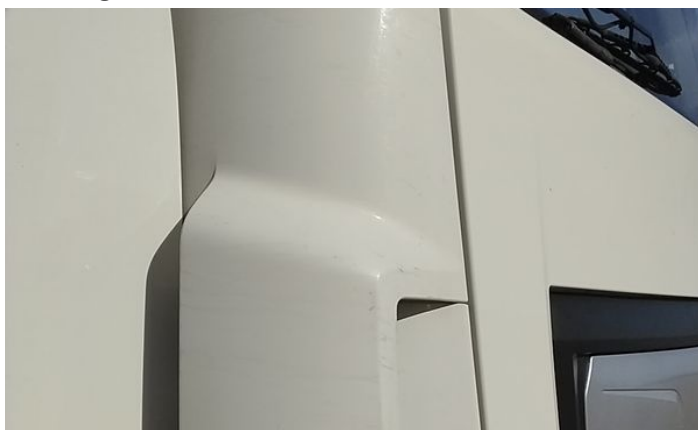
1: Wing osf  
Scratched  
Over 25mm Not Thru Paint

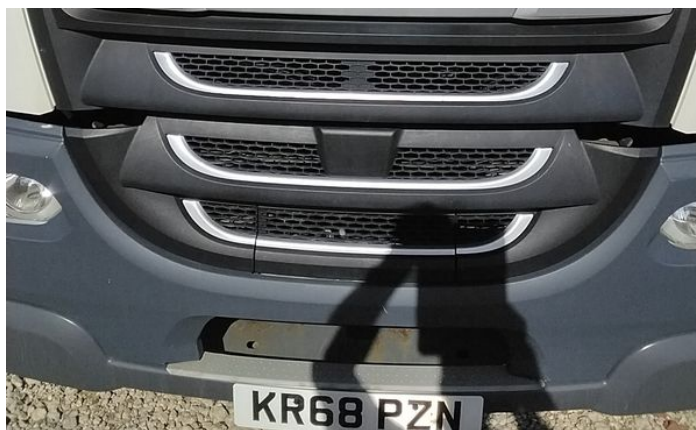
2: Bonnet  
Chipped  
Multiple Chips

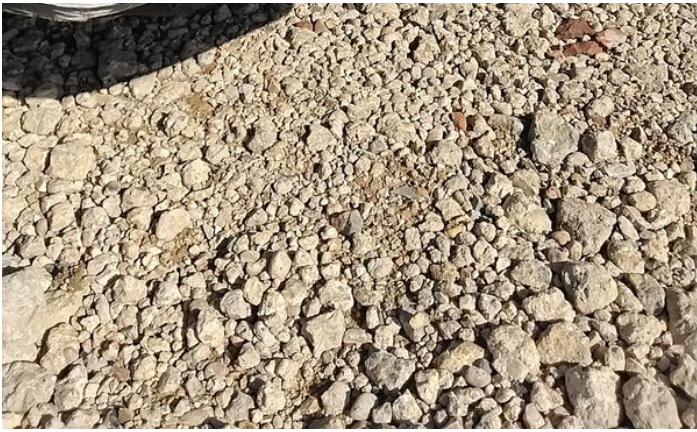
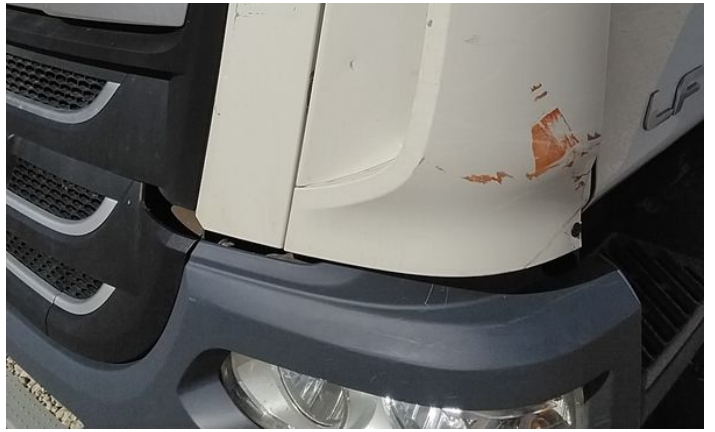
3: Bumper Front  
Scratched  
25 to 100mm Thru Paint

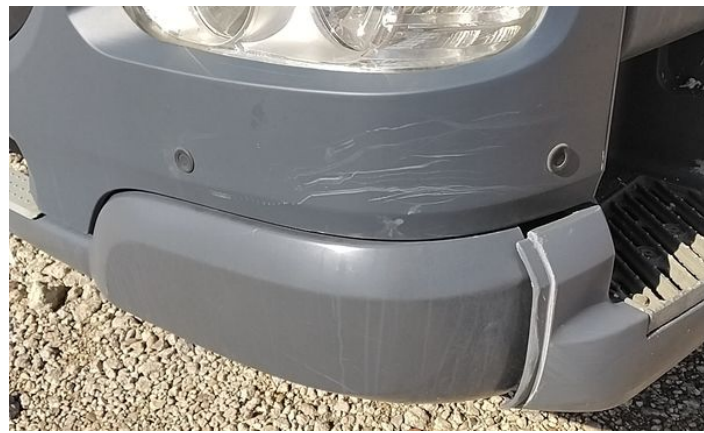
4: Wing nsf  
Poor Previous Repair  
Poor Colour

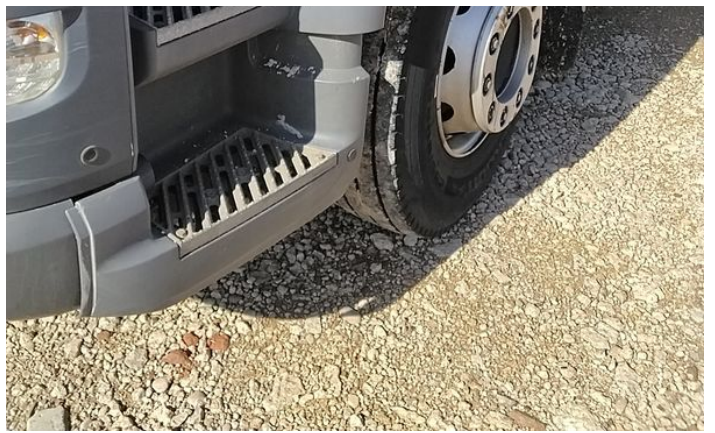
5: Fog Lamp Surround ns  
Scratched (Painted)  
Over 25mm Thru Paint

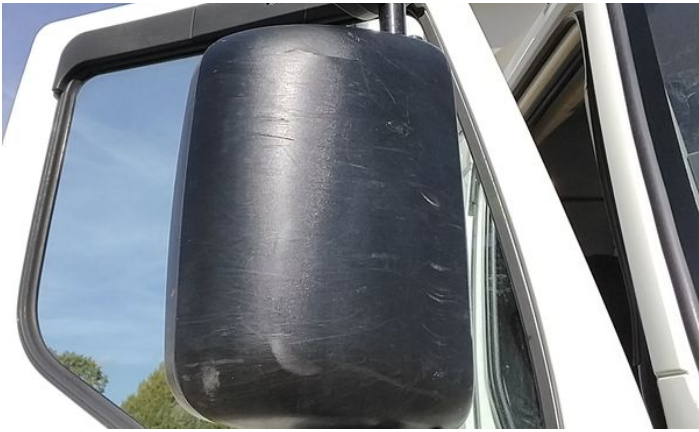
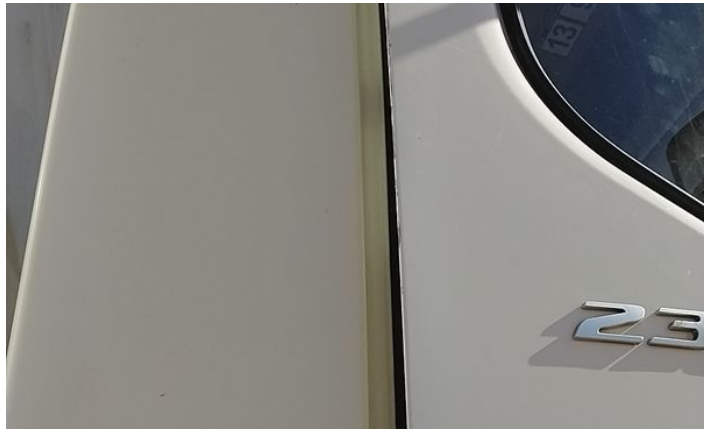
9: Door Mirror Assy osf  
Scuffed (Unpainted)  
UpTo 100mm

10: Door osf  
Chipped  
Edge Chip

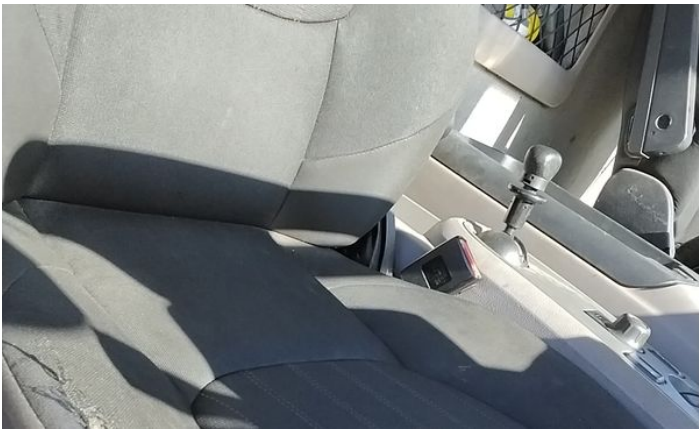
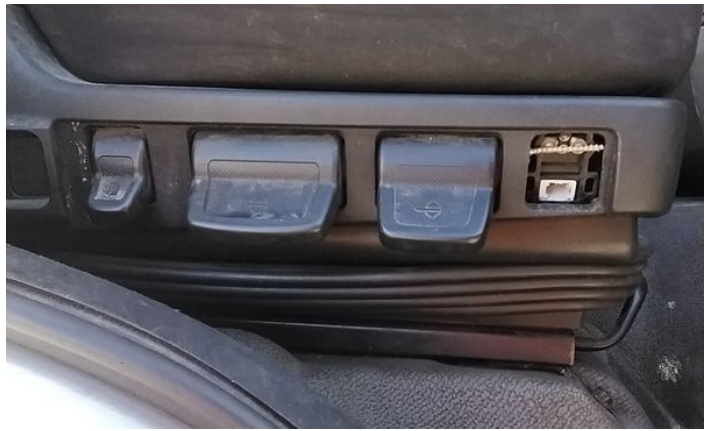
11: Seat Base Cover osf  
Holed  
Over 3mm

12: Seat Back Cover osf  
Missing  
Replace
