# VEHICLE INSPECTION REPORT

**WK18JPU**

## Volvo FH 460

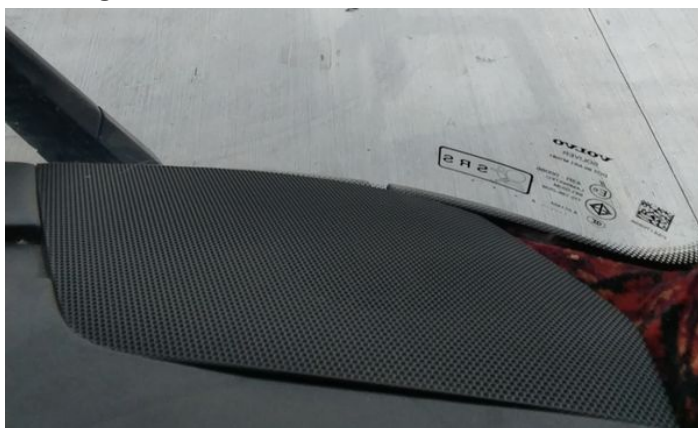
1: Screen Front  
Cracked  
Replace

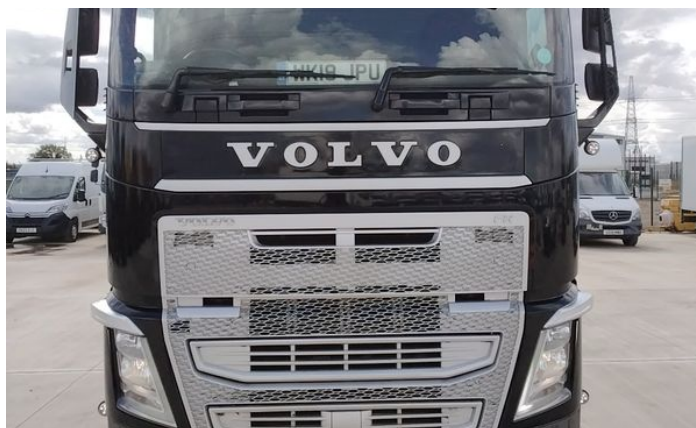
2: Bonnet  
Chipped  
Multiple Chips

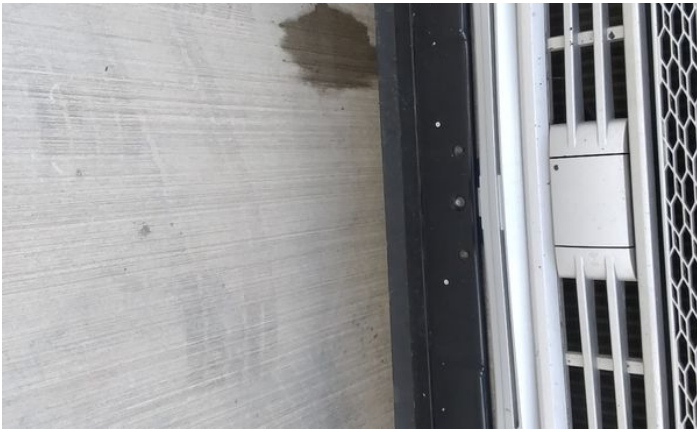
3: Number Plate Front  
Missing  
Replace

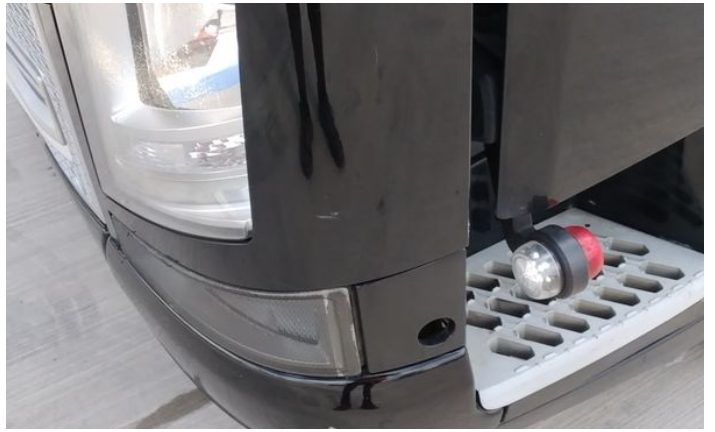
4: Moulding nsf Wing  
Scratched (Painted)  
Over 25mm Thru Paint

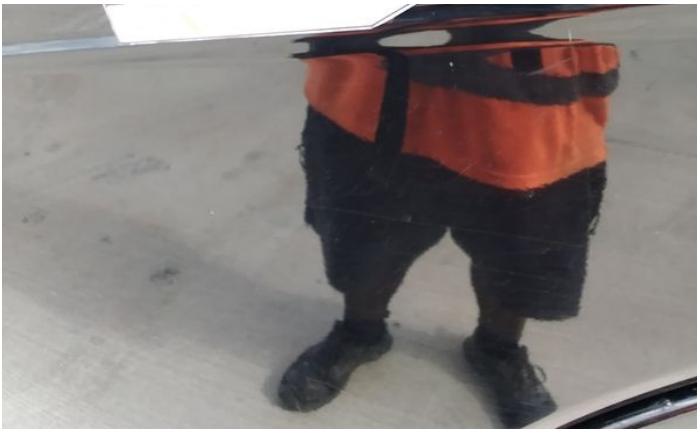
5: Door nsf  
Scratched  
Over 25mm Thru Paint

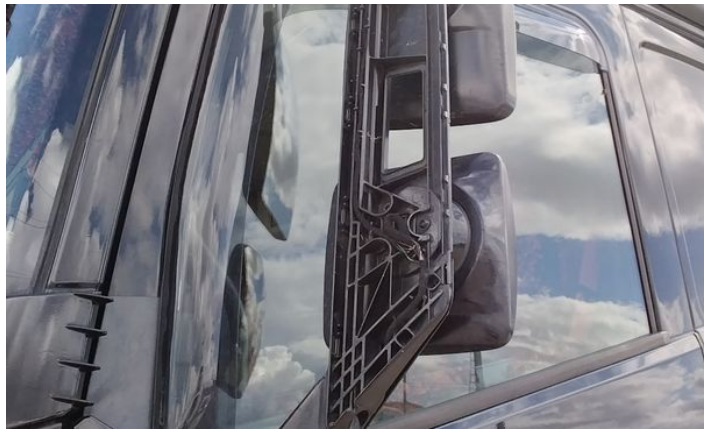
6: Door Mirror Assy nsf  
Broken  
Replace

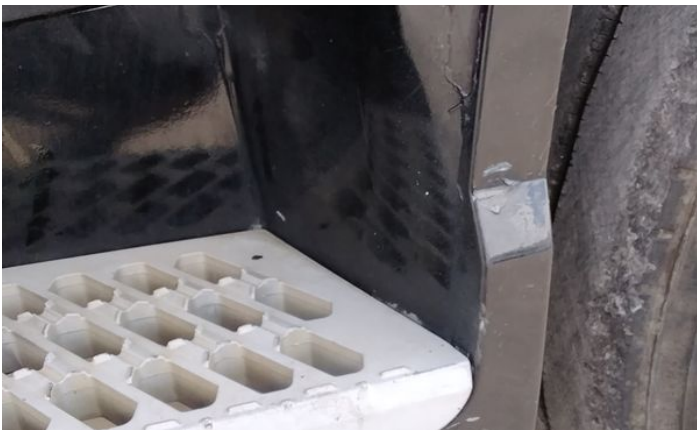
7: Wing nsf  
Cracked  
Replace

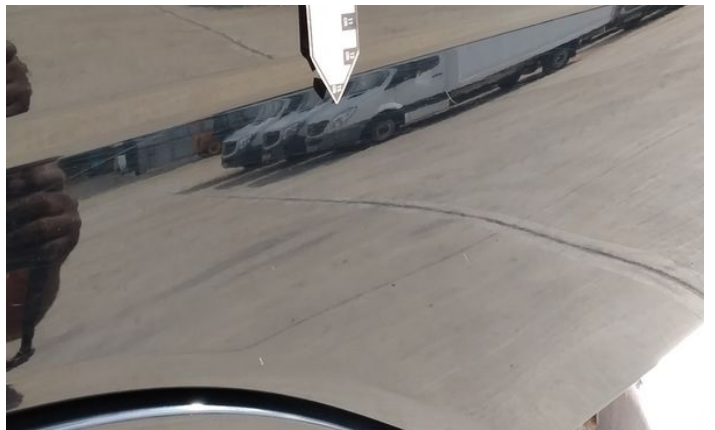
8: Qtr Panel nsr  
Scratched  
Over 25mm Thru Paint

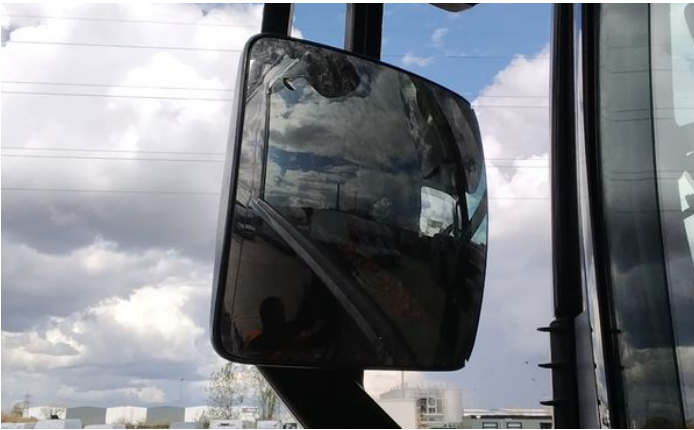
9: Door Mirror Glass ns  
Broken  
Replace

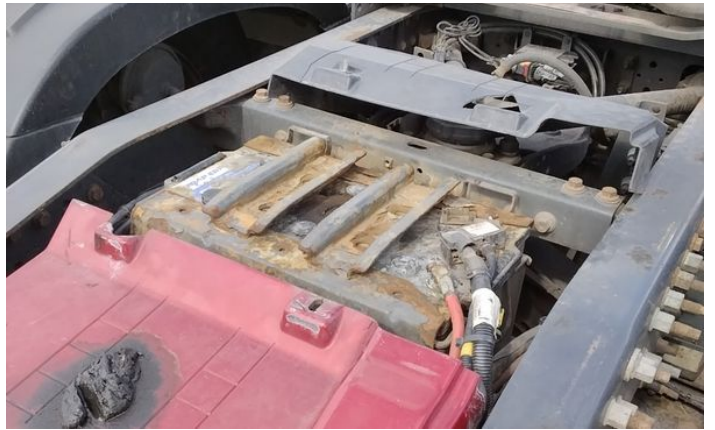
10: Qtr Panel Trim ns  
Missing  
Replace

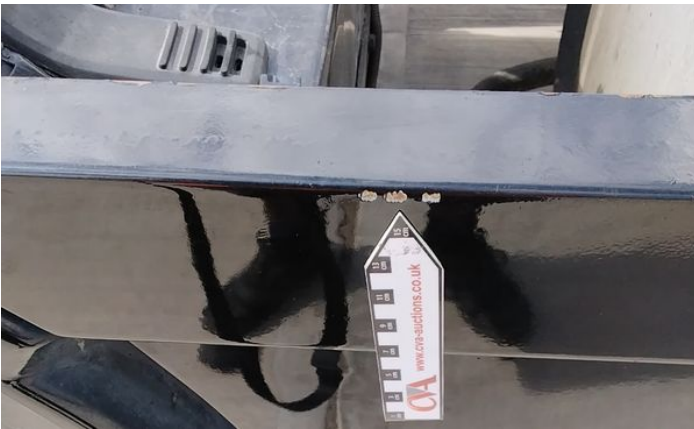
11: Qtr Panel osr  
Chipped  
Multiple Chips

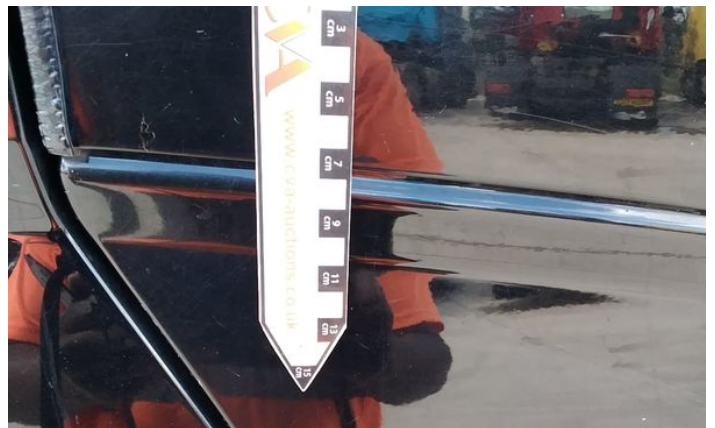
12: Door osf  
Chipped  
Multiple Chips

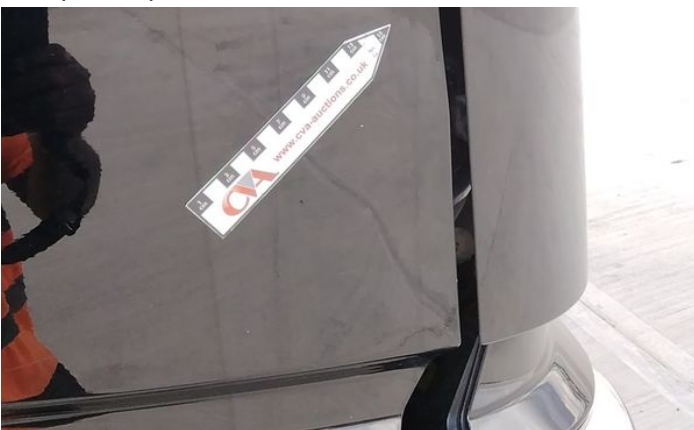
13: Door osf  
Dented  
Over 30mm

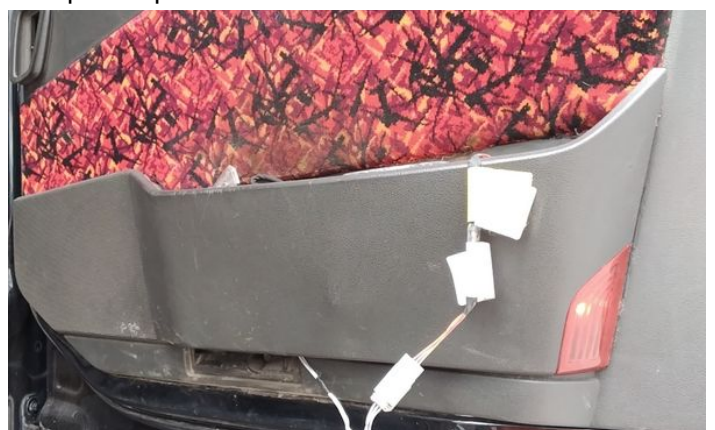
14: Fascia Trim  
Damaged  
Replace

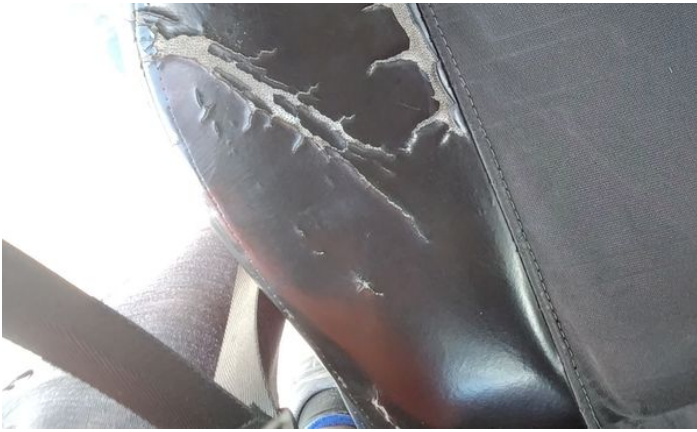
15: Seat Base Cover osf  
Holed  
Over 3mm

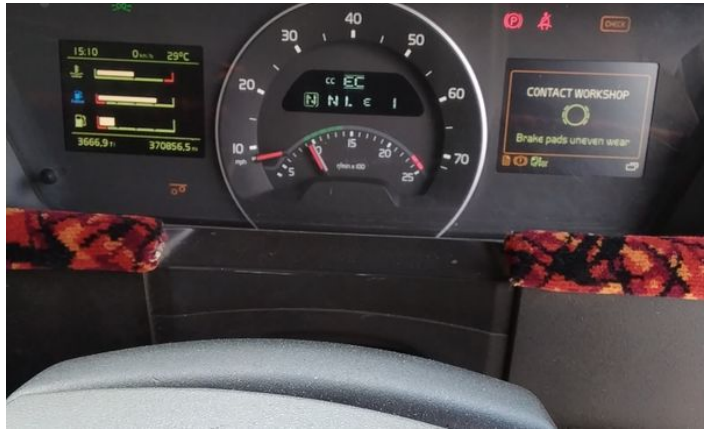
16: Dash Warning Lights  
Displayed  
No Action

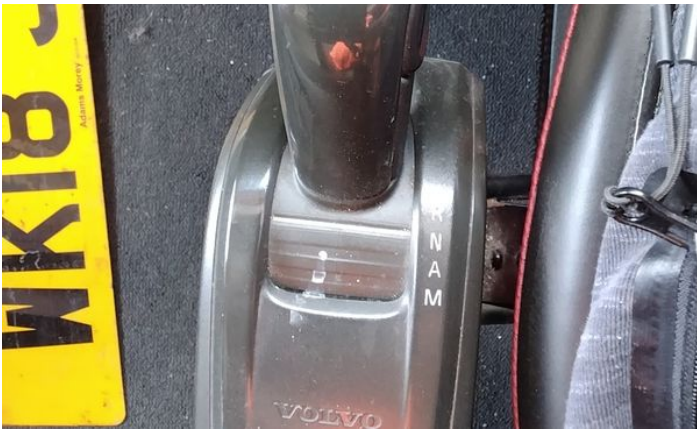
17: Fascia Trim  
Missing  
Replace

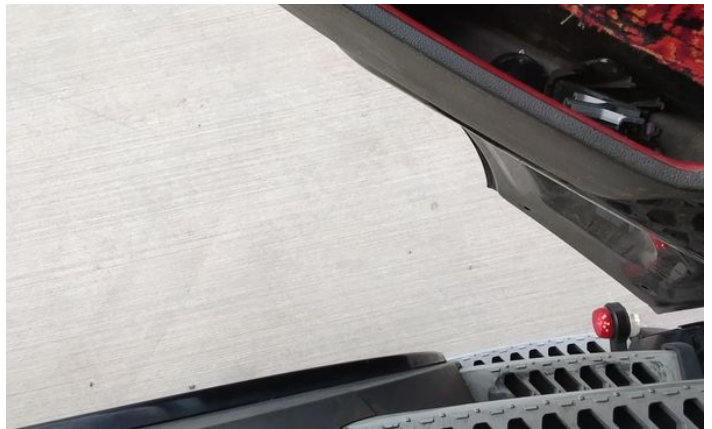
18: Fascia Trim  
Damaged  
Replace
