# VEHICLE INSPECTION REPORT

**WV70FXF**

## Vauxhall Movano 3500 2.3 Turbo D 135ps

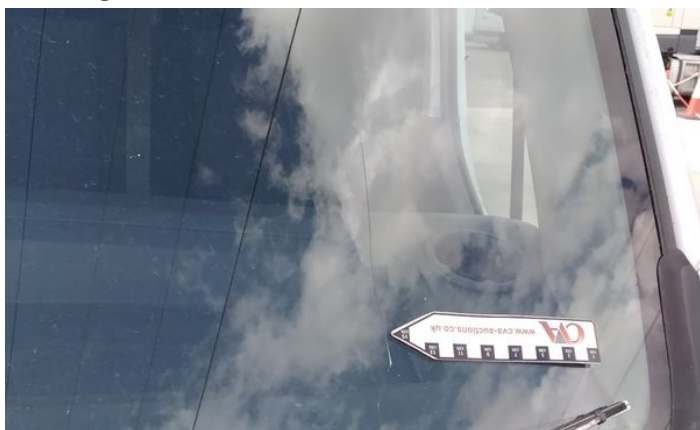
1: Screen Front  
Cracked  
Replace

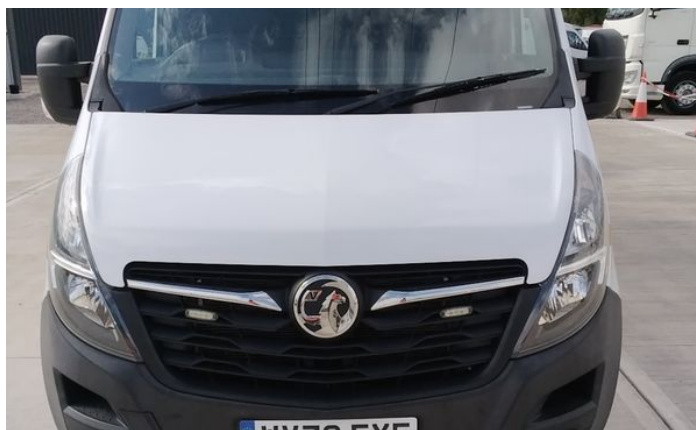
2: Bonnet  
Chipped  
Multiple Chips

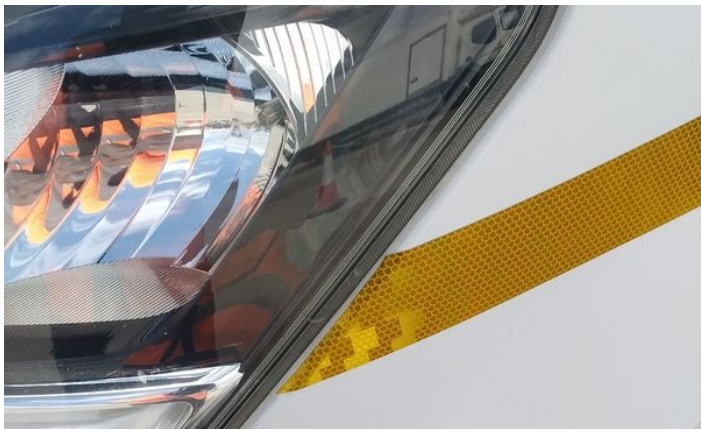
3: Wing nsf  
Chipped  
Multiple Chips

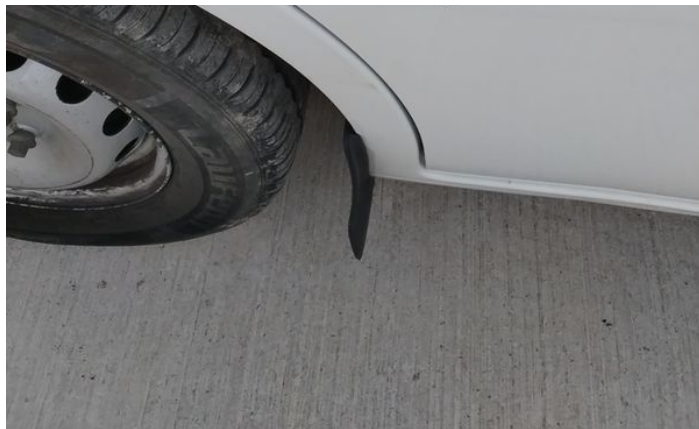
4: Door nsf  
Chipped  
1 To 5

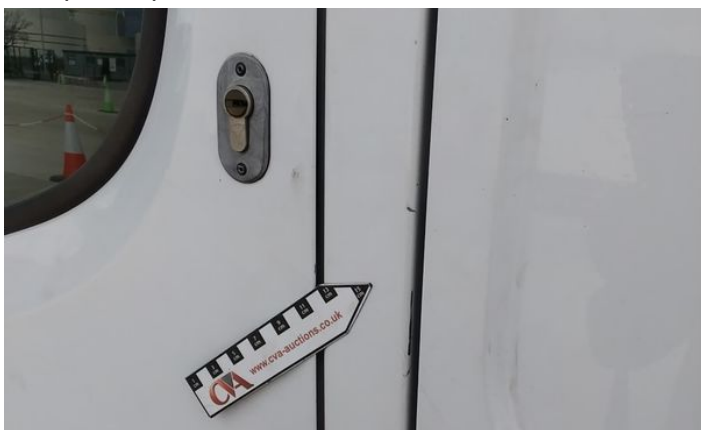
5: B Post ns  
Scratched  
Over 25mm Thru Paint

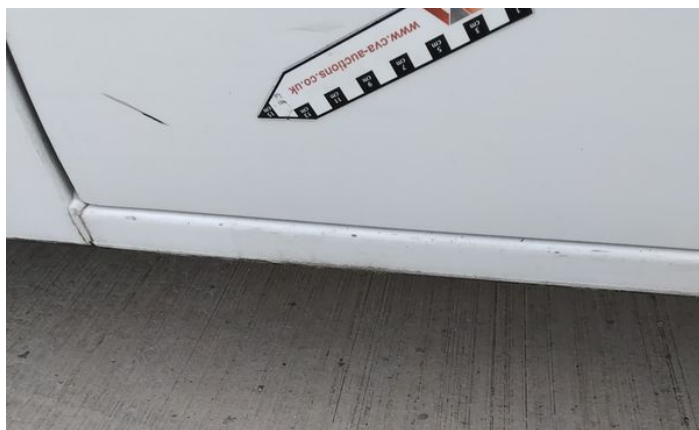
6: Qtr Panel nsr  
Scratched  
Over 25mm Not Thru Paint

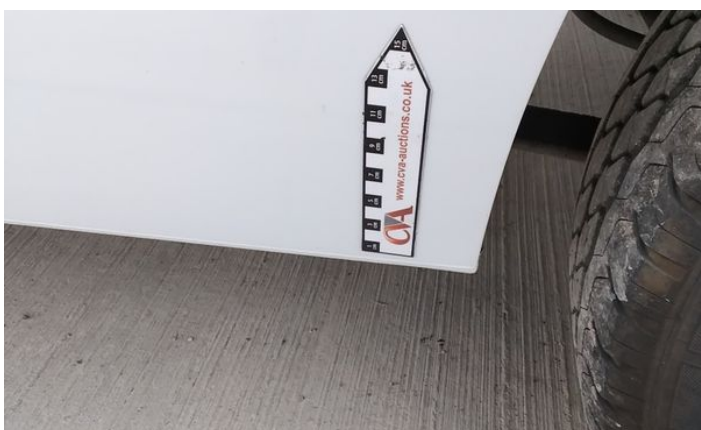
7: Qtr Panel nsr  
Scratched  
Over 25mm Not Thru Paint

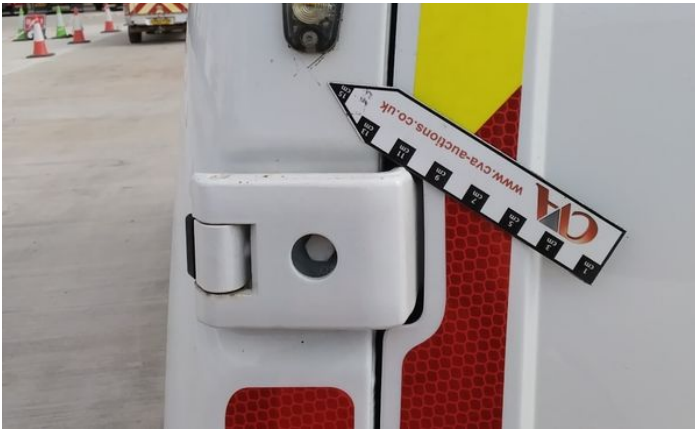
9: Panel Rear  
Scratched  
Over 25mm Thru Paint

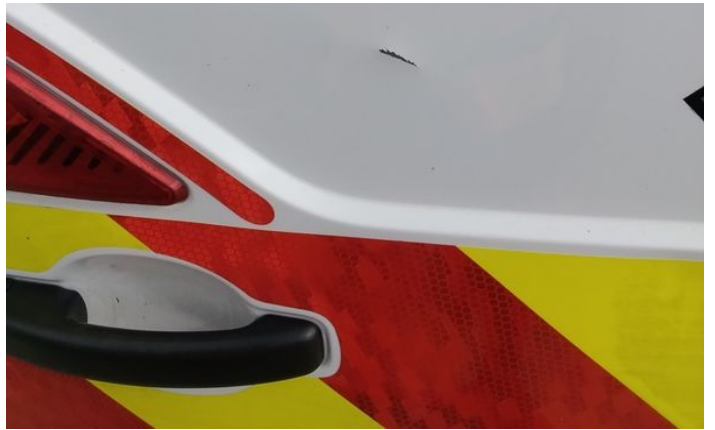
10: Door osr  
Dented  
With Paint Damage

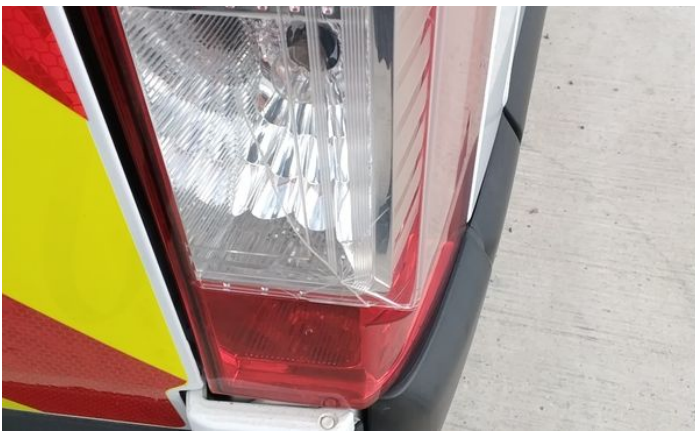
11: Lamp osr  
Broken  
Replace

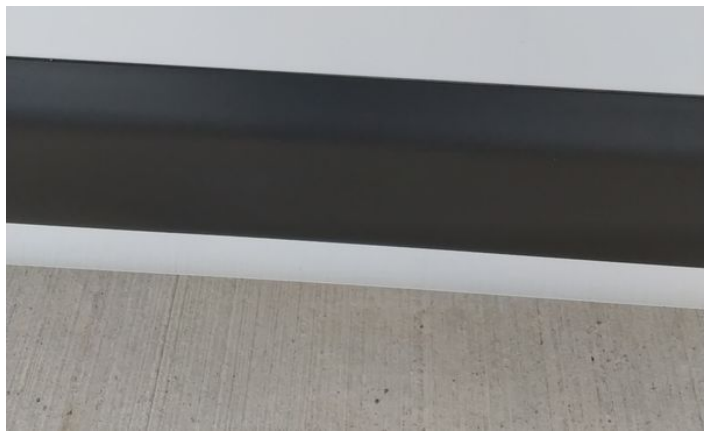
12: Qtr Panel osr  
Poor Previous Repair  
Poor Paint

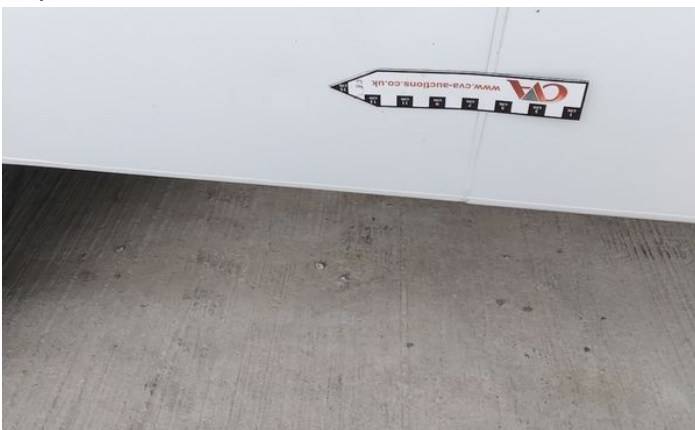
13: Qtr Panel osr  
Dented  
2 Or Less UpTo 10mm

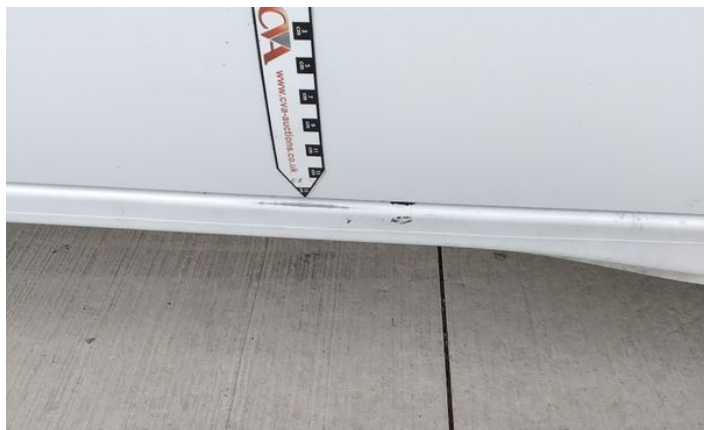
14: Sill os  
Scratched  
Over 25mm Thru Paint
