# VEHICLE INSPECTION REPORT

**BU69TNL**

## Daf LF 230

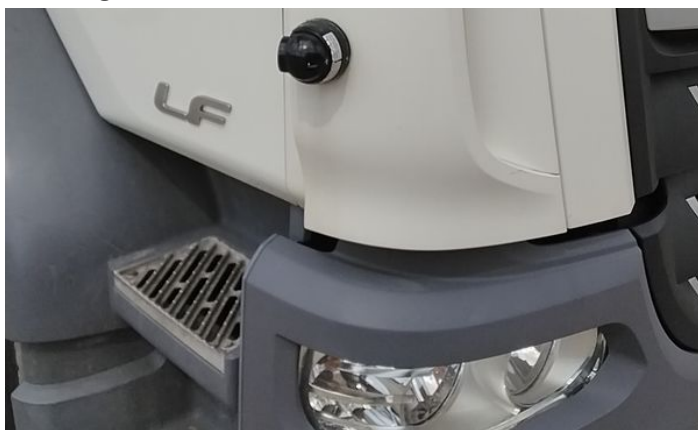
1: Wing osf  
Scratched  
UpTo 25mm Not Thru Paint

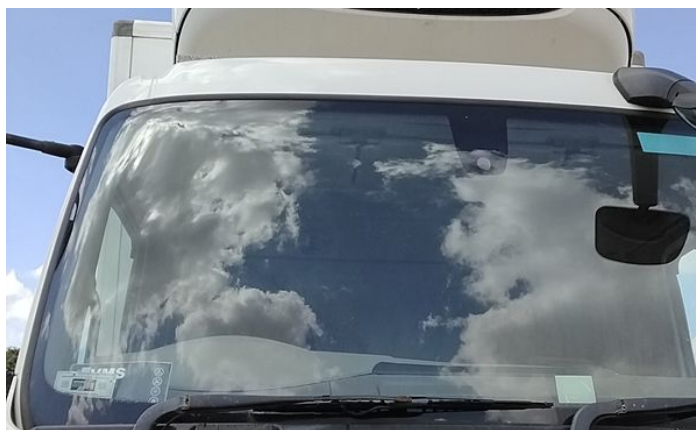
2: Screen Front  
Chipped  
UpTo 10mm

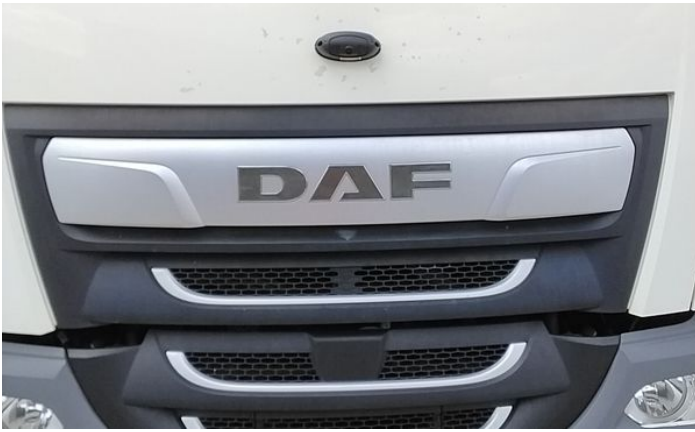
3: Bonnet  
Chipped  
Multiple Chips

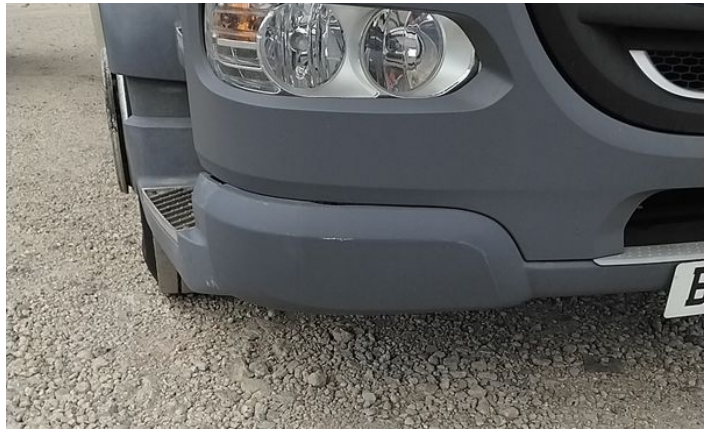
4: Bumper Front  
Scratched  
25 to 100mm Thru Paint

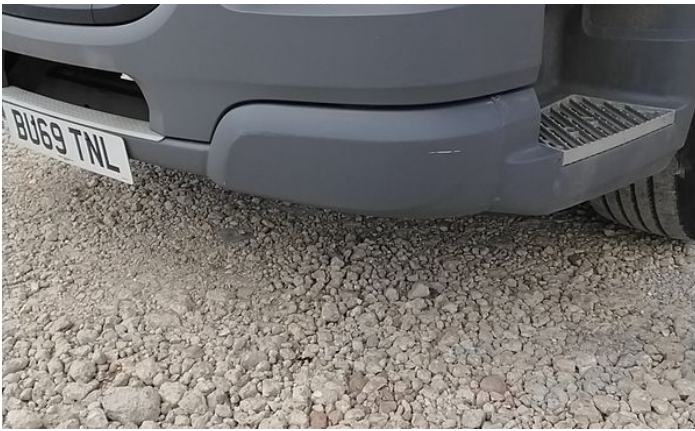
5: Bumper Front  
Scratched  
25 to 100mm Thru Paint

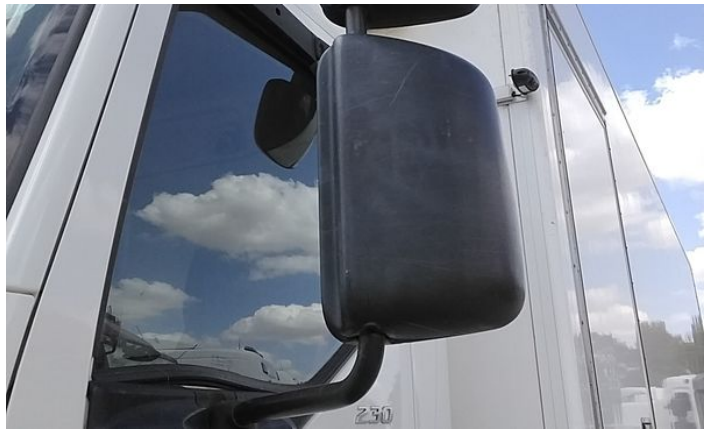
6: Door Mirror Assy nsf  
Broken  
Replace

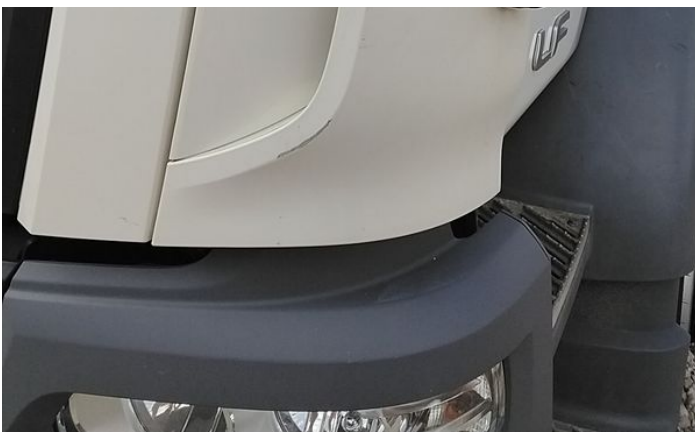
7: Wing nsf  
Scratched  
Over 25mm Thru Paint

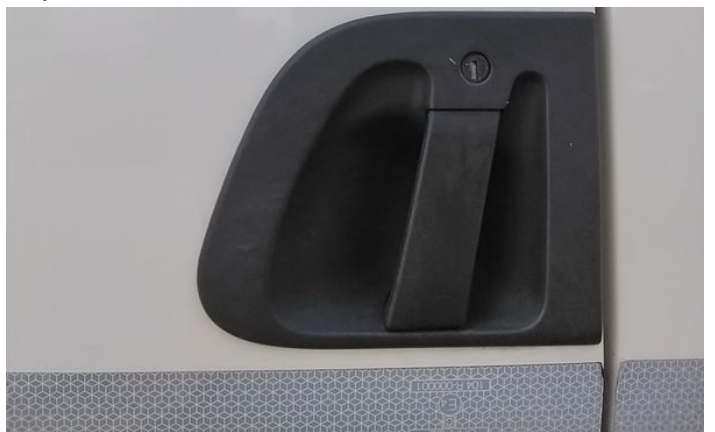
8: Door nsf  
Chipped  
1 To 5

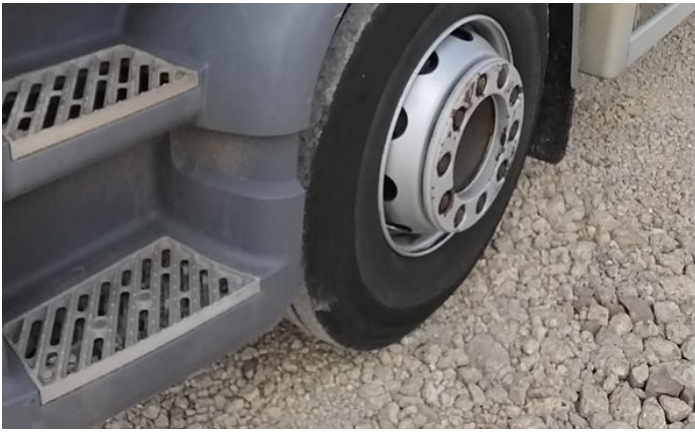
9: Wing Front Arch Extension ns  
Scuffed (Unpainted)  
Over 100mm

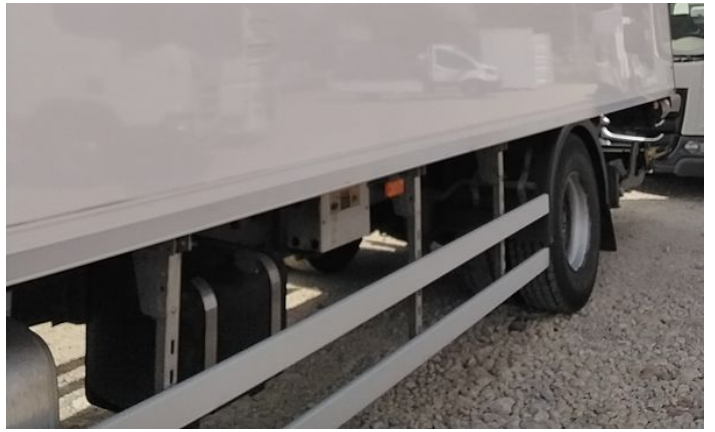
10: Qtr Panel nsr  
Scratched  
Over 25mm Not Thru Paint

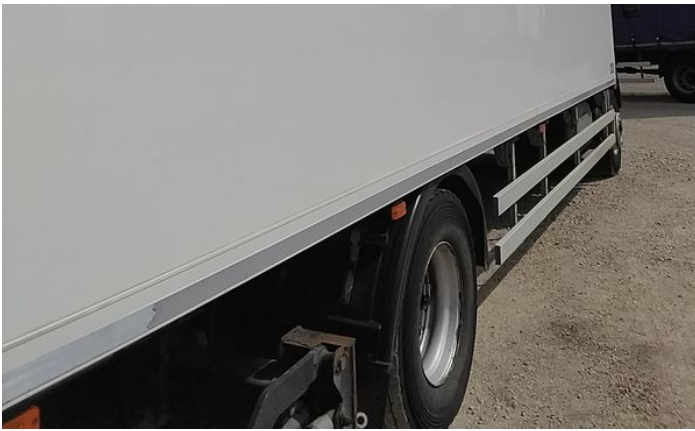
11: Qtr Panel osr  
Scratched  
Over 25mm Thru Paint

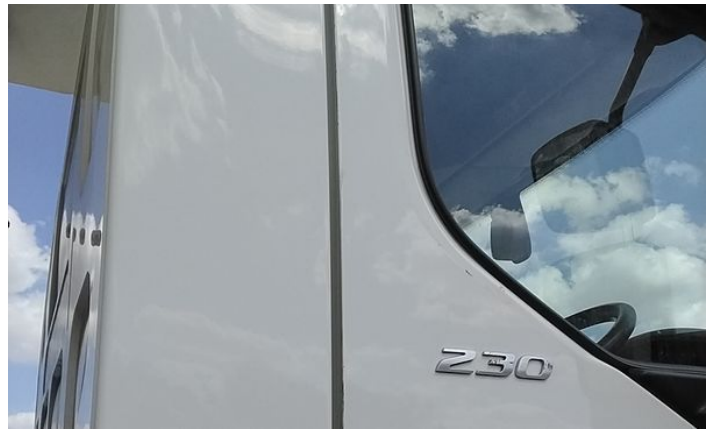
12: Door osf  
Chipped  
Edge Chip

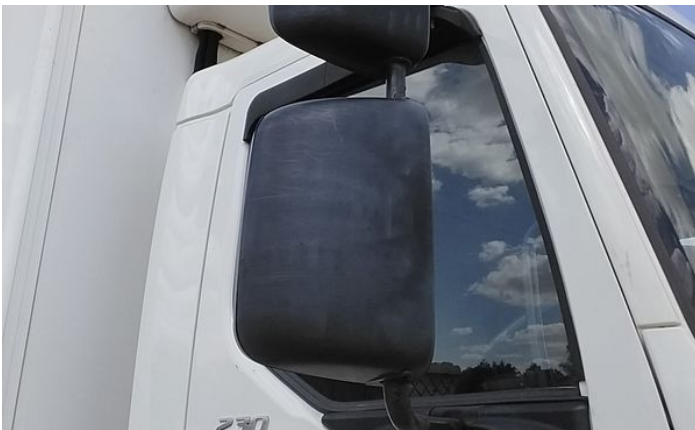
13: Door Mirror Assy osf  
Scuffed (Unpainted)  
Over 100mm

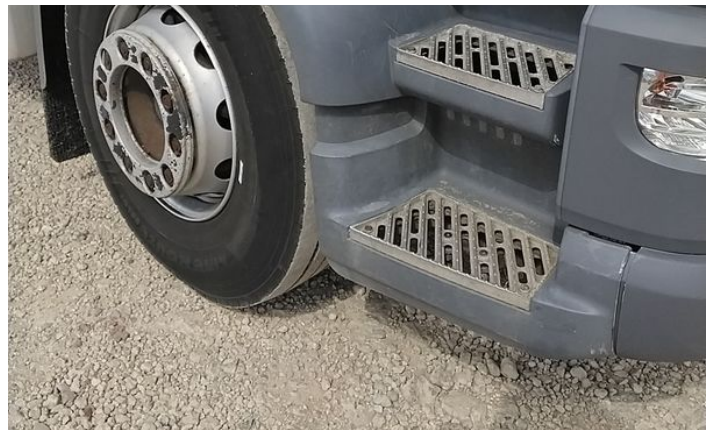
14: Wing Front Arch Extension os  
Scuffed (Unpainted)  
Over 100mm

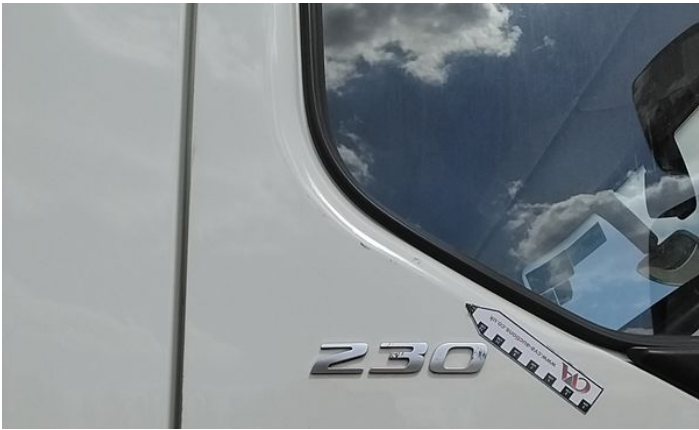
15: Door osf  
 Scratched  
 Over 25mm Not Thru Paint

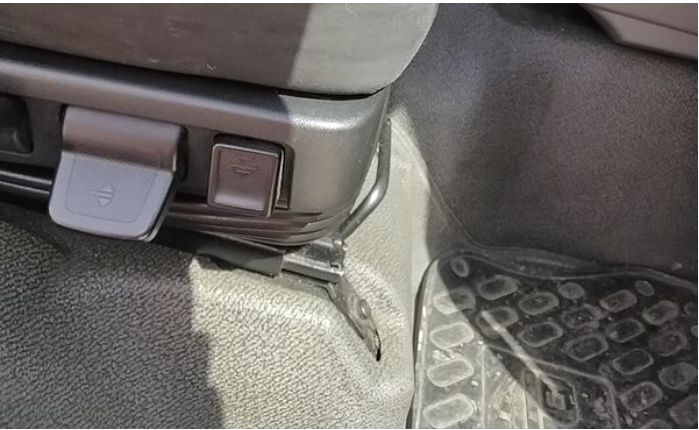
16: Seat Base Cover osf  
 Holed  
 Over 3mm
