# VEHICLE INSPECTION REPORT

**KX16ZWM**

## Scania P 410

Body Style Refuse Collector

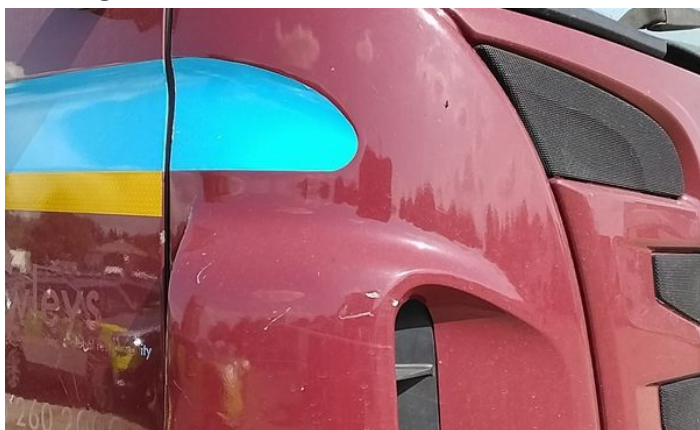
1: Wing of  
Cracked  
Replace

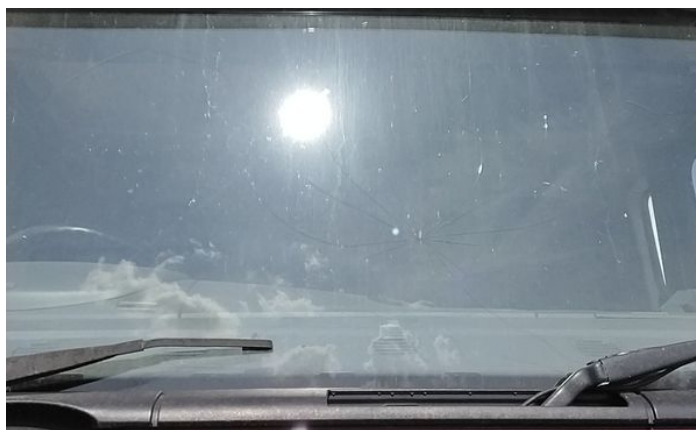
2: Screen Front  
Cracked  
Replace

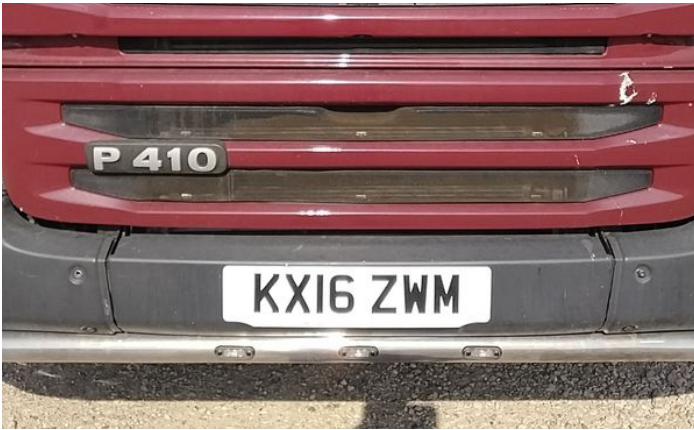
3: Bonnet  
Cracked  
Replace

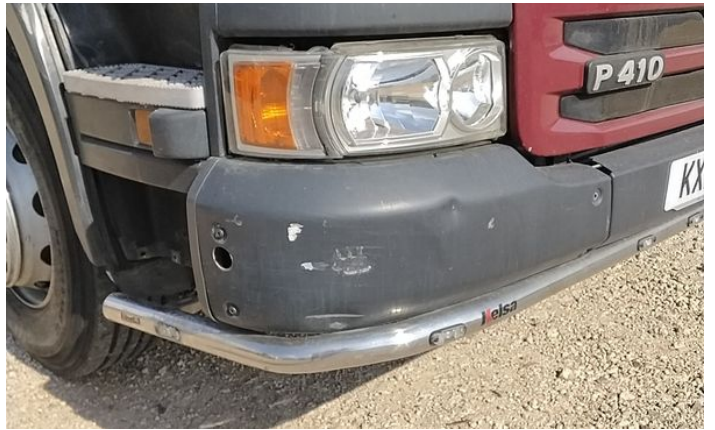
4: Bumper Front  
Dented  
Between 10mm + 30mm

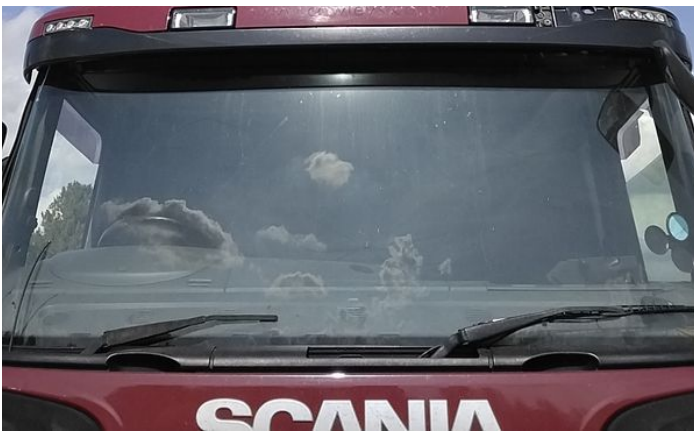
5: Panel Front  
Cracked  
Replace

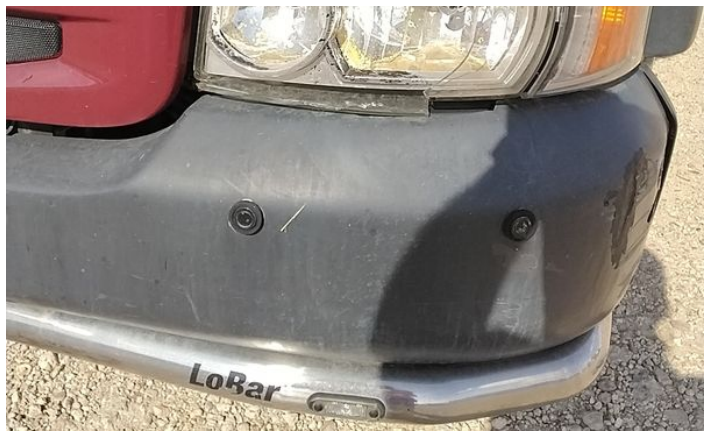
6: Headlamp ns  
Broken  
Replace

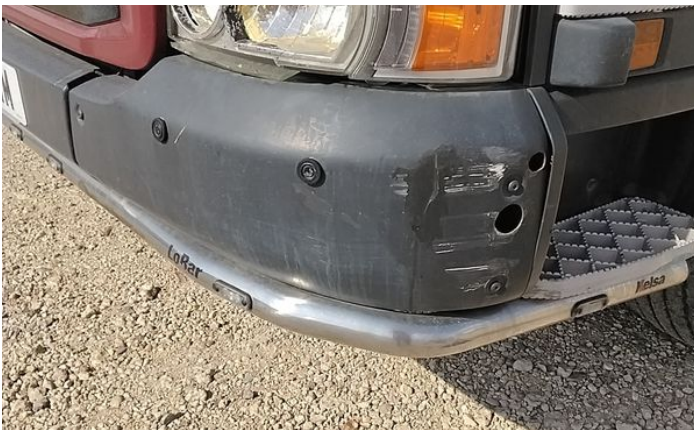
7: Bumper Front  
Scratched  
25 to 100mm Thru Paint

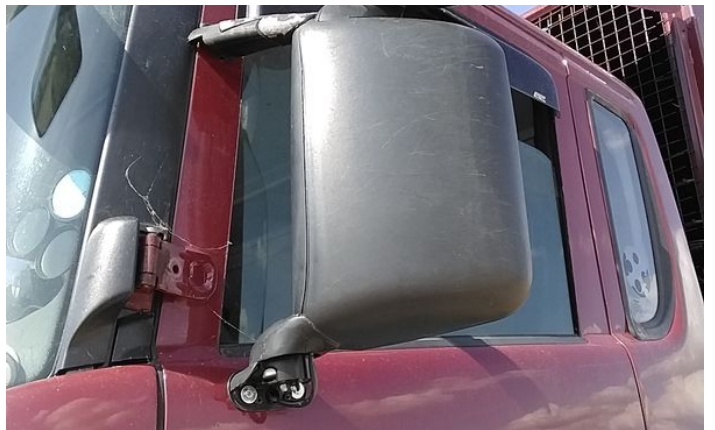
8: Door Mirror Assy nsf  
Scuffed (Unpainted)  
Over 100mm

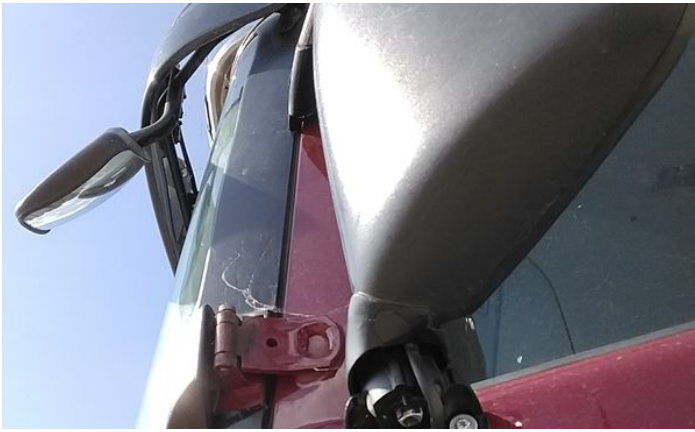
9: Door Mirror Assy nsf  
Broken  
Replace

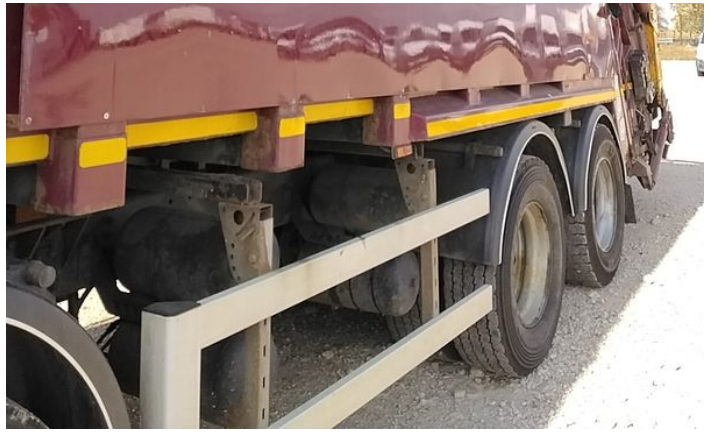
10: Qtr Panel nsr  
Scratched  
Over 25mm Not Thru Paint

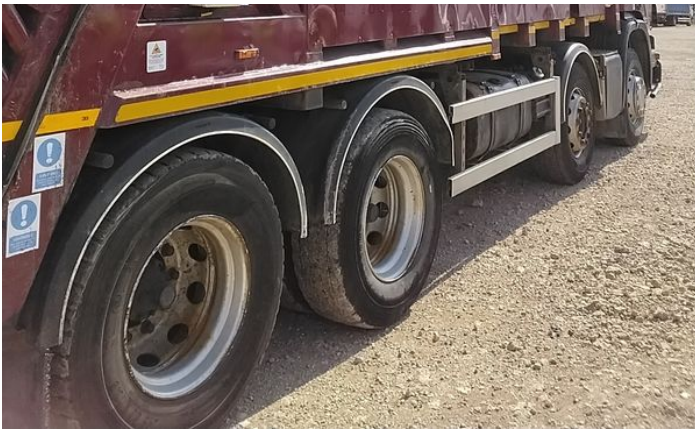
11: Qtr Panel osr  
Scratched  
Over 25mm Thru Paint

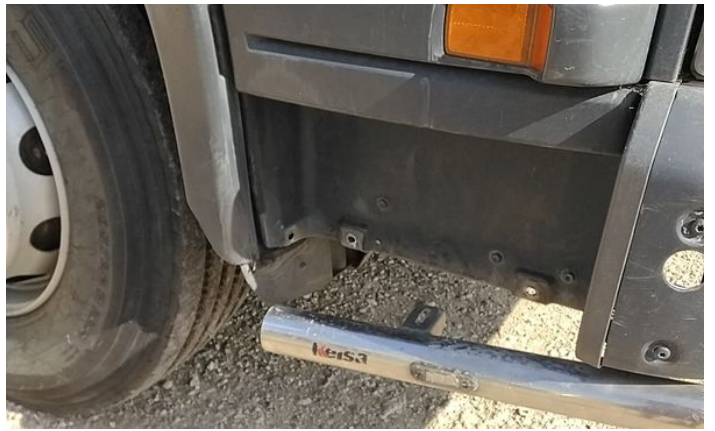
12: Wing Front Arch Extension os  
Broken  
Replace

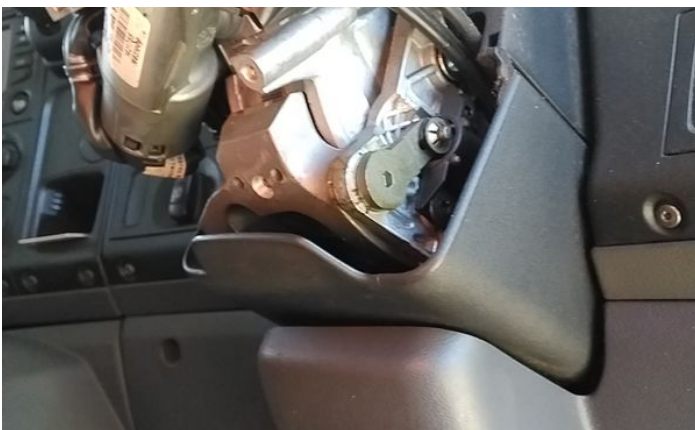
13: Centre Console Front  
Missing  
Replace
