# VEHICLE INSPECTION REPORT

**LN68ZKO**

## Daf LF 180

SCARAB BODY, 3470 SWEEPING HOURS, 6773 RUNNING HOURS

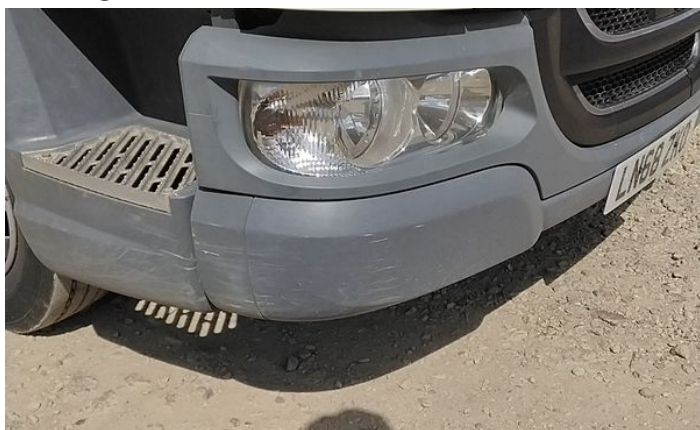
1: Bumper Front  
Scratched  
25 to 100mm Thru Paint

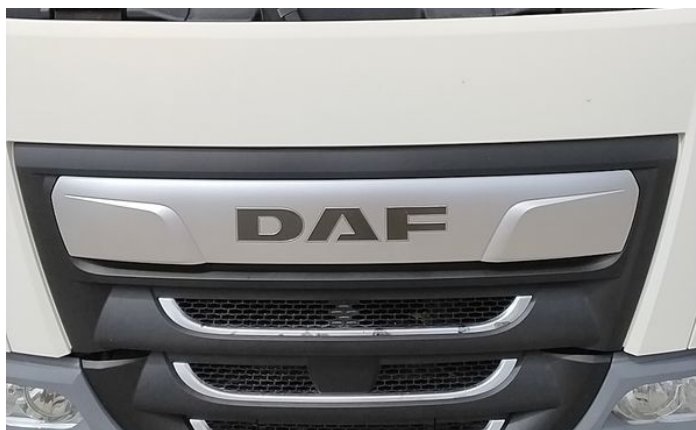
2: Bonnet  
Chipped  
Multiple Chips

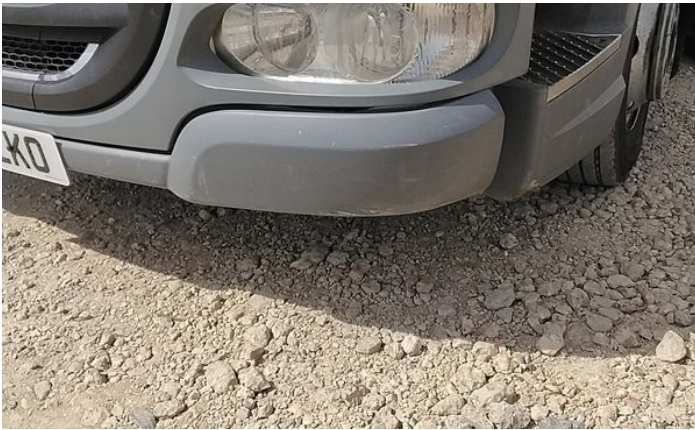
3: Bumper Front  
Scratched  
25 to 100mm Thru Paint

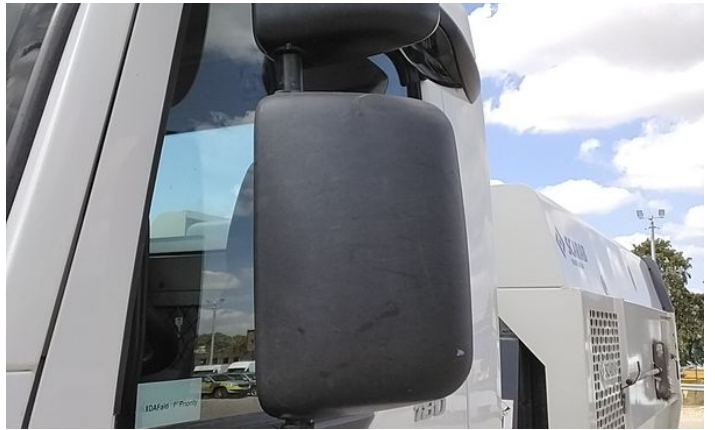
4: Door Mirror Assy nsf  
Scuffed (Unpainted)  
UpTo 100mm

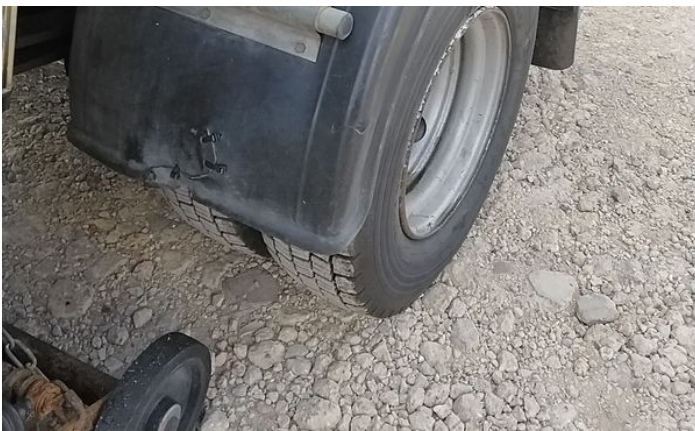
5: Qtr Panel Arch Extension ns  
Broken  
Replace

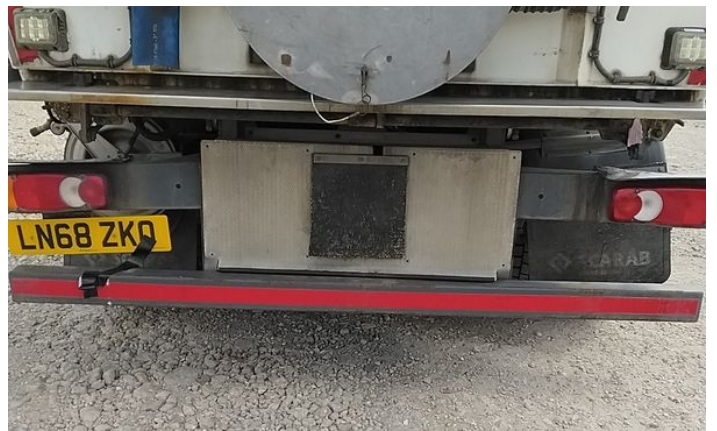
6: Bumper Rear  
Rusted  
Over 5mm

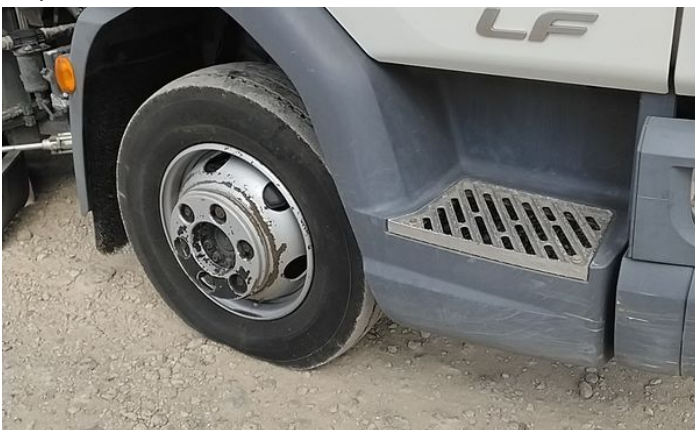
7: Wing Front Arch Extension os  
Scuffed (Unpainted)  
Over 100mm

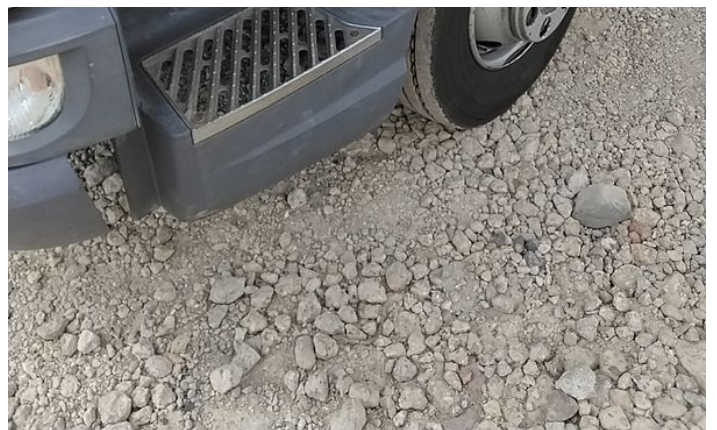
8: Wing Front Arch Extension ns  
Scuffed (Unpainted)  
Over 100mm
