# **VEHICLE INSPECTION REPORT**

## Peugeot Expert 1000 1.5 BLUEHDi 100PS PROFESSIONAL

**Commercial Vehicle Auctions Limited**

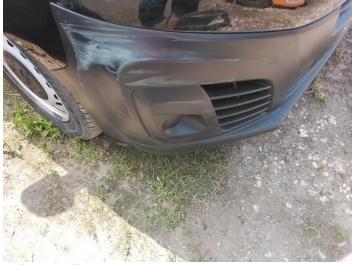
1: Bumper Front Scratched Over 100mm Thru Paint

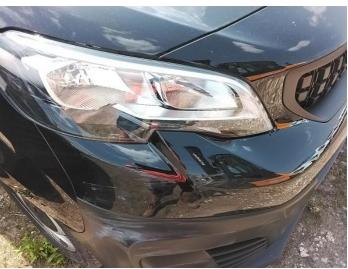
2: Panel Front Scratched Over 25mm Thru Paint

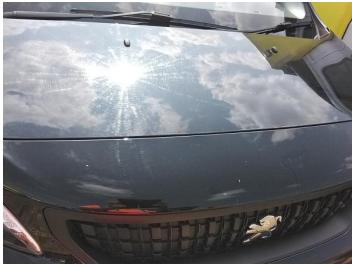
3: Bonnet Chipped Multiple Chips

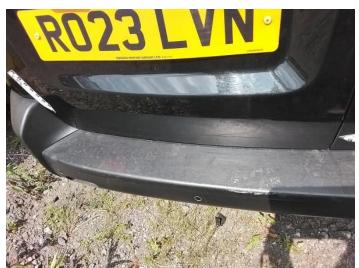
4: Door nsr

Scratched

Over 25mm Thru Paint

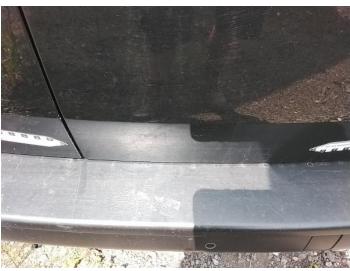
5: Door osr Scratched Over 25mm Thru Paint

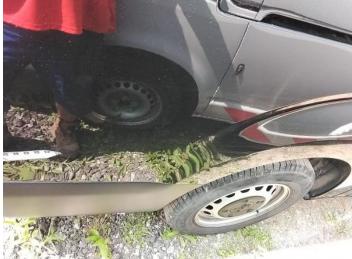
6: Qtr Panel osr Scratched Over 25mm Not Thru Paint

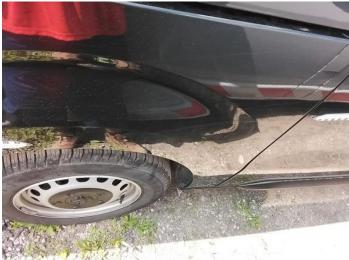
7: Qtr Panel osr Scratched Over 25mm Not Thru Paint

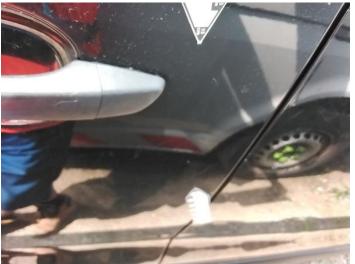
8: Qtr Panel osr Scratched Over 25mm Thru Paint

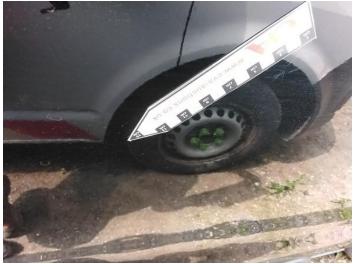
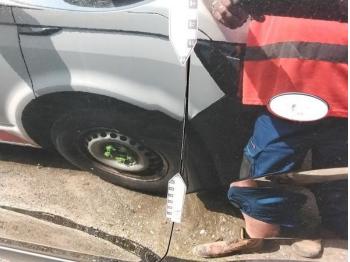
9: Door osf Scratched Over 25mm Thru Paint 10: Door osf Dented With Paint Damage
