VEHICLE INSPECTION REPORT

RO23LVL

Peugeot Expert 1000 1.5 BLUEHDi 100PS PROFESSIONAL

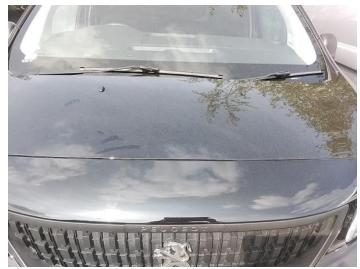
1: Bonnet Chipped Multiple Chips

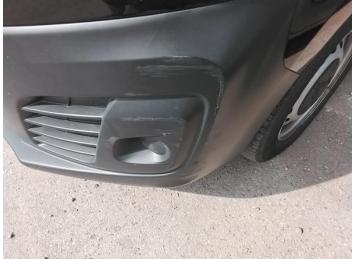
2: Bumper Front Scratched Over 100mm Thru Paint

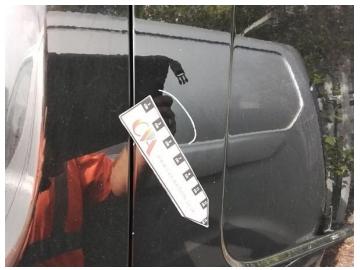
3: Qtr Panel nsr Scratched Over 25mm Thru Paint

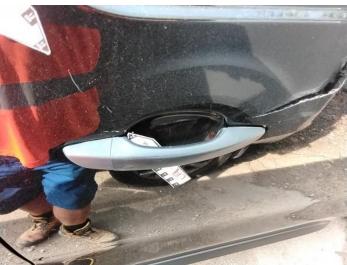
4: Qtr Panel nsr Scratched Over 25mm Thru Paint

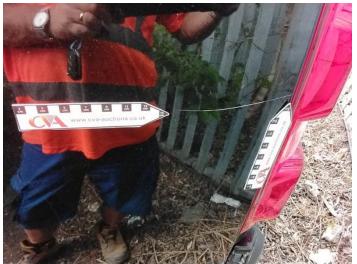
5: Qtr Panel nsr Scratched Over 25mm Thru Paint

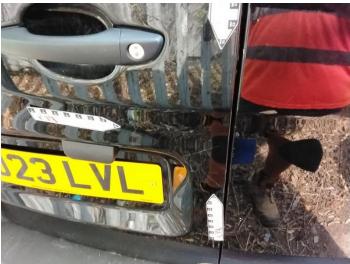
6: Door nsr Scratched Over 25mm Thru Paint

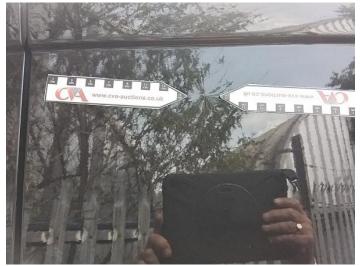
7: Door osr Dented Between 10mm + 30mm

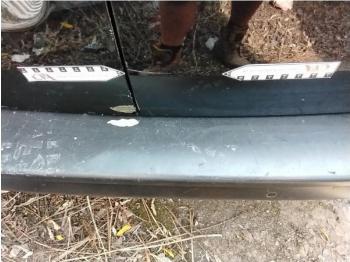
8: Door osr Scratched Over 25mm Thru Paint

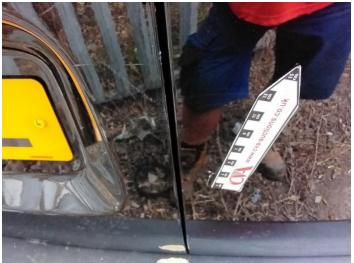
9: Door osr Scratched Over 25mm Thru Paint

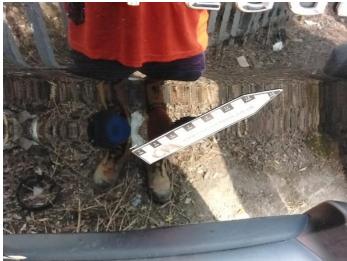
10: Door osr Scratched UpTo 25mm Thru Paint

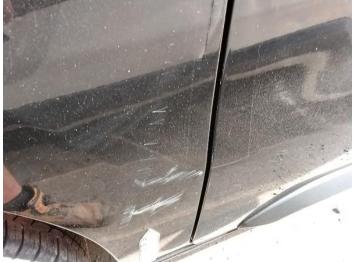
11: Qtr Panel osr Scratched Over 25mm Thru Paint

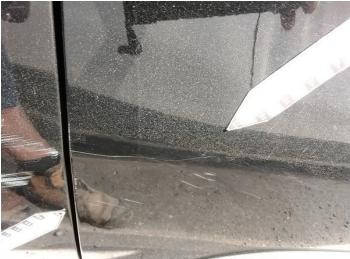
12: Qtr Panel osr Scratched Over 25mm Thru Paint

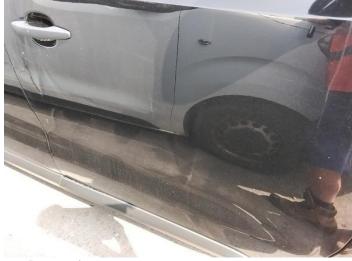
13: Door osf Chipped Multiple Chips

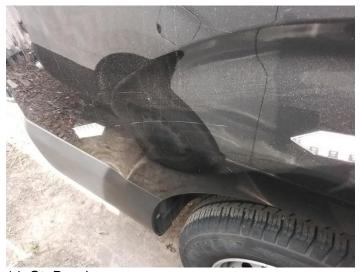
14: Qtr Panel osr Scratched Over 25mm Thru Paint

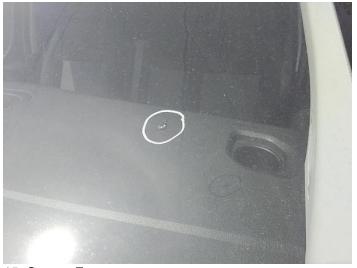
15: Screen Front Chipped Over 10mm

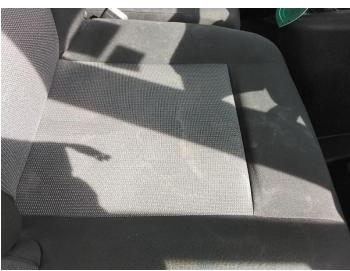
16: Seat Base Cover osf Soiled Heavy

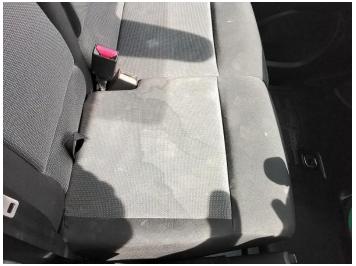
17: Seat Base Cover nsf Soiled Heavy
