# VEHICLE INSPECTION REPORT

**C467466**

## FRUEHAUF TIPPER TASSC

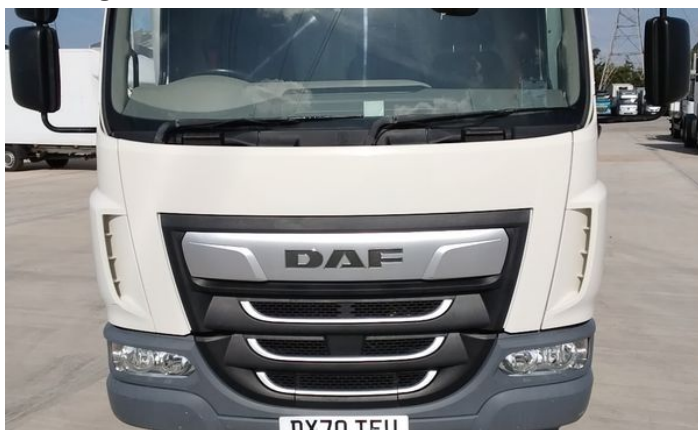
1: Bonnet  
Chipped  
Multiple Chips

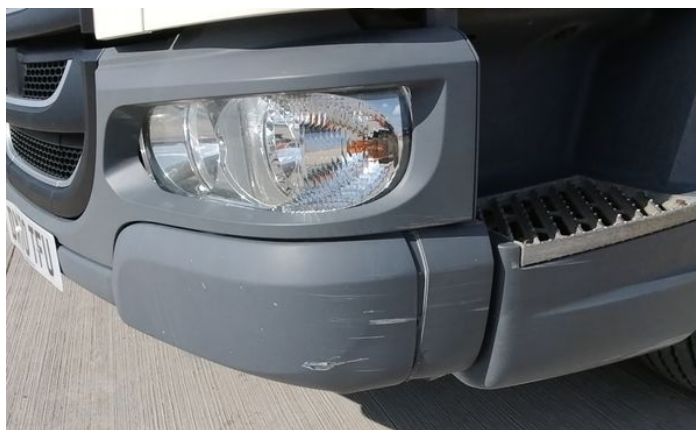
2: Bumper Front  
Scratched  
Over 100mm Thru Paint

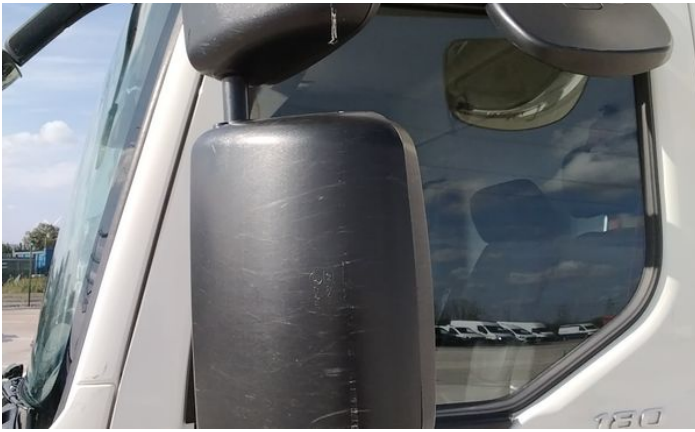
3: Door Mirror Assy nsf  
Scuffed (Unpainted)  
Over 100mm

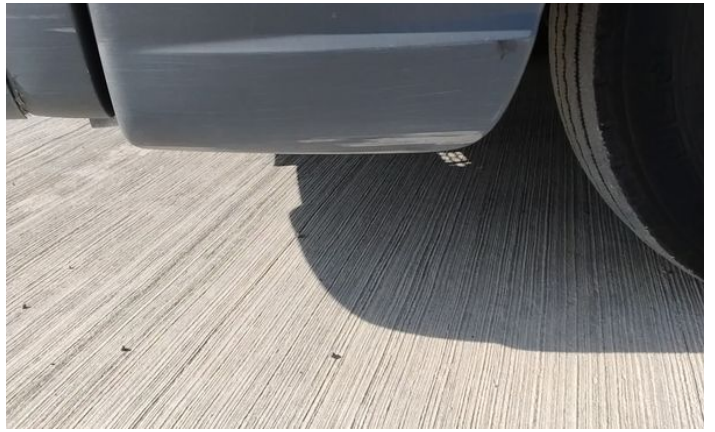
4: Wing nsf  
Scratched  
Over 25mm Thru Paint

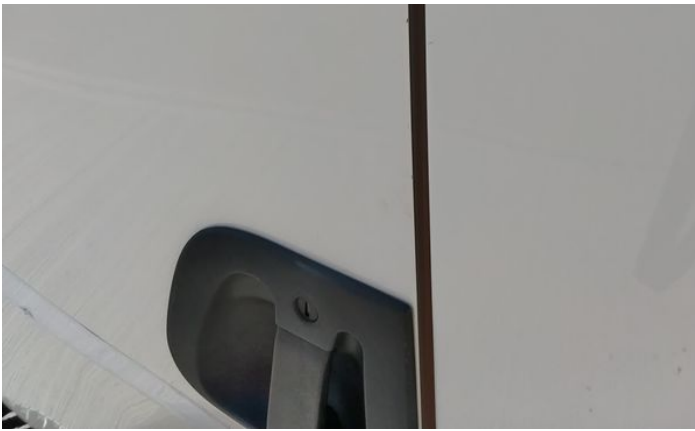
5: Door nsf  
Chipped  
Multiple Chips

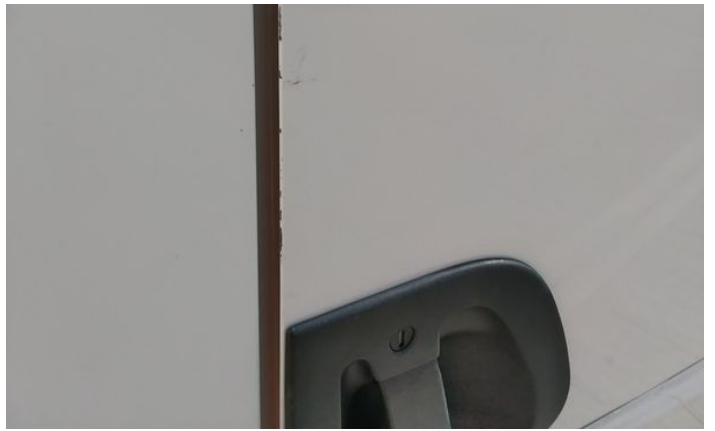
6: Door osf  
Chipped  
Multiple Chips

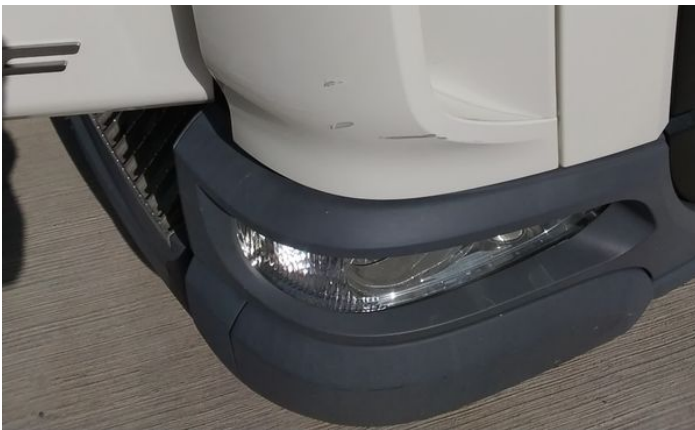
7: Moulding osf Wing  
Scratched (Painted)  
Over 25mm Thru Paint

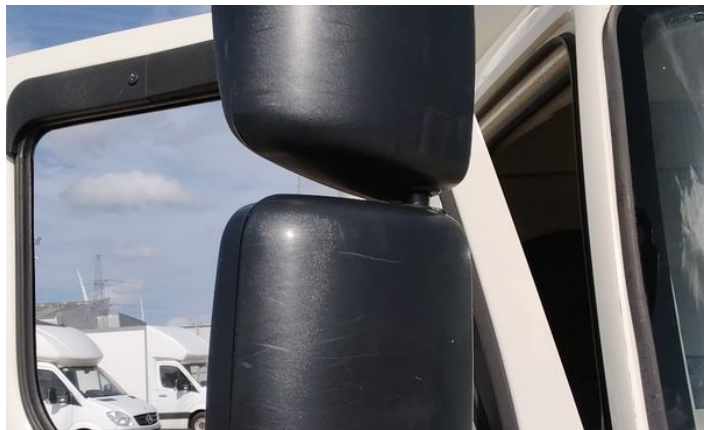
8: Door Mirror Assy osf  
Scuffed (Unpainted)  
Over 100mm

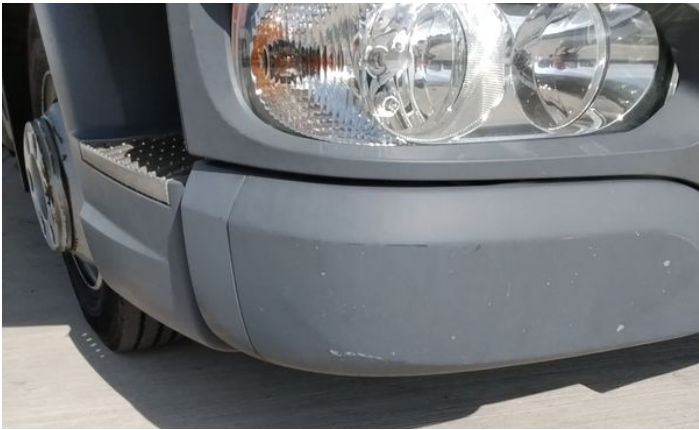
9: Bumper Front  
Scratched  
25 to 100mm Thru Paint

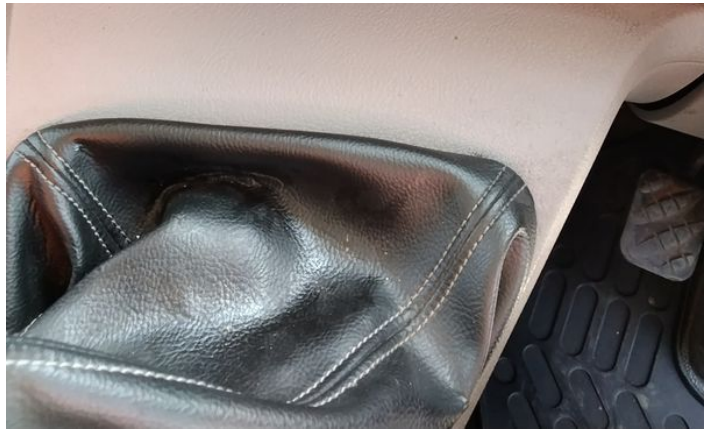
10: Switches And Controls  
Missing  
Replace

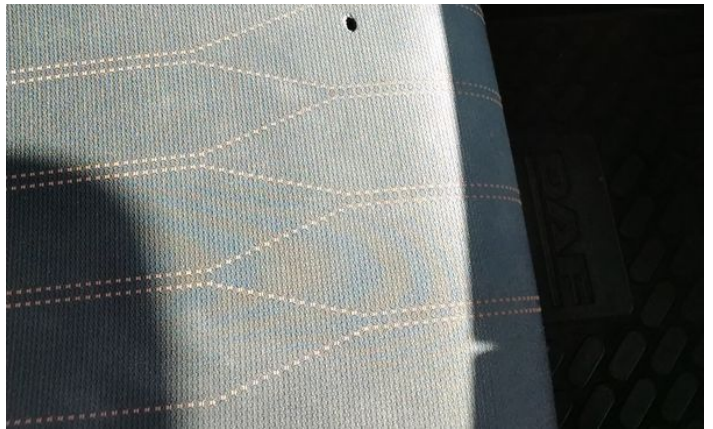
12: Seat Base Cover osf  
Burn  
Over 3mm
