# VEHICLE INSPECTION REPORT

**NX21UPA**

## Man TGX 18.640

**Non Runner**  
Inspection

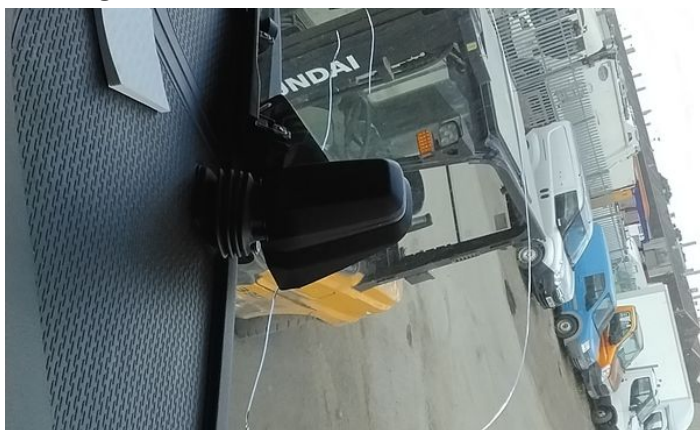
1: Screen Front  
Cracked  
Replace

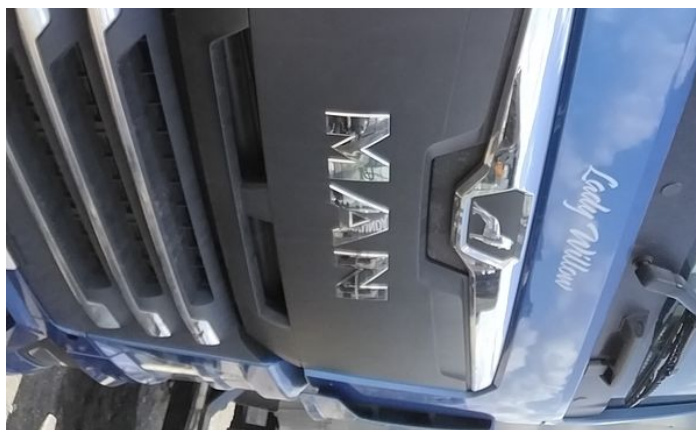
2: Bonnet  
Chipped  
Multiple Chips

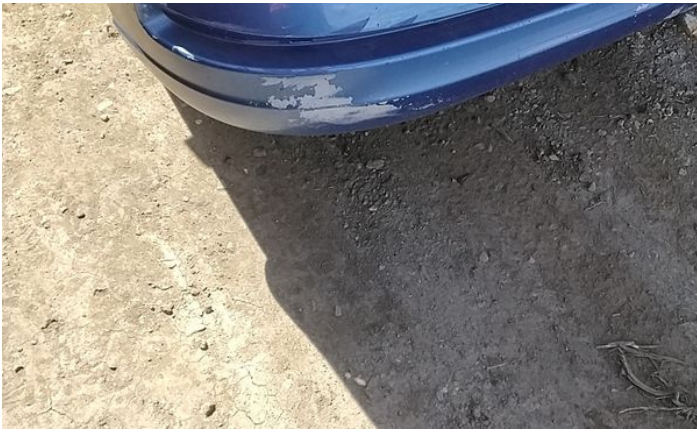
3: Bumper Front Moulding  
Scratched (Painted)  
Over 25mm Thru Paint

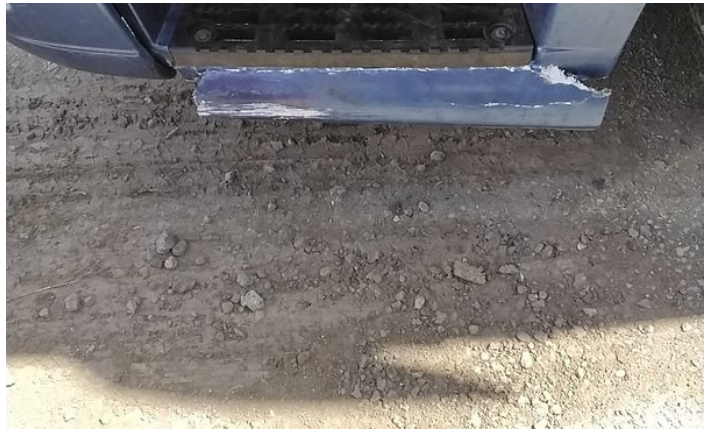
4: Bumper Front Moulding  
Broken  
Replace

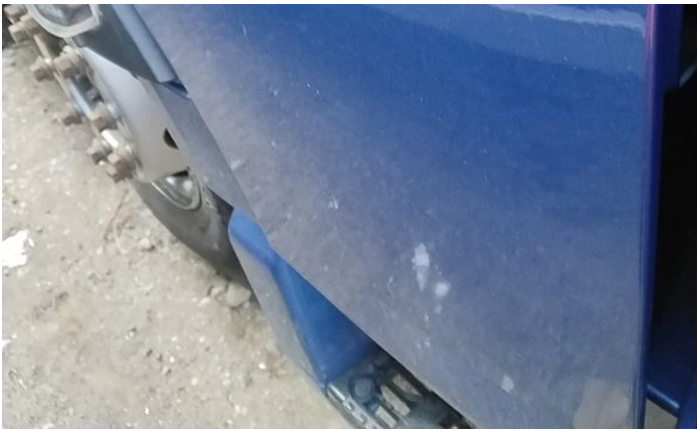
5: Door Moulding of  
Scratched (Painted)  
Over 25mm Thru Paint

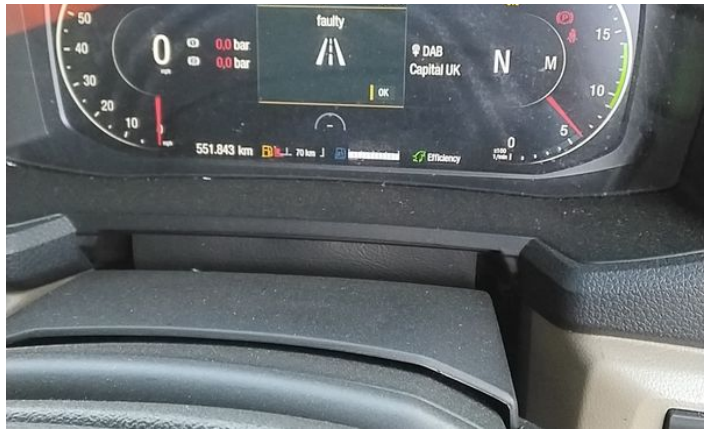
6: Dash Warning Lights  
Displayed  
No Action
