# VEHICLE INSPECTION REPORT

**WS19AEJ**

## Fiat Ducato 35 II 2.3 Multijet 130PS

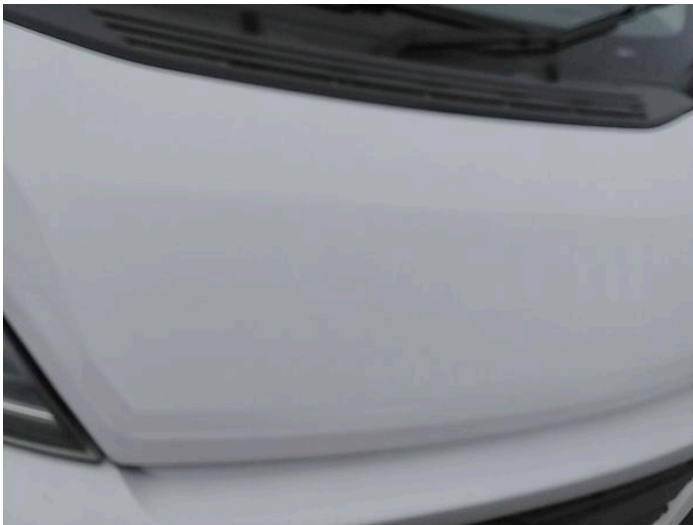
1: Bonnet  
Chipped  
Multiple Chips

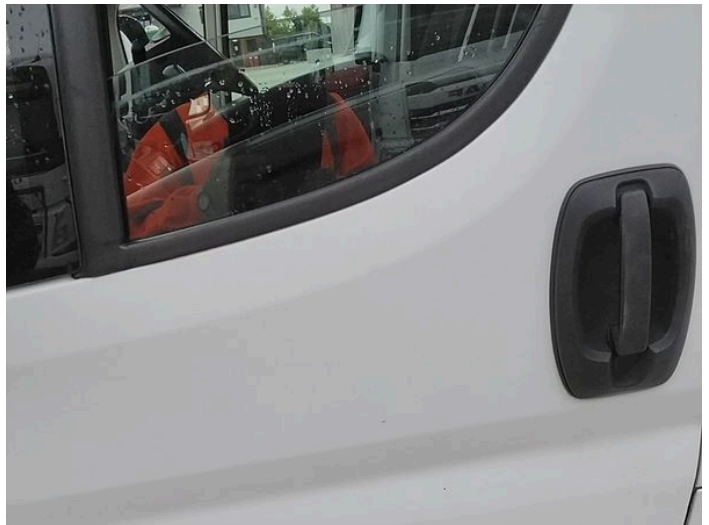
2: Door nsf  
Chipped  
Multiple Chips

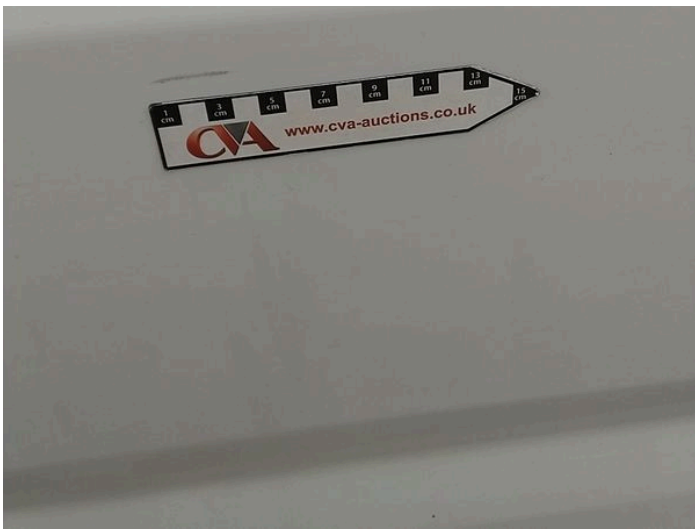
3: Qtr Panel nsr  
Scratched  
Over 25mm Thru Paint

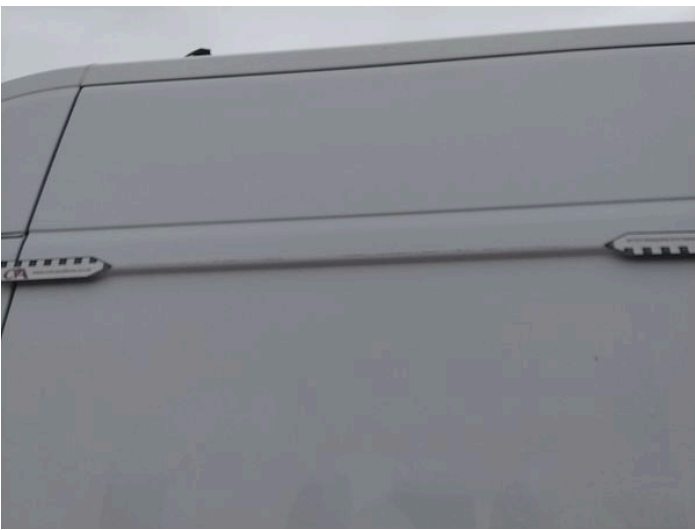
4: Qtr Panel nsr  
Scratched  
Over 25mm Thru Paint

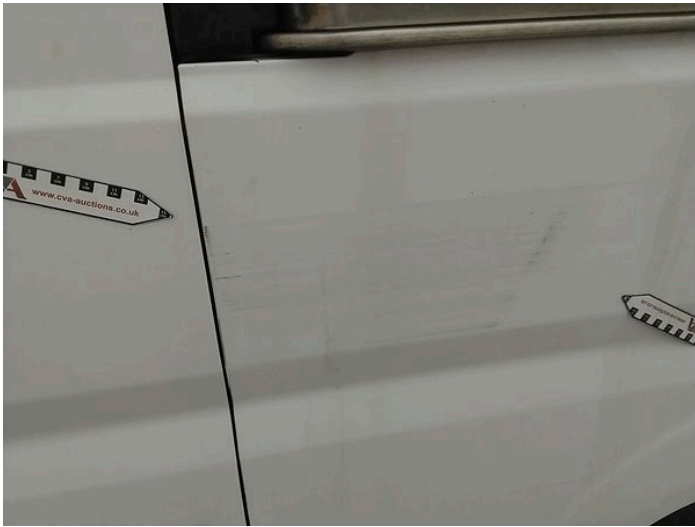
5: Qtr Panel nsr  
Scratched  
Over 25mm Thru Paint

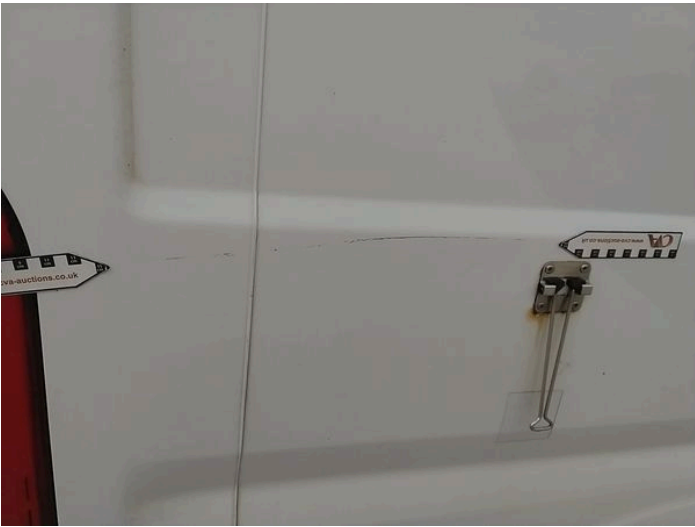
6: Qtr Panel osr  
Scratched  
Over 25mm Thru Paint

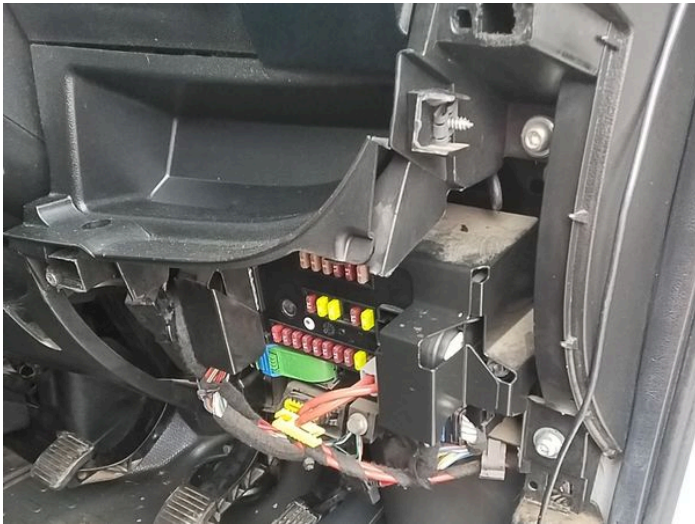
7: Fascia Panel  
Missing  
Replace

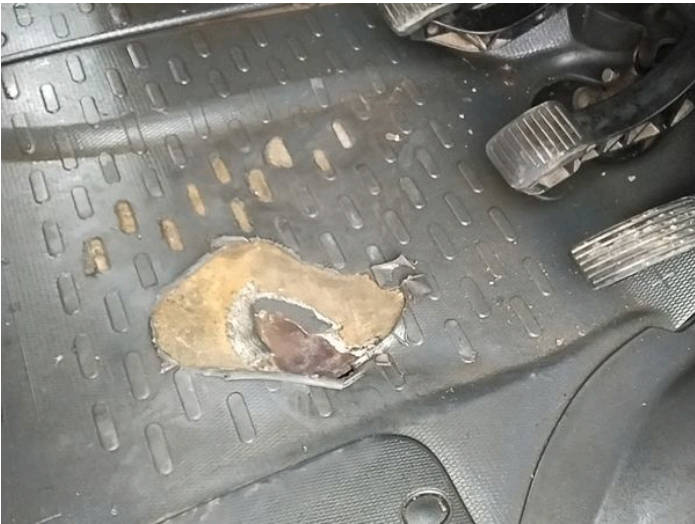
8: Carpets Front  
Holed  
Over 3mm

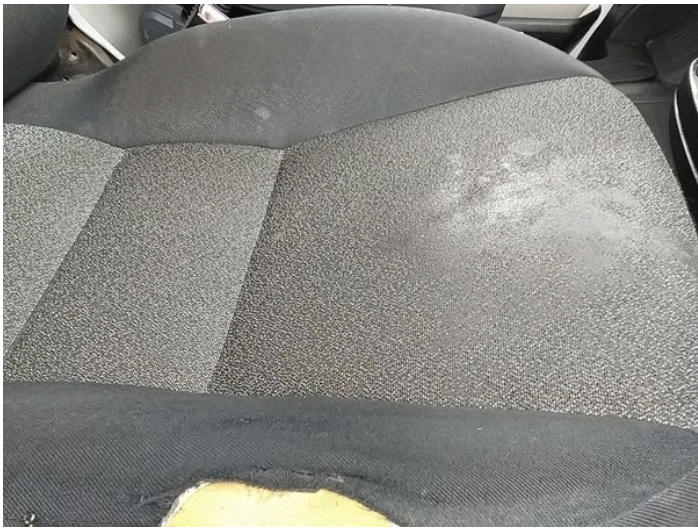
9: Seat Base Cover osf  
Holed  
Over 3mm

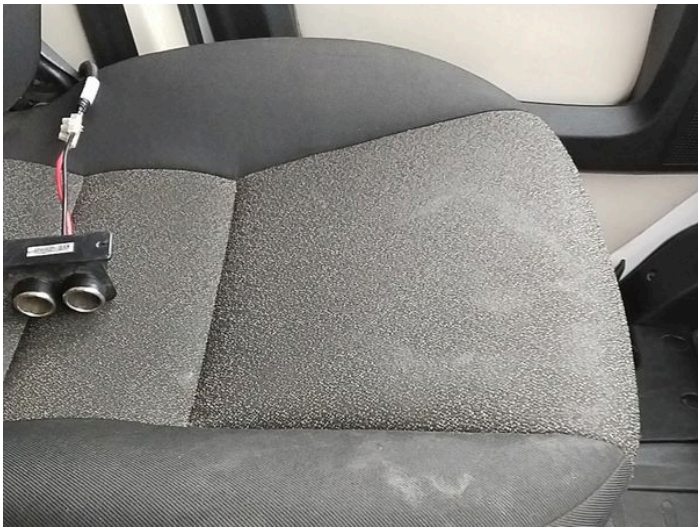
10: Seat Base Cover nsf  
Soiled  
Heavy

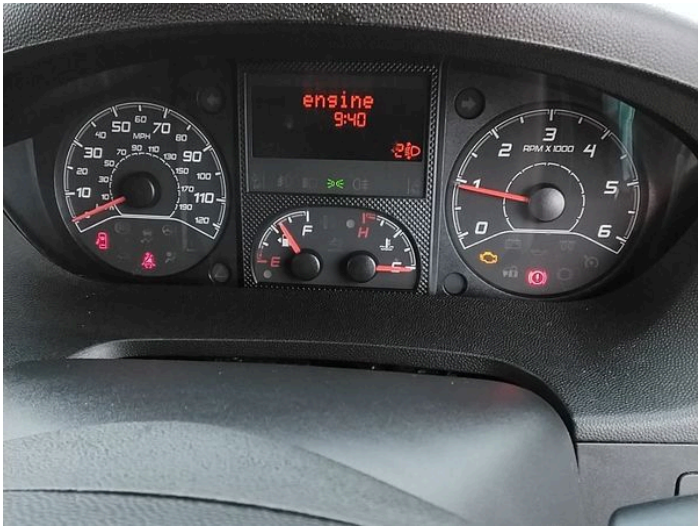
11: Dash Warning Lights  
Displayed  
No Action

| EML light illuminated | | Fault | DPF light illuminated | | OK |
