VEHICLE INSPECTION REPORT

BN19VEM

Fiat Ducato Maxi 2.3 MULTIJET 150PS

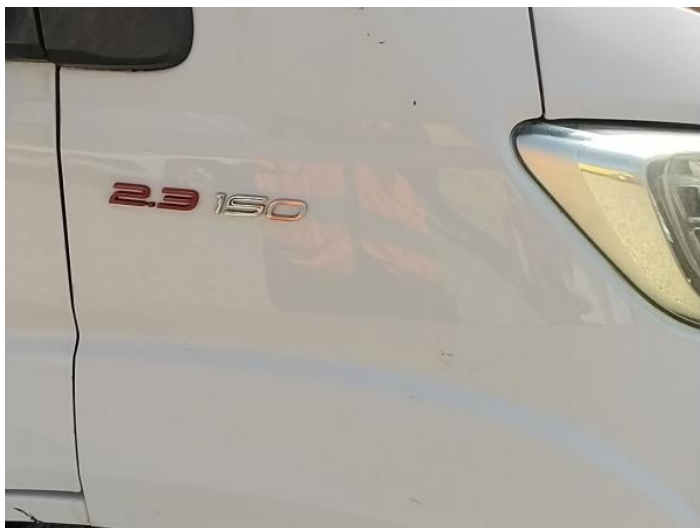
1: Wing of
Chipped
Multiple Chips

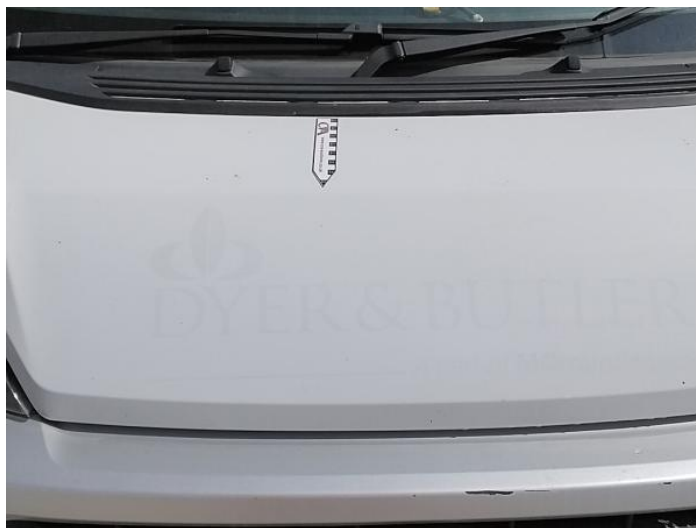
2: Bonnet
Chipped
Multiple Chips

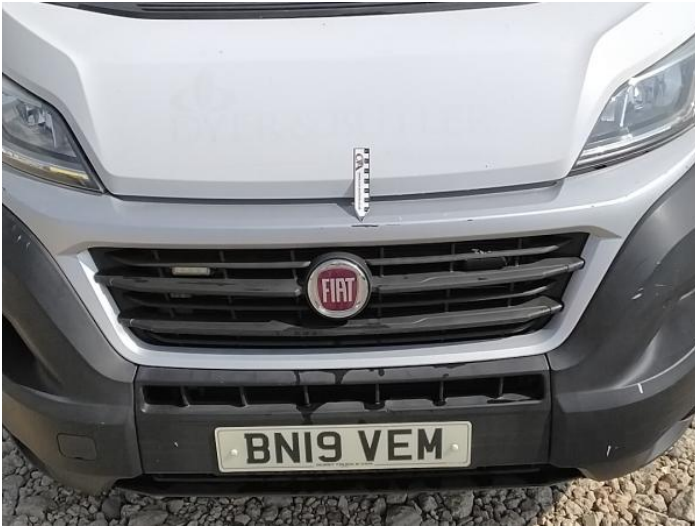
3: Grille Front
Scratched (Painted)
Over 25mm Thru Paint

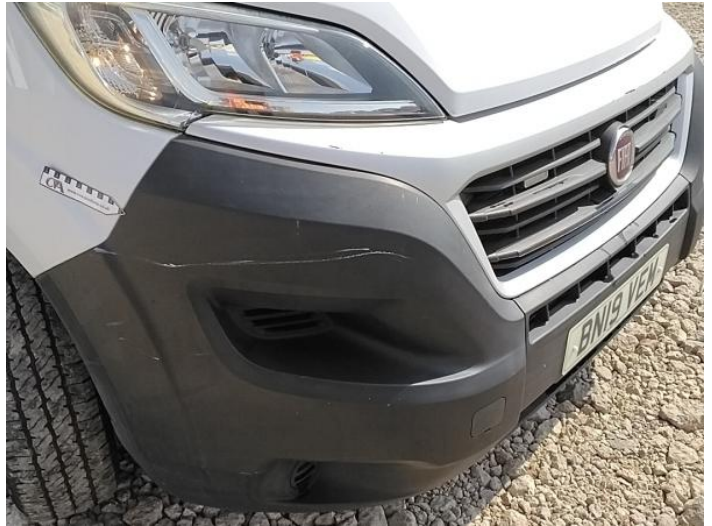
4: Bumper Front
Scratched
Over 25mm Not Thru Paint

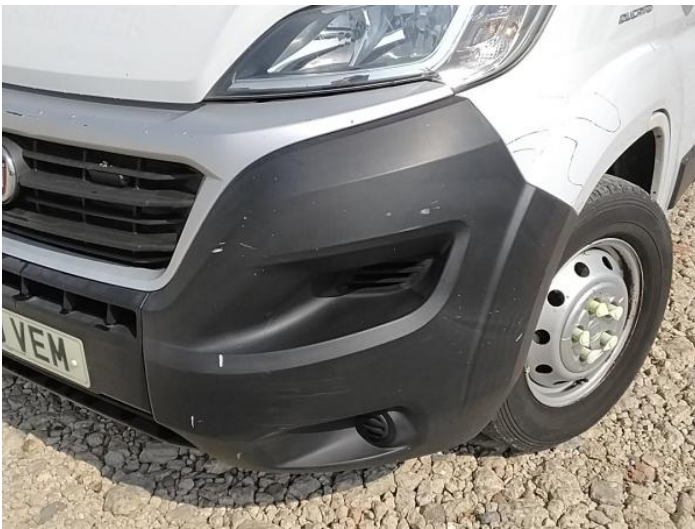
5: Bumper Front
Scratched
Over 25mm Not Thru Paint

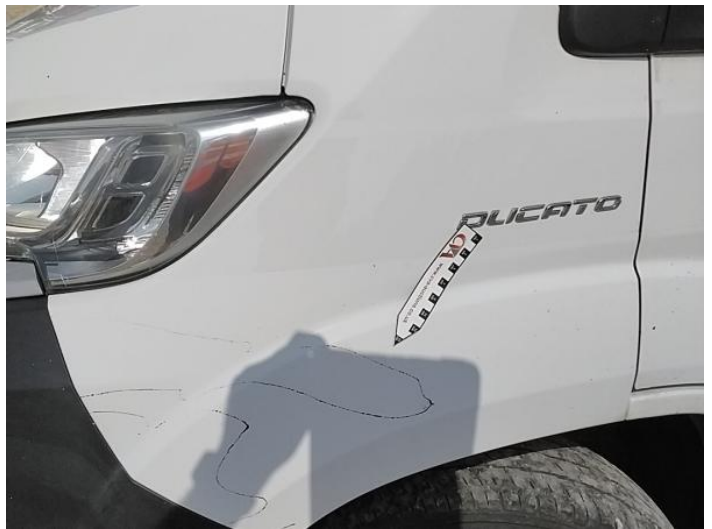
6: General Exterior
Soiled
Light

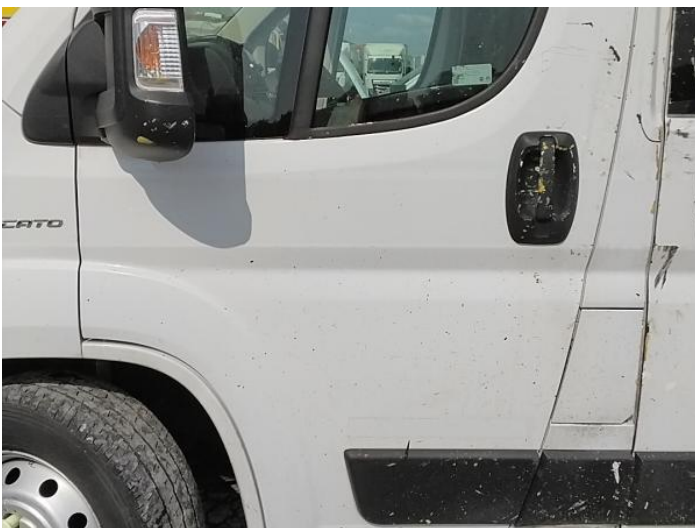
7: General Exterior
Soiled
Light

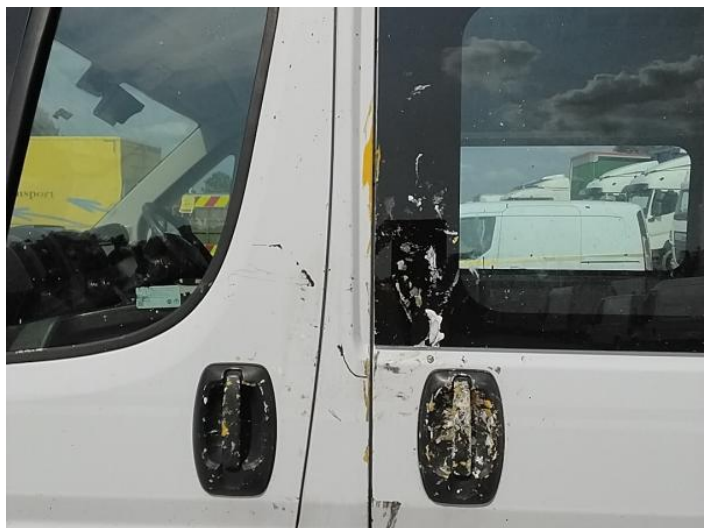
8: General Exterior
Soiled
Light

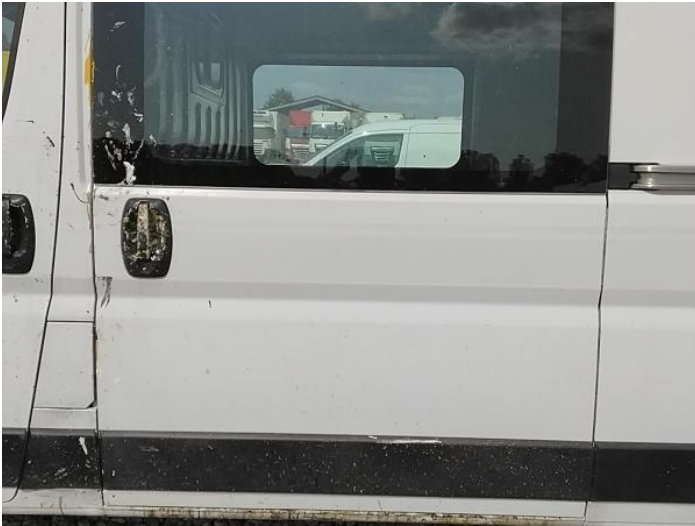
9: General Exterior
Soiled
Light

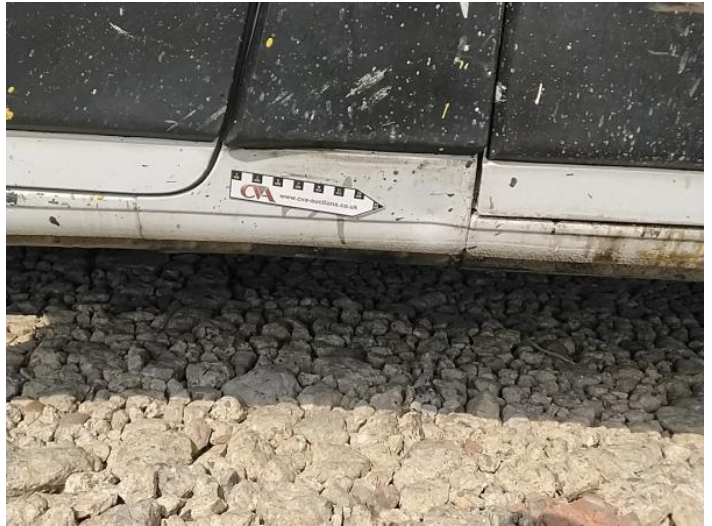
10: B Posts
Dented
Between 10mm + 30mm

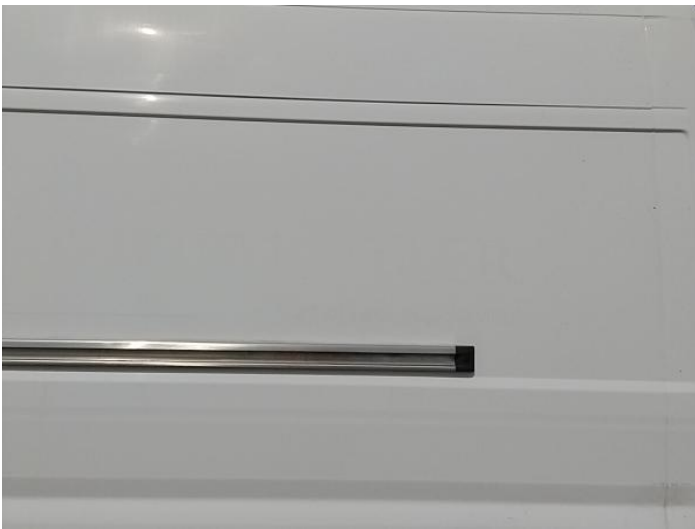
11: General Exterior
Soiled
Light

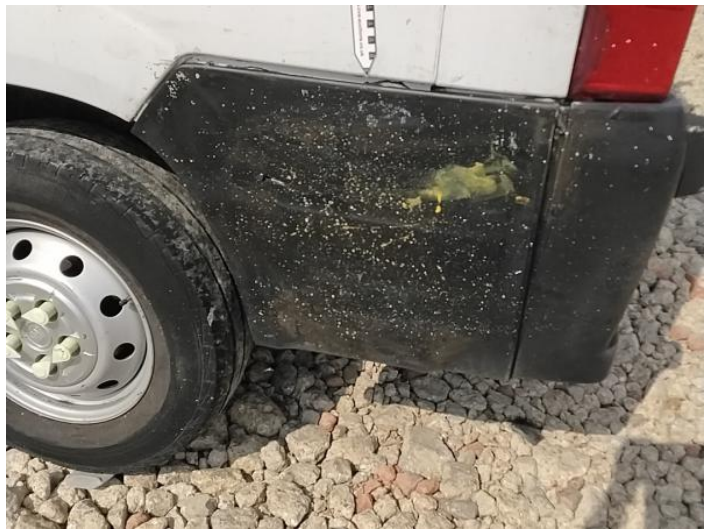
12: General Exterior
Soiled
Light

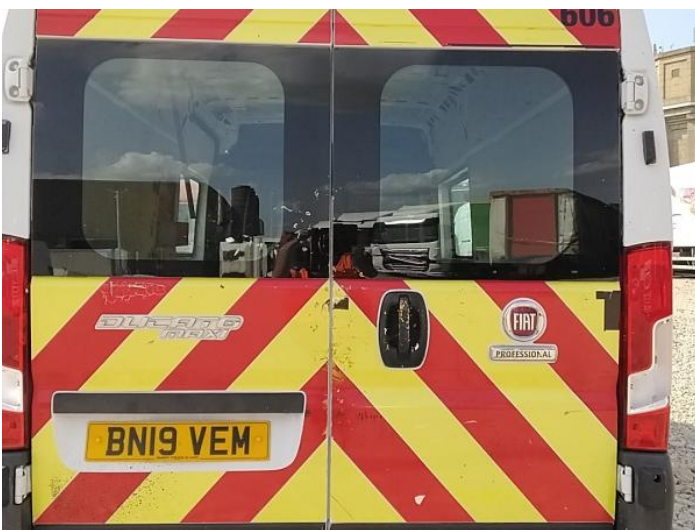
13: General Exterior
Soiled
Light

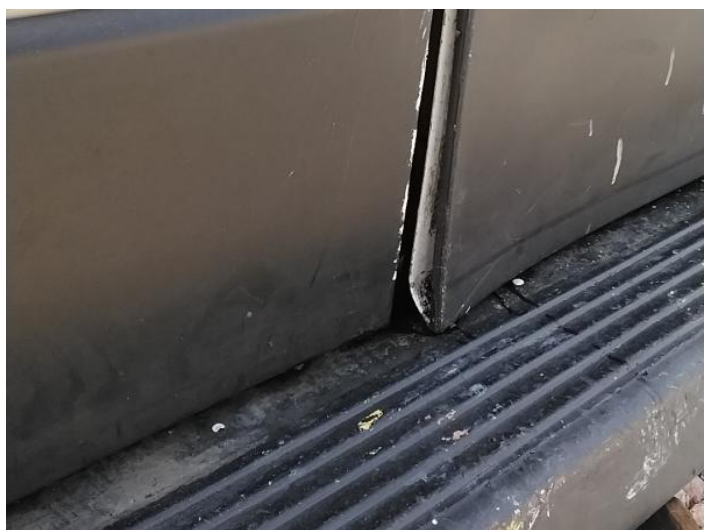
14: General Exterior
Soiled
Light

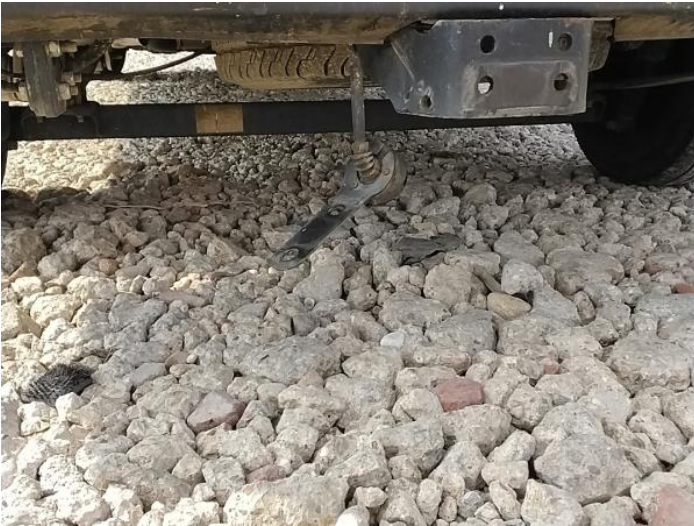
15: General Exterior
Soiled
Light

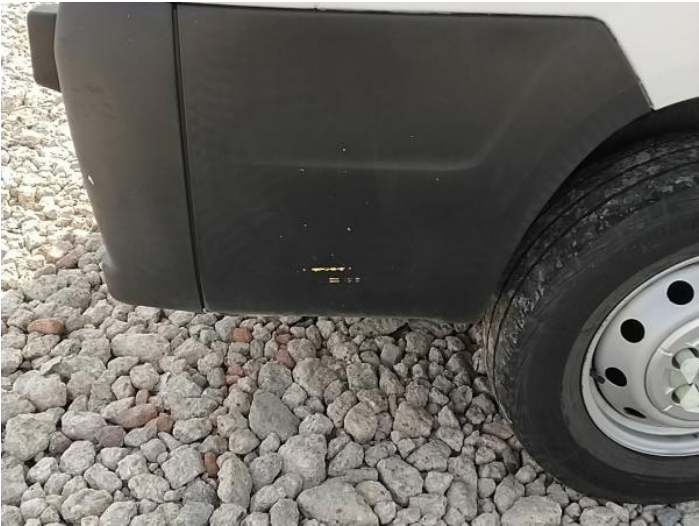
16: General Exterior
Soiled
Light

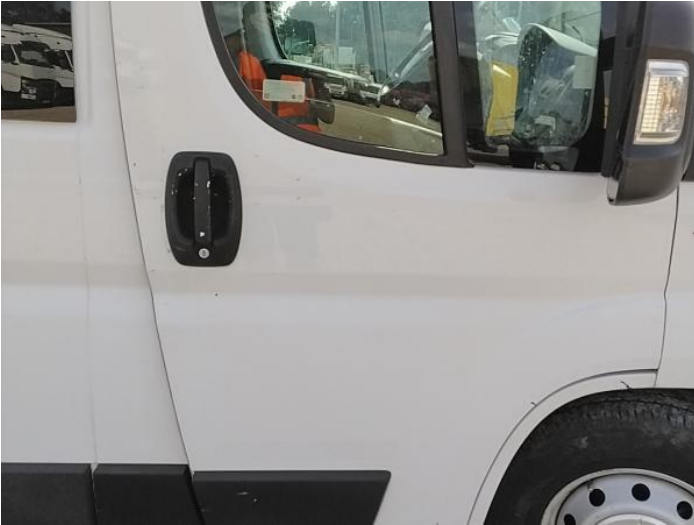
17: General Exterior
Soiled
Light

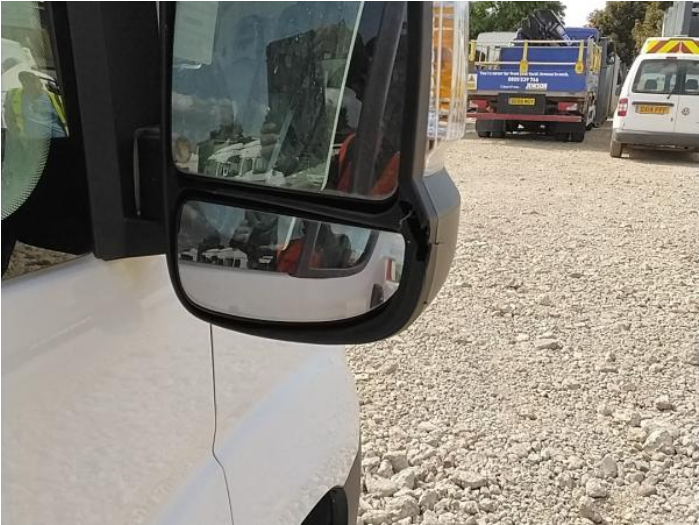
18: Door Mirror Assy osf
Broken
Replace

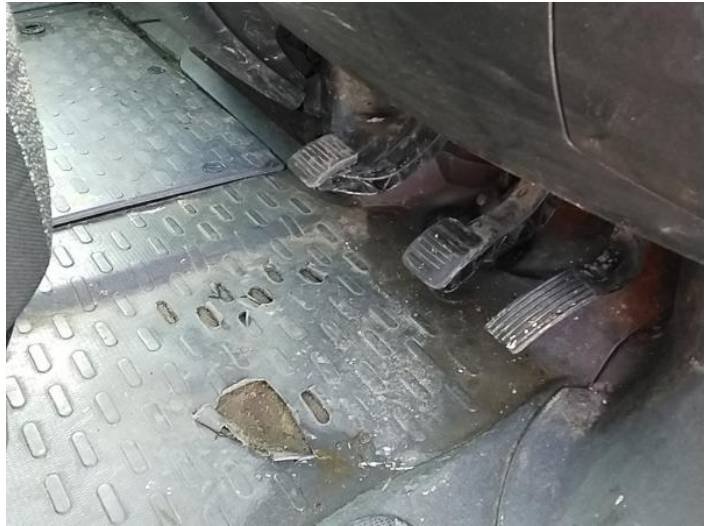
22: Carpets Front
Holed
Over 3mm
