# VEHICLE INSPECTION REPORT

**DK17LNG**

## Man TGL 12.220

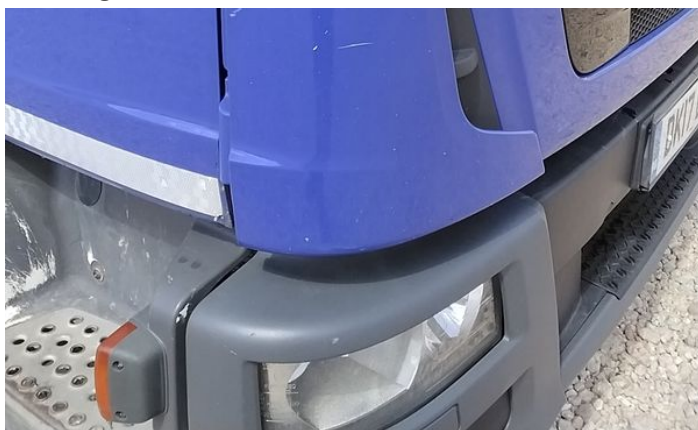
1: Wing of  
Scratched  
Over 25mm Thru Paint

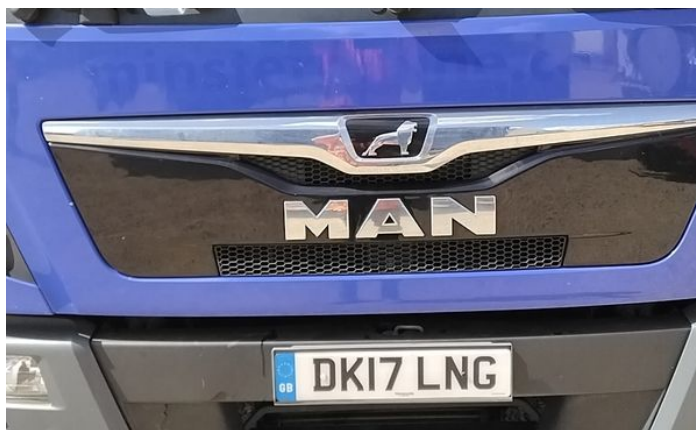
2: Bonnet  
Chipped  
Multiple Chips

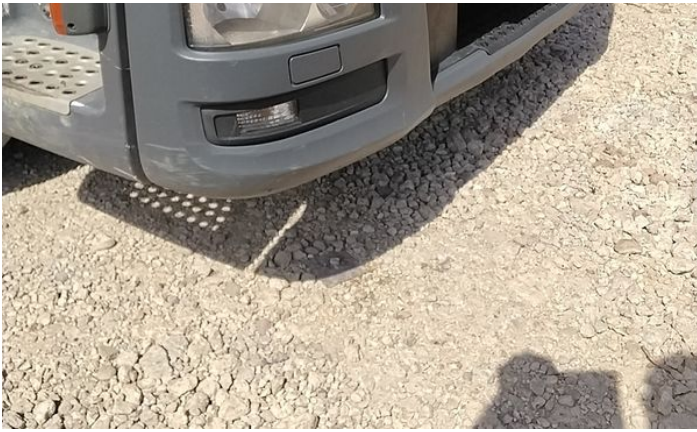
3: Bumper Front Moulding  
Scuffed (Unpainted)  
Over 100mm

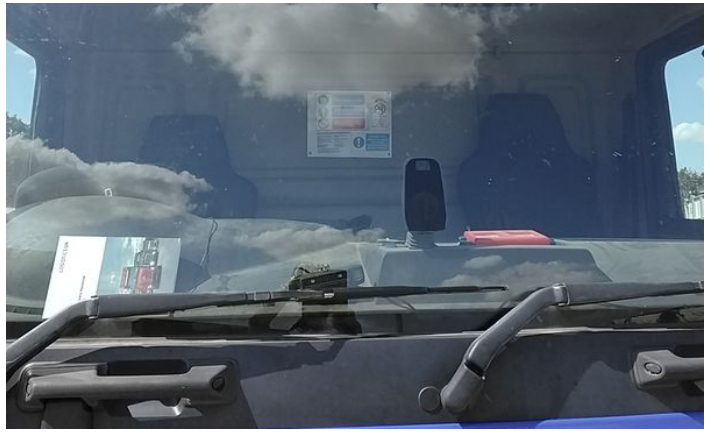
4: Screen Front  
Chipped  
Over 10mm

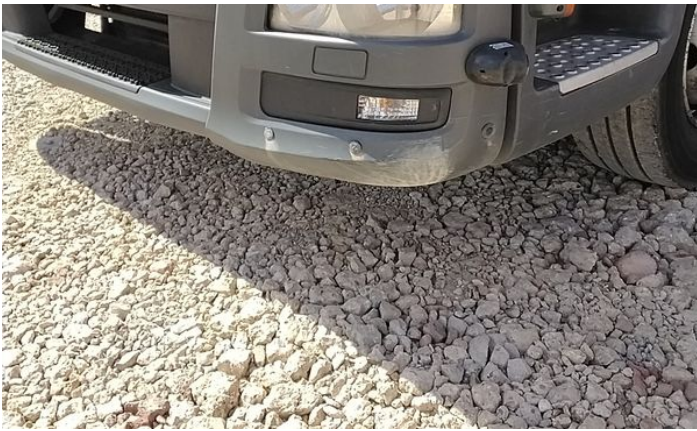
5: Bumper Front Moulding  
Scuffed (Unpainted)  
Over 100mm

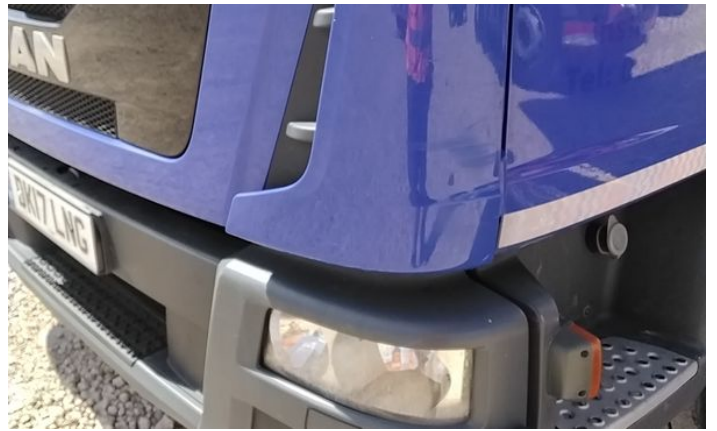
6: Wing nsf  
Scratched  
Over 25mm Not Thru Paint

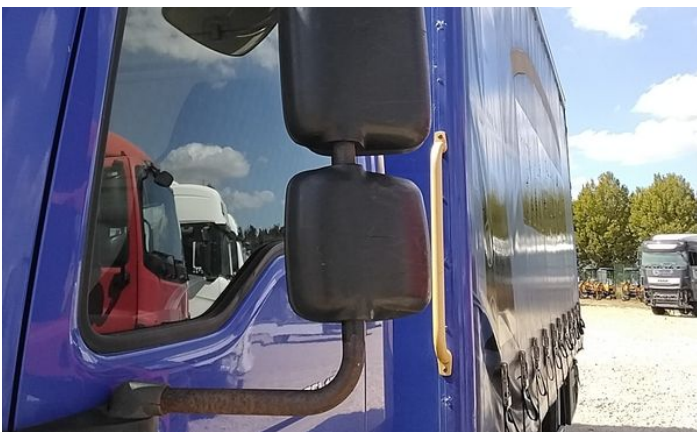
7: Door Mirror Assy nsf  
Scuffed (Unpainted)  
Over 100mm

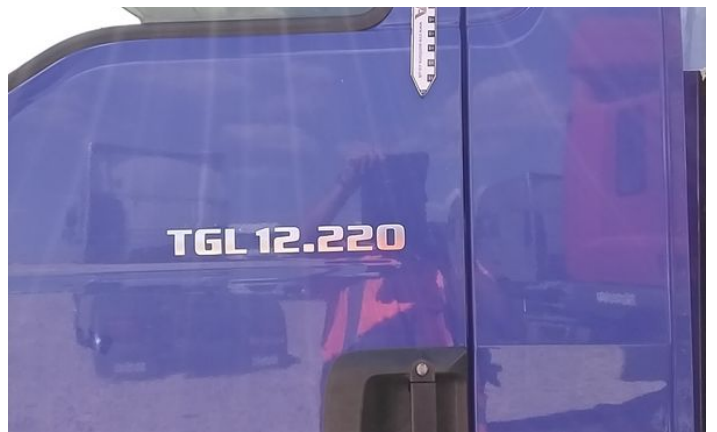
8: Door nsf  
Scratched  
UpTo 25mm Not Thru Paint

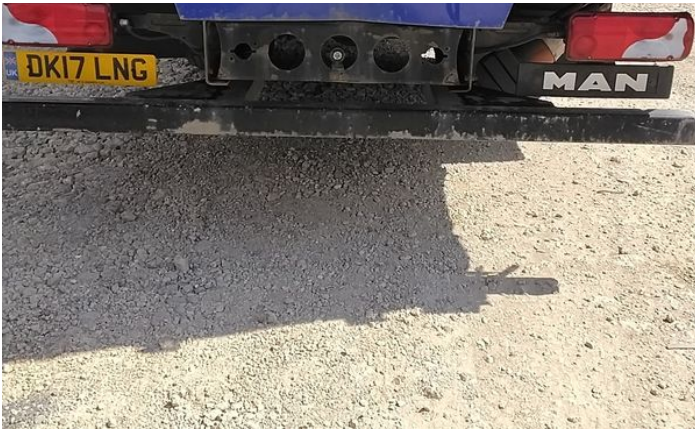
9: Bumper Rear  
Rusted  
Over 5mm

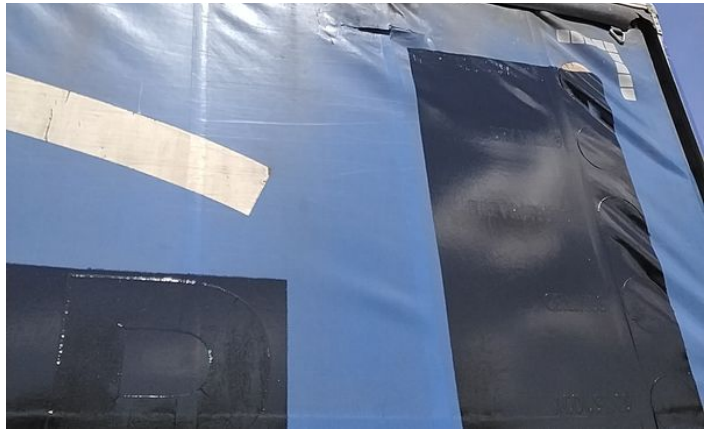
10: Qtr Panel osr  
Scratched  
Over 25mm Thru Paint

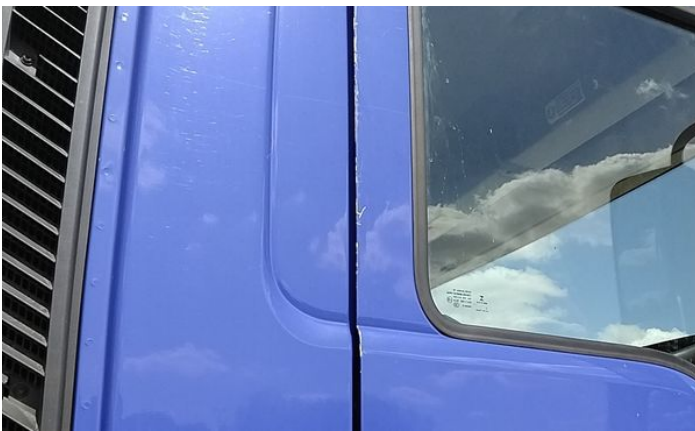
11: Door osf  
Chipped  
Edge Chip

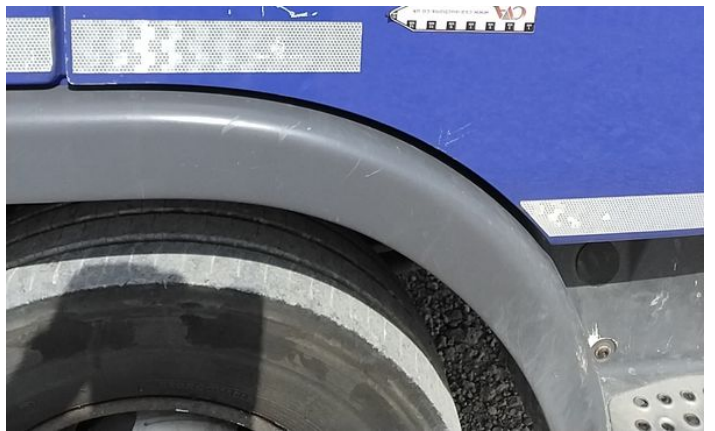
12: Door osf  
Scratched  
Over 25mm Thru Paint

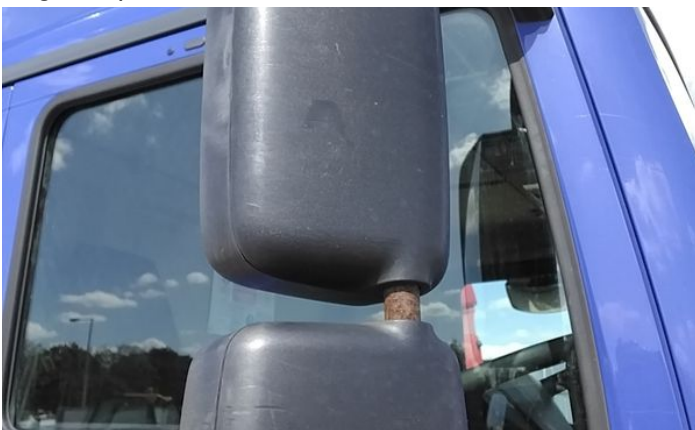
13: Door Mirror Assy osf  
Scuffed (Unpainted)  
Over 100mm

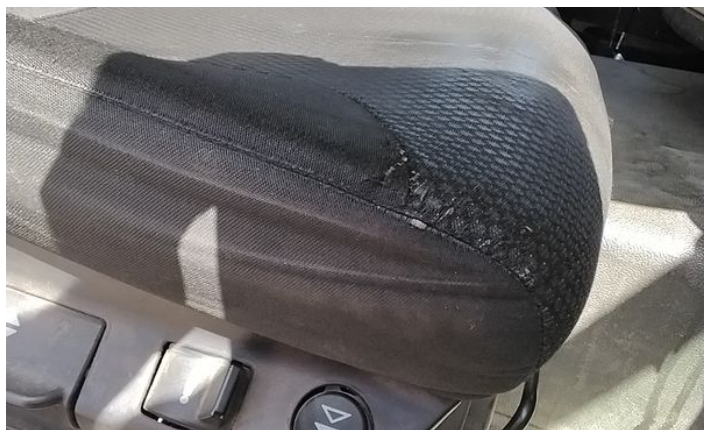
14: Seat Base Cover osf  
Holed  
Over 3mm

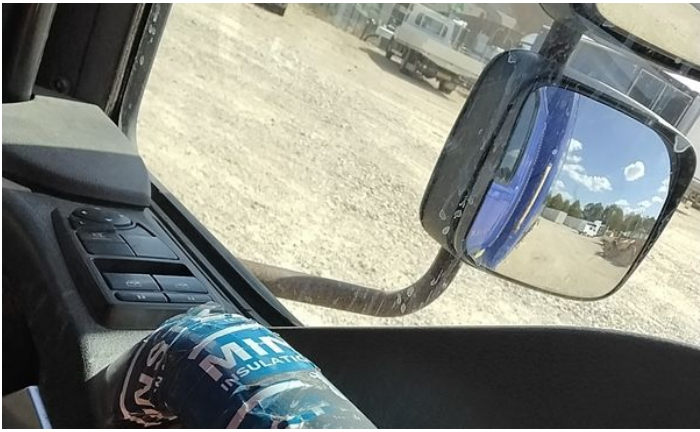
15: Door Pad osf  
Broken  
Replace
