# VEHICLE INSPECTION REPORT

**ND75MVM**

## Mercedes-Benz Sprinter 315 CDI

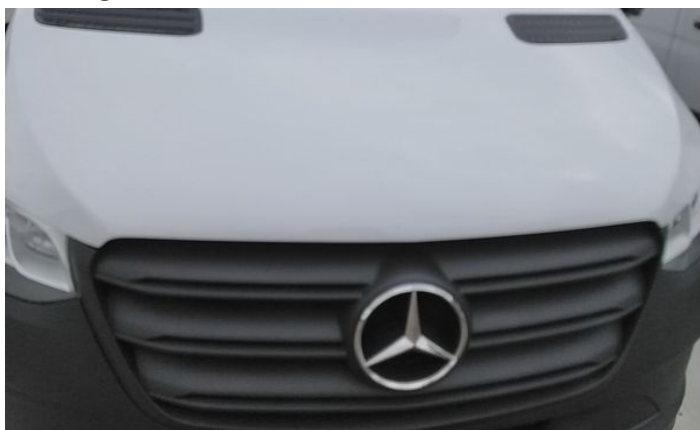
1: Bonnet  
Chipped  
Multiple Chips

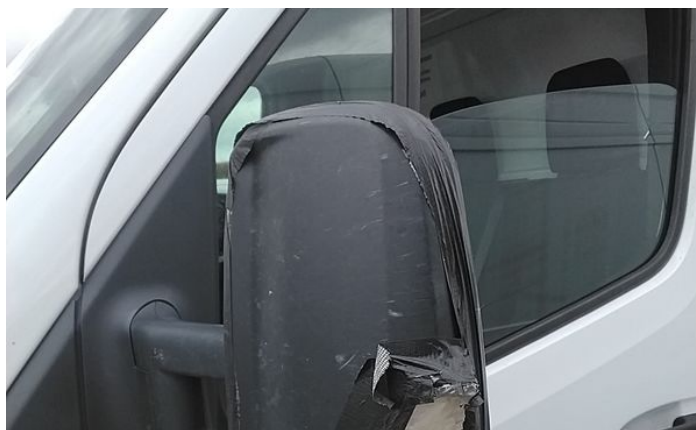
2: Door Mirror Assy nsf  
Broken  
Replace

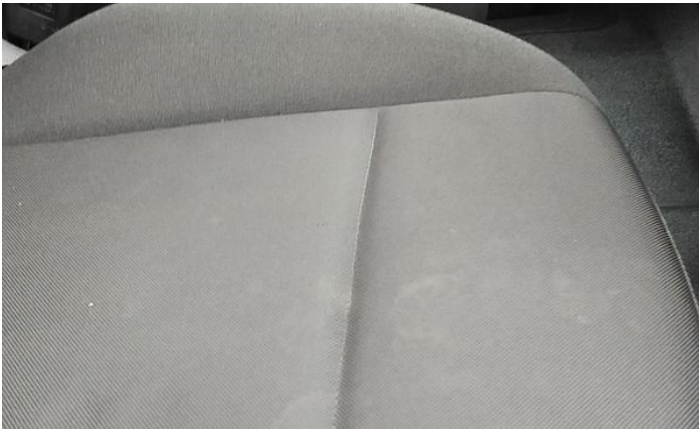
3: Seat Base Cover osf  
Soiled  
Heavy

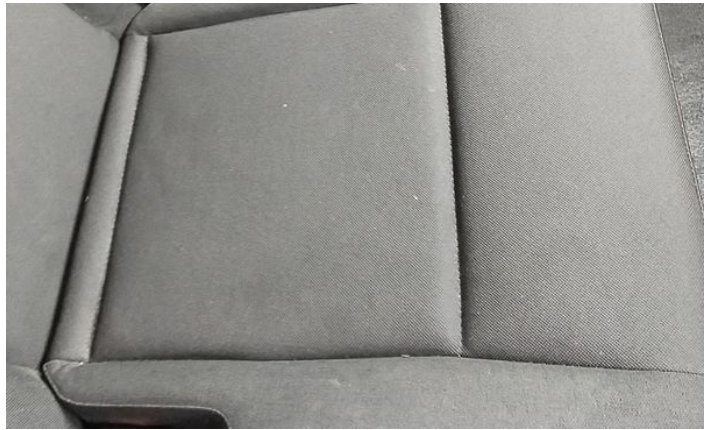
4: Seat Base Cover nsf  
Soiled  
Heavy

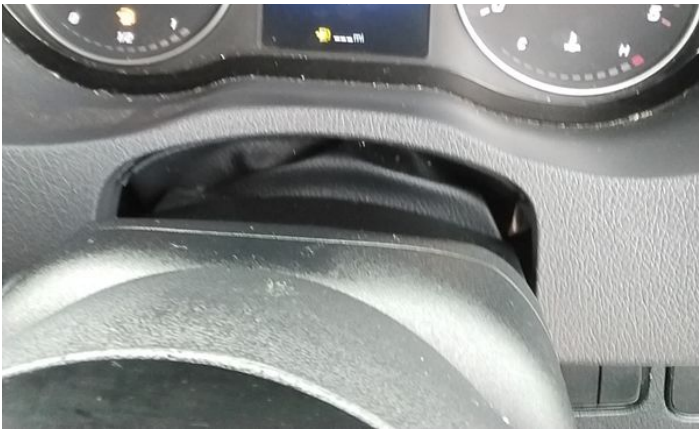
\*WARNING LIGHT ON DASH\* AD-BLUE, E/MIRRORS

5: Dash Warning Lights  
Displayed  
No Action
