# VEHICLE INSPECTION REPORT

**NL25VRV**

## Mercedes-Benz Sprinter 313 CDI

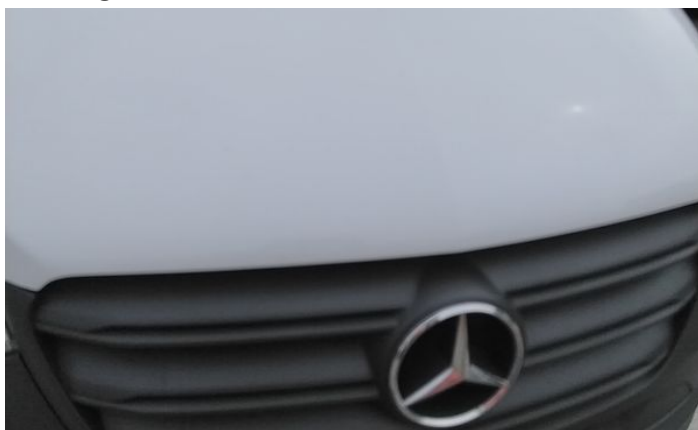
1: Bonnet  
Chipped  
Multiple Chips

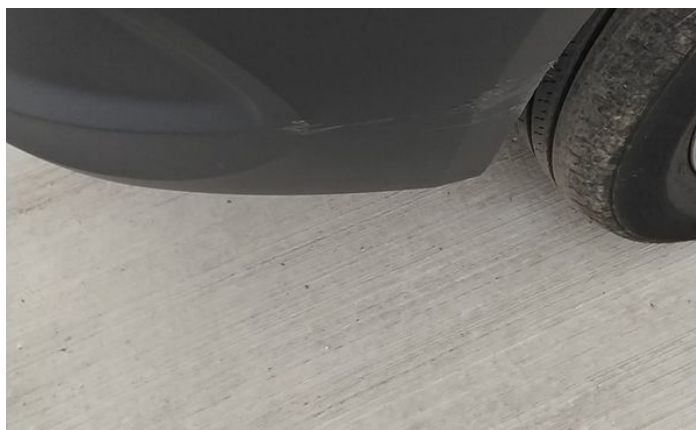
2: Bumper Front  
Scratched  
Over 100mm Thru Paint

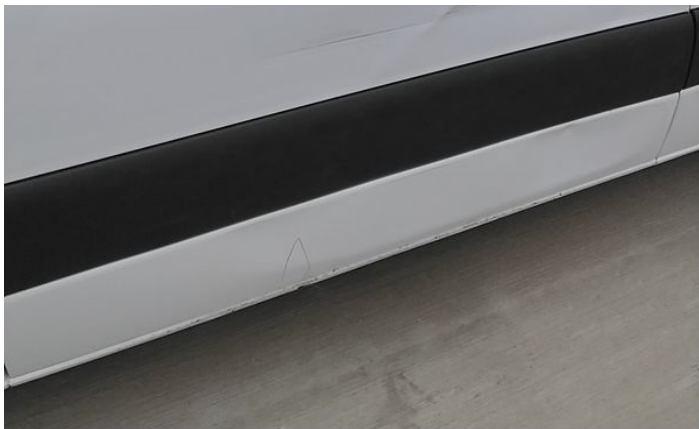
3: Qtr Panel nsr  
Dented  
Over 30% Of Panel

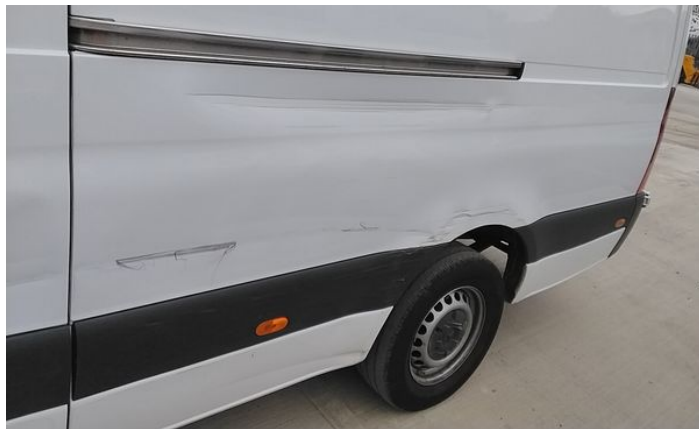
4: Qtr Panel nsr  
Dented  
Over 30% Of Panel

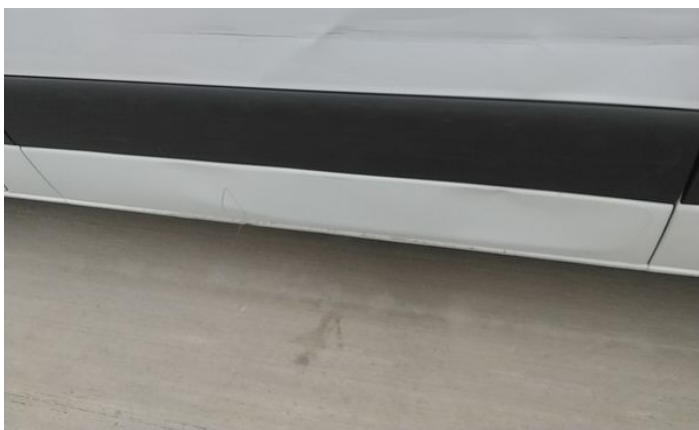
5: Qtr Panel Moulding ns  
Scuffed (Unpainted)  
Over 100mm

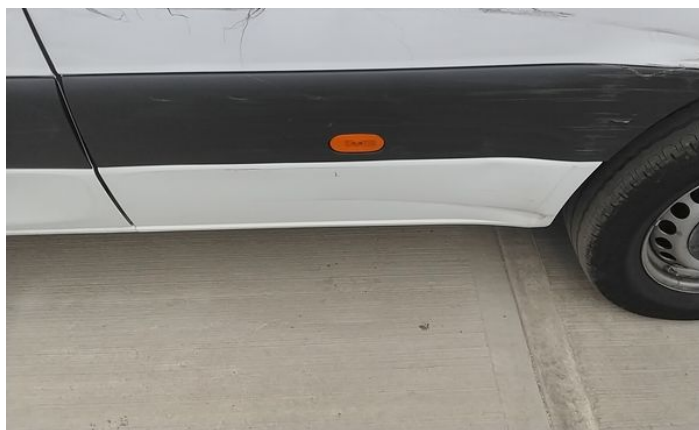
6: Qtr Panel Moulding ns  
Scuffed (Unpainted)  
Over 100mm

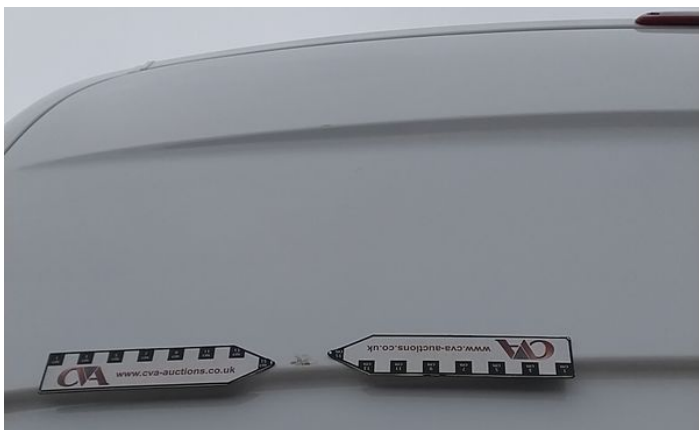
7: Door nsr  
Dented  
With Paint Damage

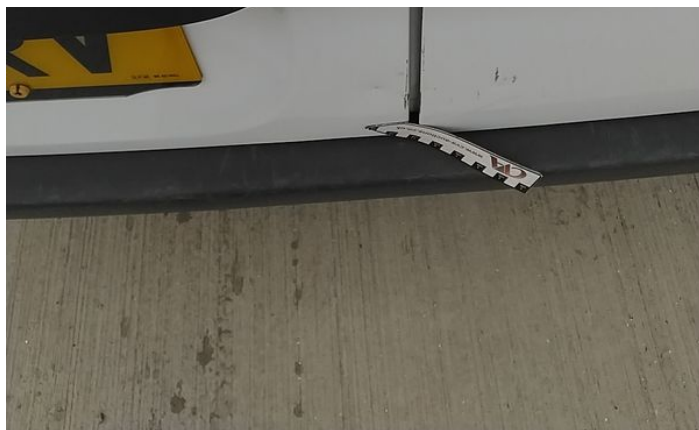
8: Door nsr  
Dented  
With Paint Damage

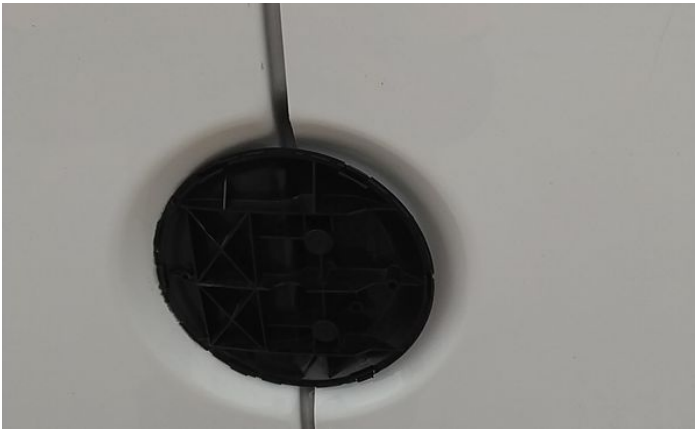
9: Badgedecal Rear  
Missing  
Replace

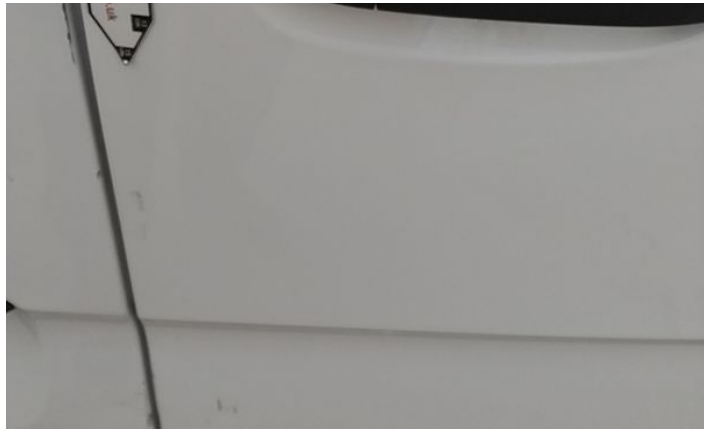
10: Door osr  
Dented  
With Paint Damage

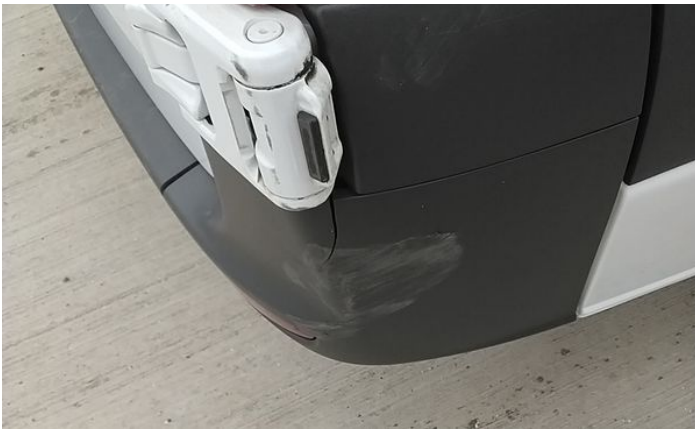
11: Bumper Rear Moulding  
Broken  
Replace

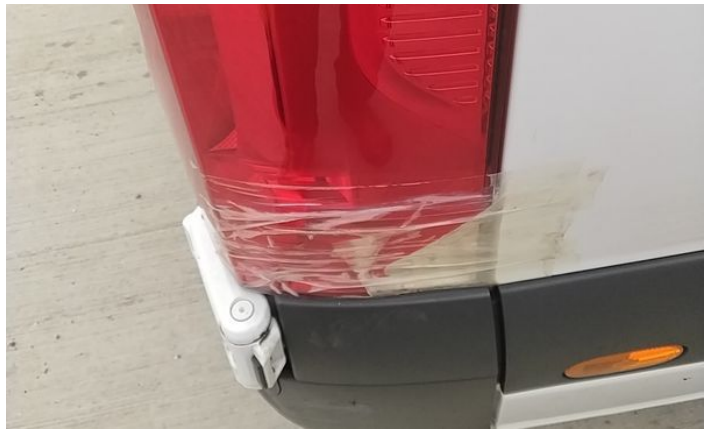
12: Lamp osr  
Broken  
Replace

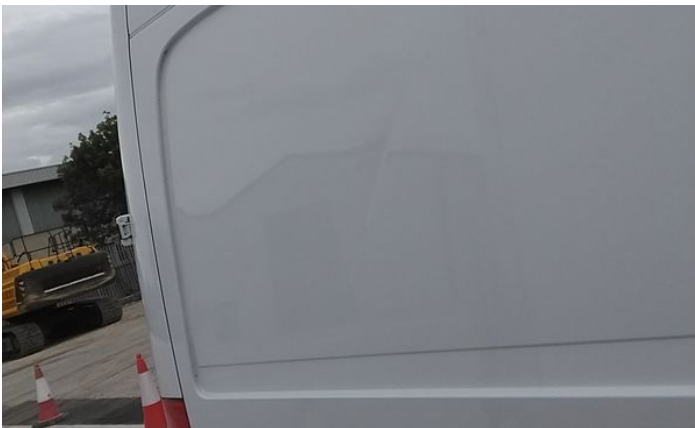
13: Qtr Panel osr  
Dented  
With Paint Damage

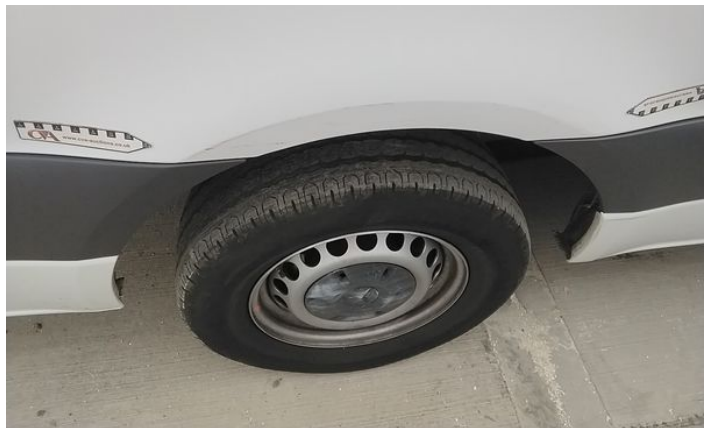
14: Qtr Panel osr  
Dented  
With Paint Damage

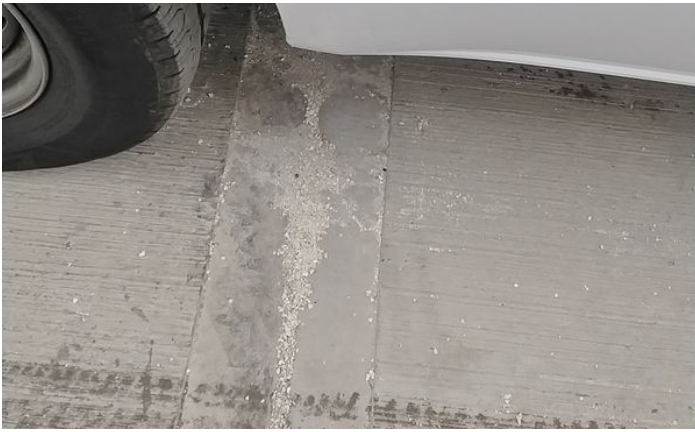
15: Qtr Panel osr  
Scratched  
Over 25mm Thru Paint

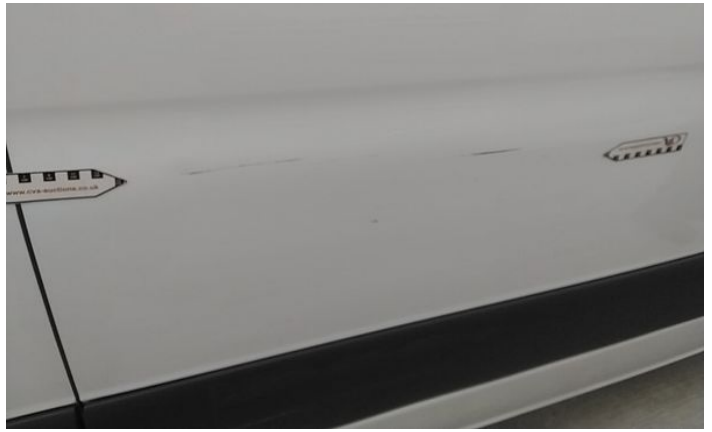
16: Qtr Panel osr  
Scratched  
Over 25mm Thru Paint

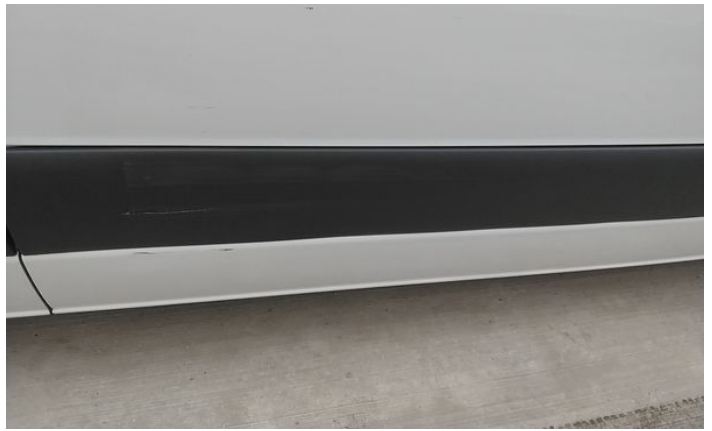
18: Qtr Panel Moulding os  
Scuffed (Unpainted)  
Over 100mm

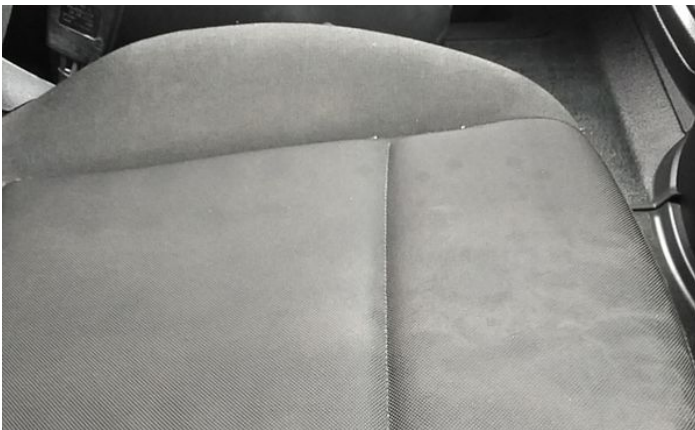
19: Seat Base Cover osf  
Soiled  
Heavy

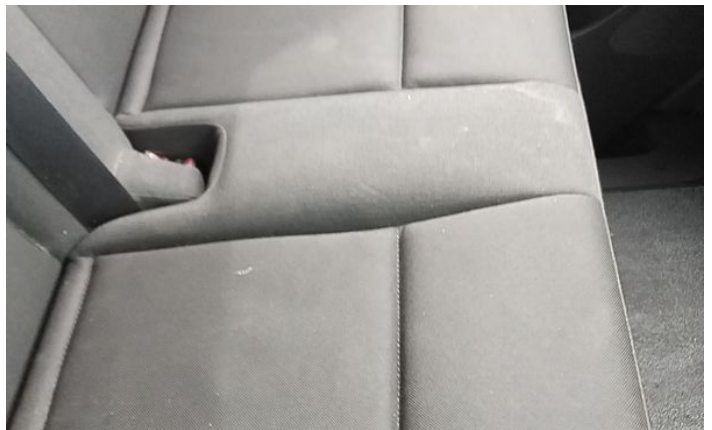
20: Seat Base Cover nsf  
Soiled  
Heavy

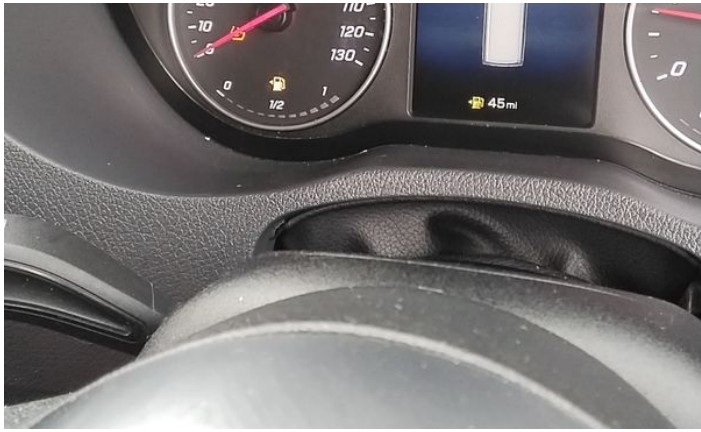
\*WARNING LIGHT ON DASH\* SIDE LOAD DOOR, E/MIRRORS, AD-BLUE

21: Dash Warning Lights  
Displayed  
No Action
