# VEHICLE INSPECTION REPORT

**BT68LXE**

## Iveco Daily 35-140

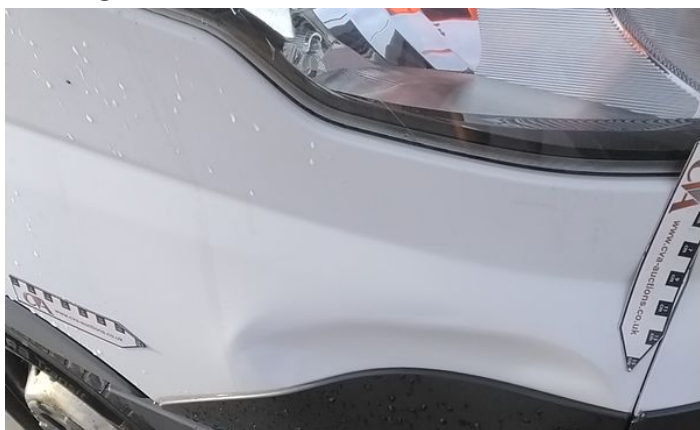
1: Wing osf  
Dented  
Over 30mm

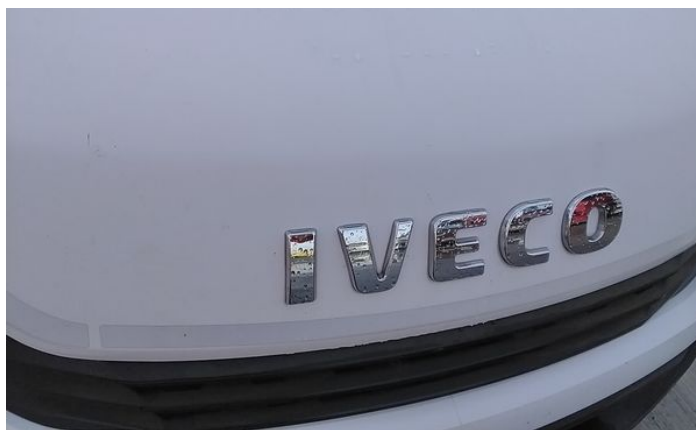
2: Bonnet  
Chipped  
Multiple Chips

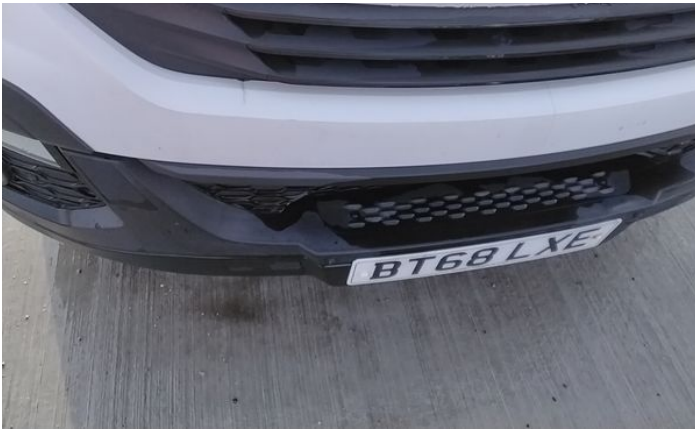
3: Panel Front  
Cracked  
Replace

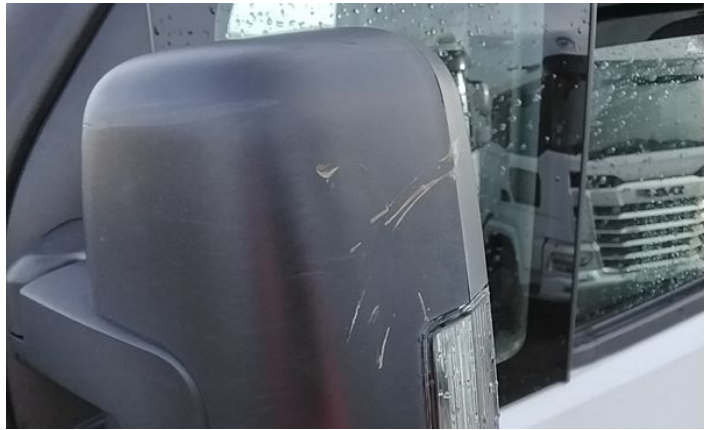
4: Door Mirror Assy nsf  
Scuffed (Unpainted)  
UpTo 100mm

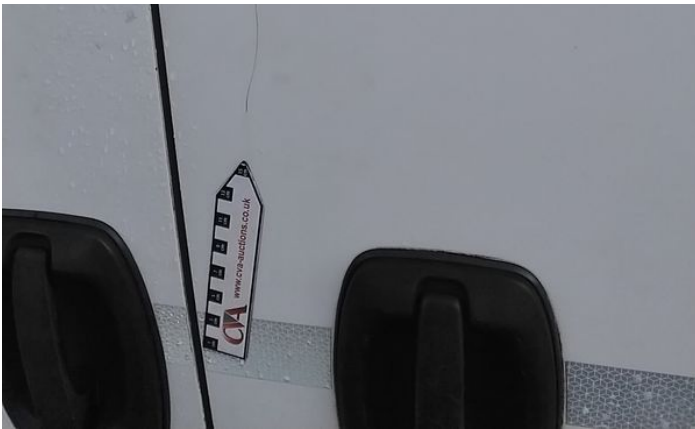
5: Qtr Panel nsr  
Scratched  
Over 25mm Thru Paint

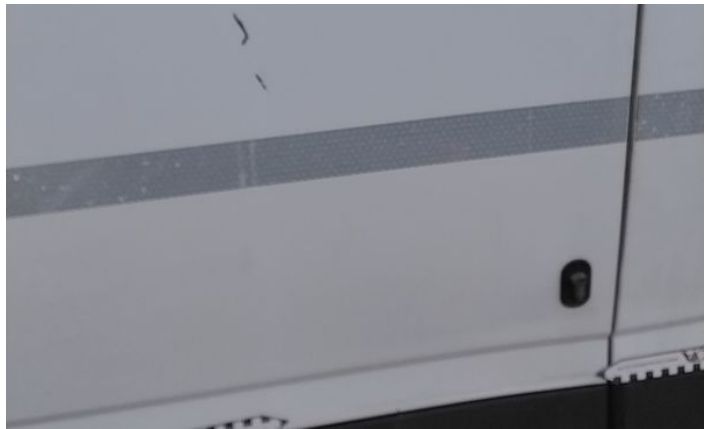
6: Qtr Panel nsr  
Dented  
With Paint Damage

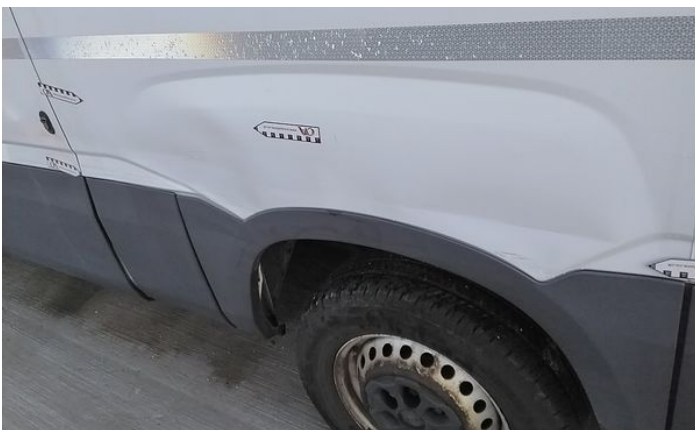
7: Qtr Panel nsr  
Dented  
With Paint Damage

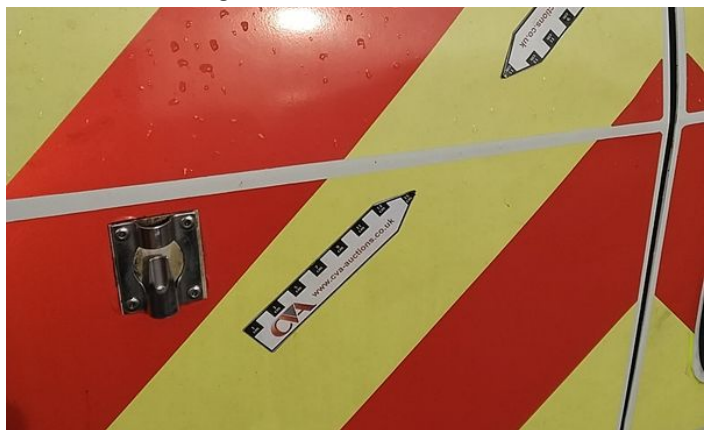
8: Door nsr  
Dented  
Over 30mm

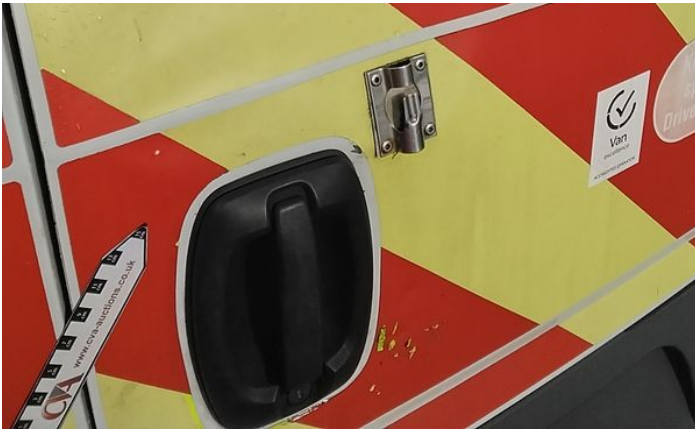
9: Door osr  
Dented  
Over 30mm

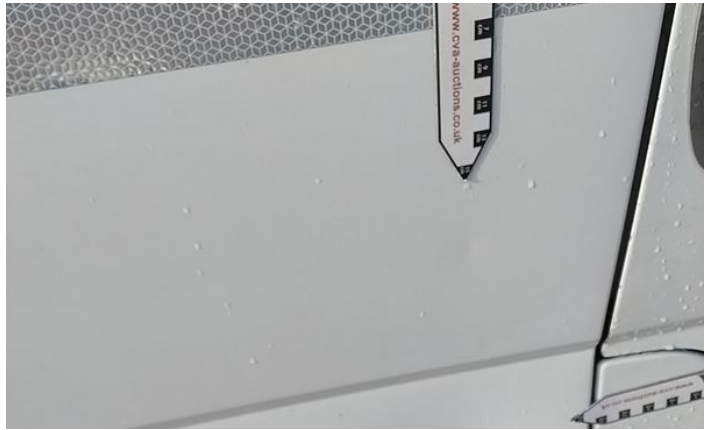
10: Qtr Panel osr  
Dented  
Over 30mm

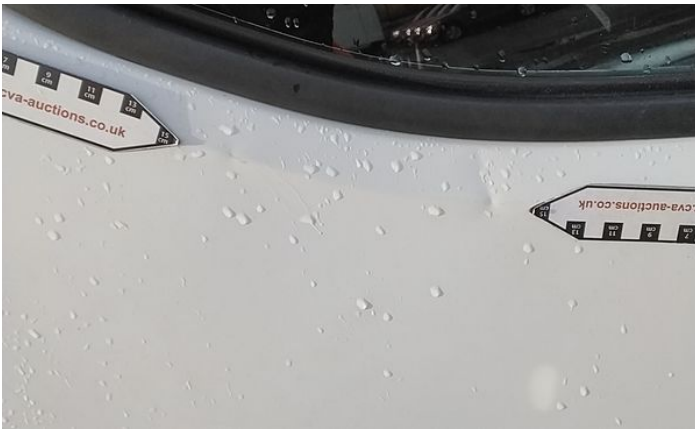
11: Door osf  
Dented  
Over 30mm

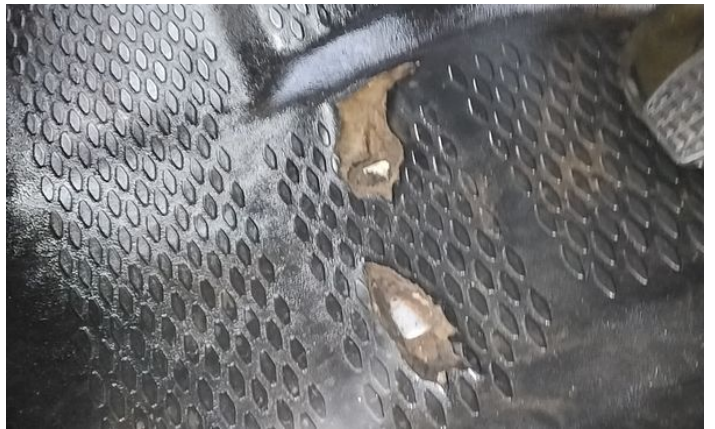
12: Carpets Front  
Holed  
Over 3mm

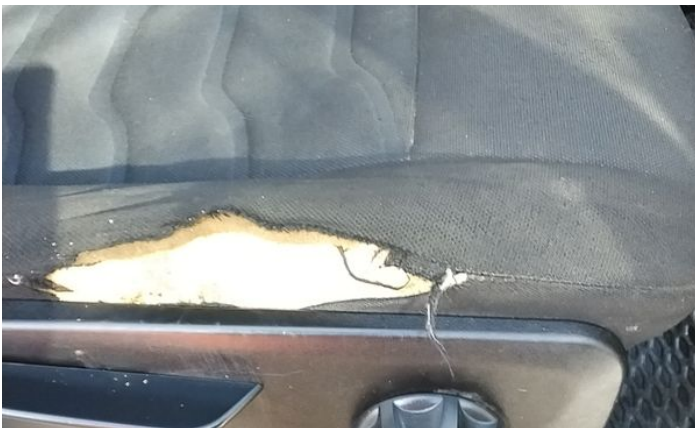
13: Seat Base Cover osf  
Holed  
Over 3mm
