# VEHICLE INSPECTION REPORT

**CN72WLF**

## Mercedes-Benz Vito 114 CDI

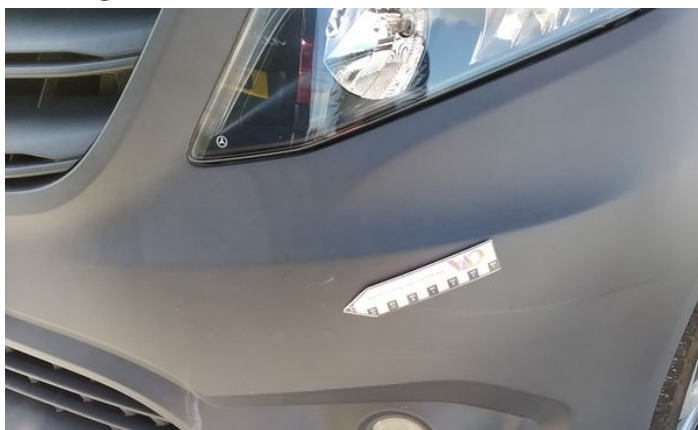
1: Bumper Front  
Scratched  
Over 25mm Not Thru Paint

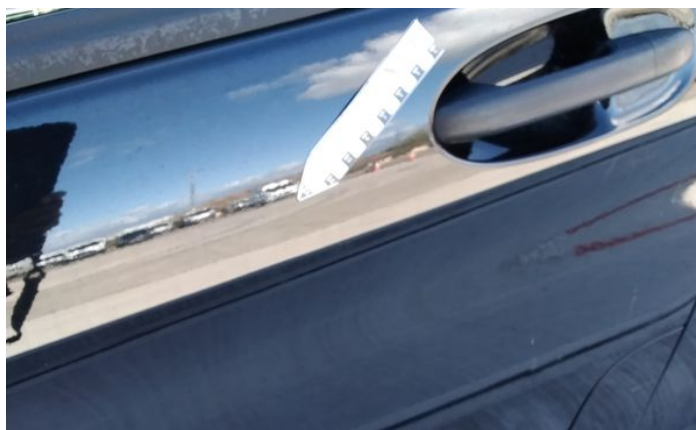
2: Door nsf  
Scratched  
UpTo 25mm Not Thru Paint

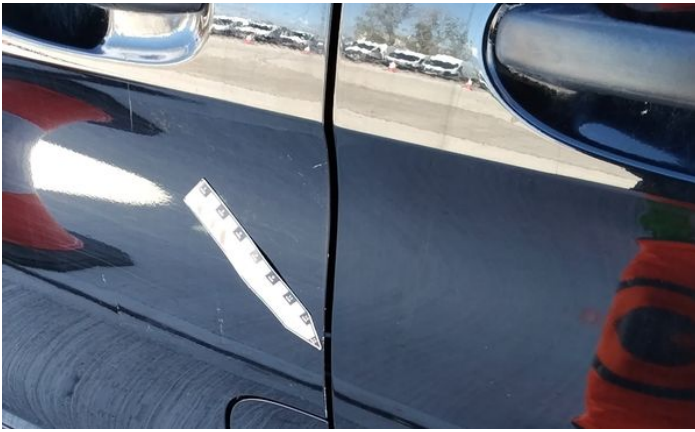
3: Door nsf  
Chipped  
Edge Chip

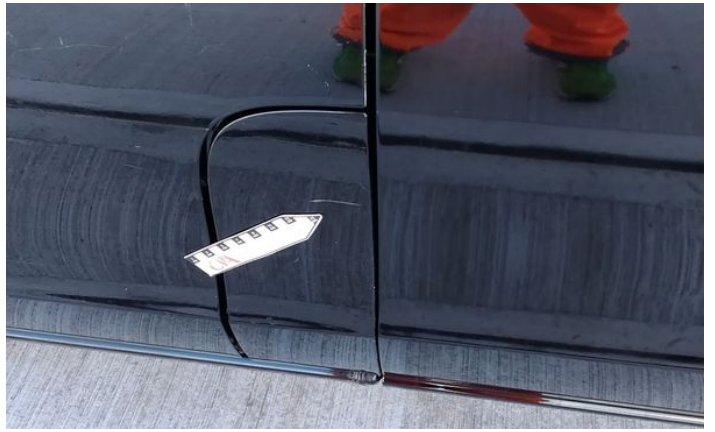
4: Fuel Flap  
Scratched  
UpTo 25mm Not Thru Paint

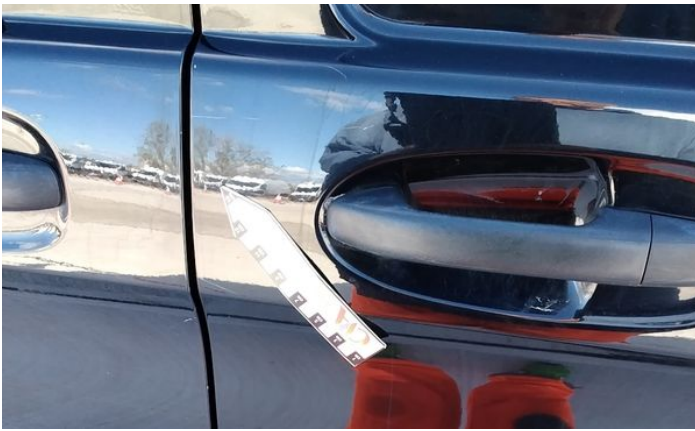
5: Door osr  
Scratched  
Over 25mm Not Thru Paint

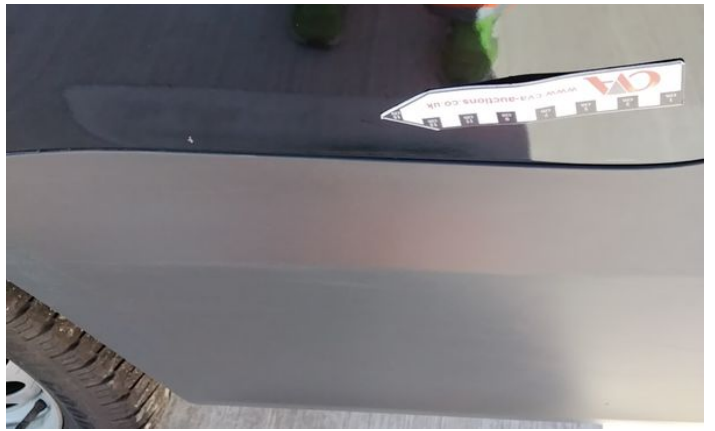
6: Qtr Panel nsr  
Dented  
Over 2 UpTo 10mm

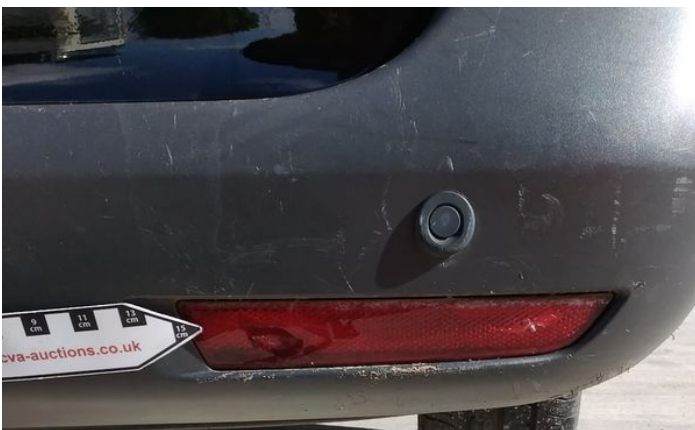
7: Bumper Reflector osr  
Broken  
Replace

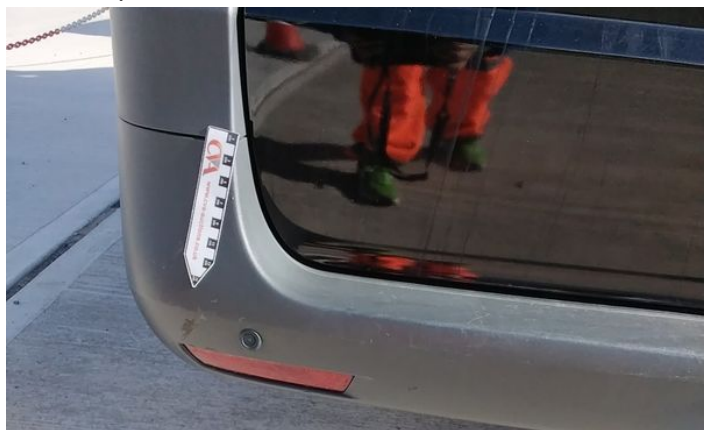
8: Bumper Rear  
Scratched  
Over 25mm Not Thru Paint

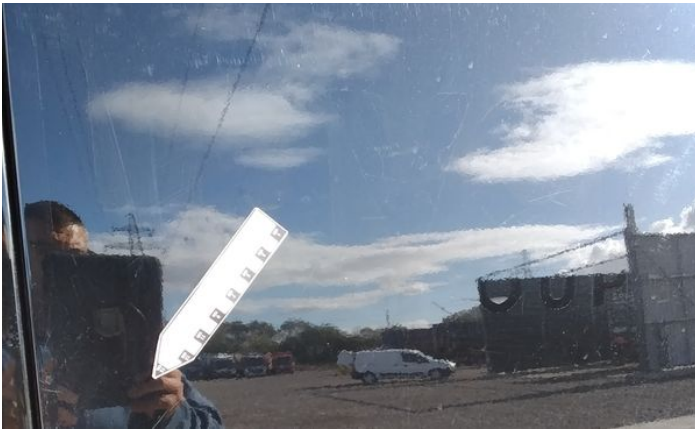
9: Door osr  
Scratched  
Over 25mm Not Thru Paint

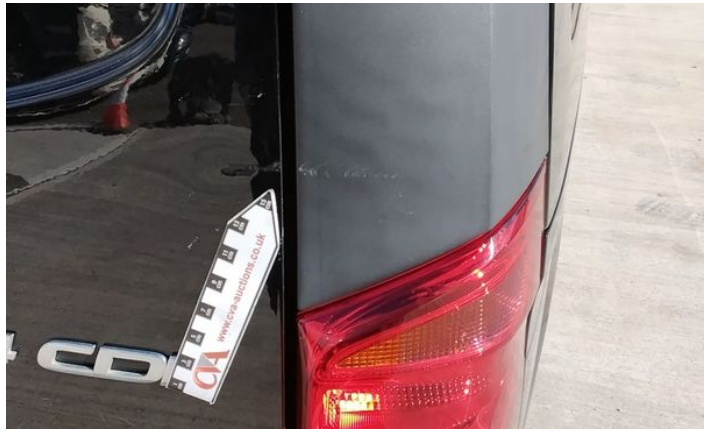
10: Qtr Panel Trim os  
Scuffed  
Over 25mm

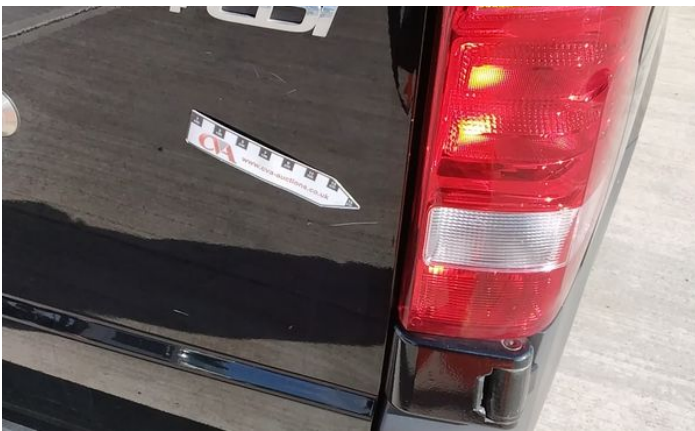
11: Door osr  
Scratched  
Over 25mm Not Thru Paint

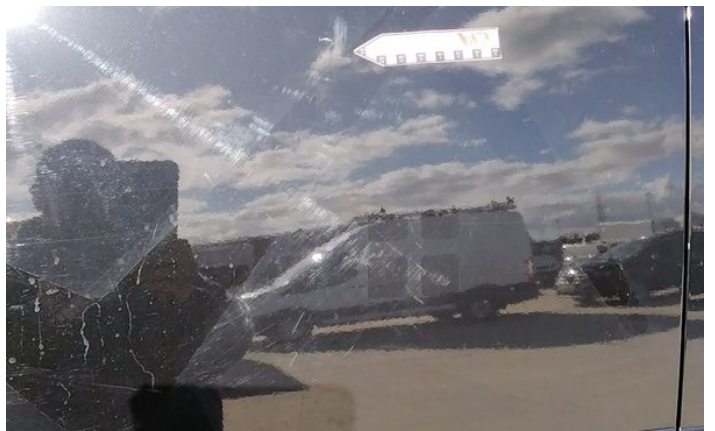
12: Qtr Panel osr  
Scratched  
Over 25mm Not Thru Paint

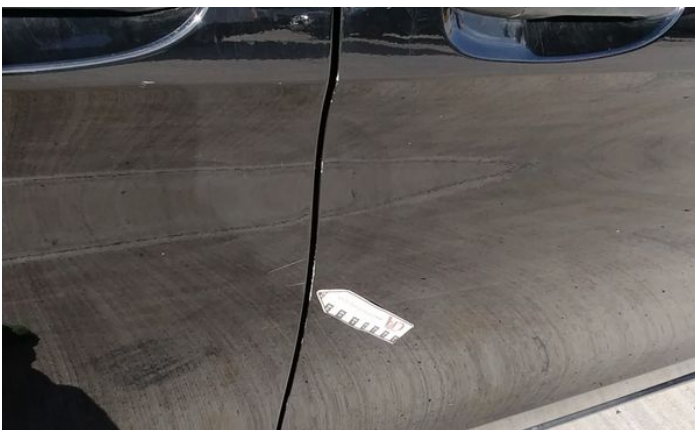
13: Door osf  
Chipped  
Multiple Chips
