## VEHICLE INSPECTION REPORT

**OE21KYC**

### Mercedes-Benz Sprinter 315cdi L3 Diesel Rwd 3.5t Progressive Dropside

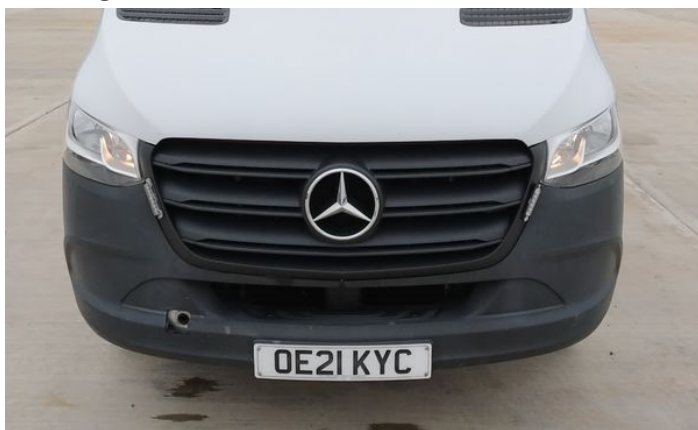
1: Bonnet  
Chipped  
Multiple Chips

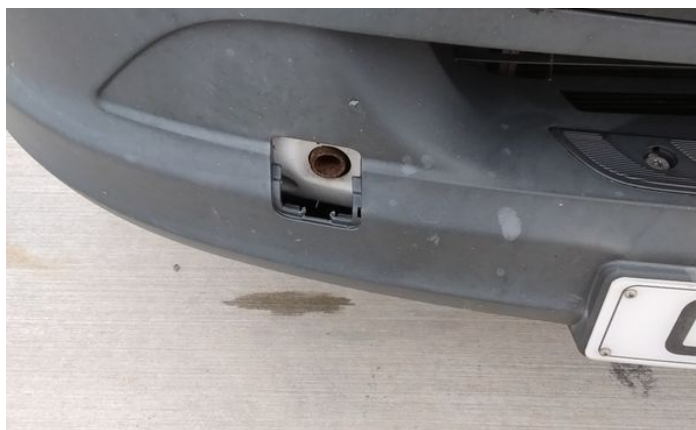
2: Front TowEye Cvr  
Missing  
Replace

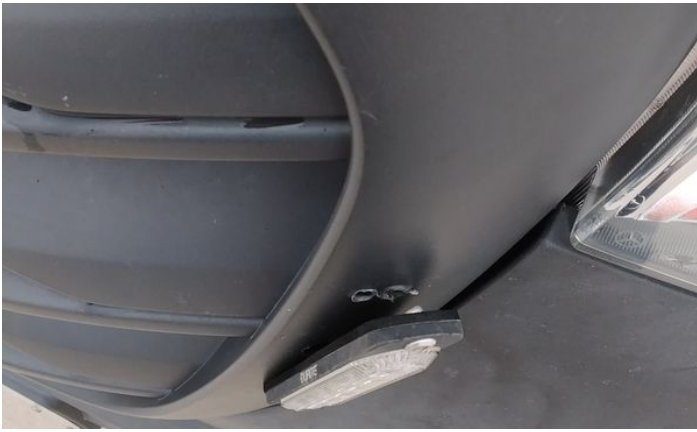
3: Bumper Front Moulding  
Broken  
Replace

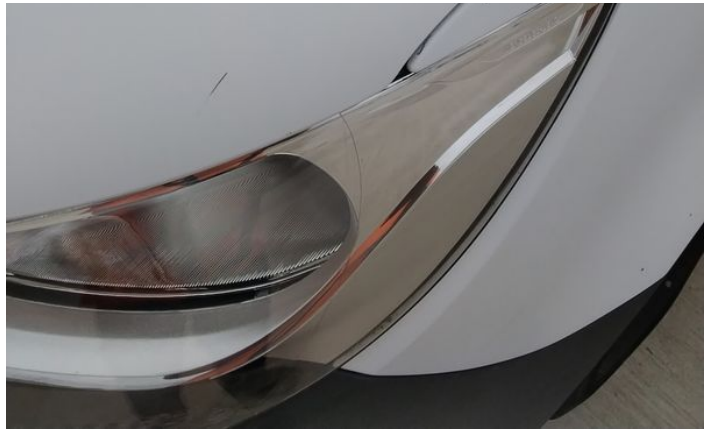
4: Bonnet  
Scratched  
Over 25mm Thru Paint

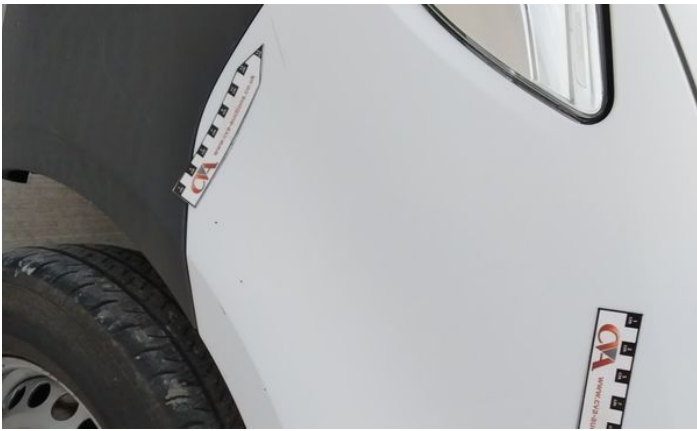
5: Wing nsf  
Scratched  
Over 25mm Thru Paint

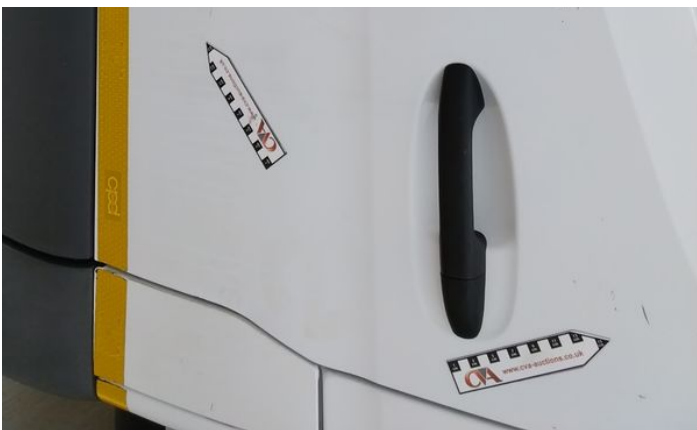
7: Door nsf  
Scratched  
Over 25mm Thru Paint

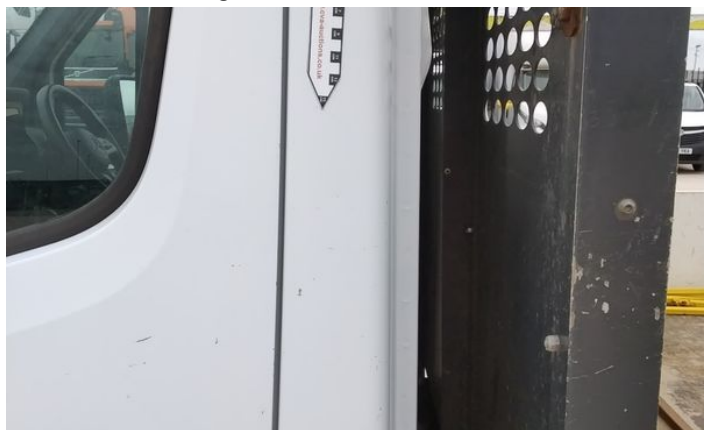
8: B Post ns  
Scratched  
Over 25mm Thru Paint

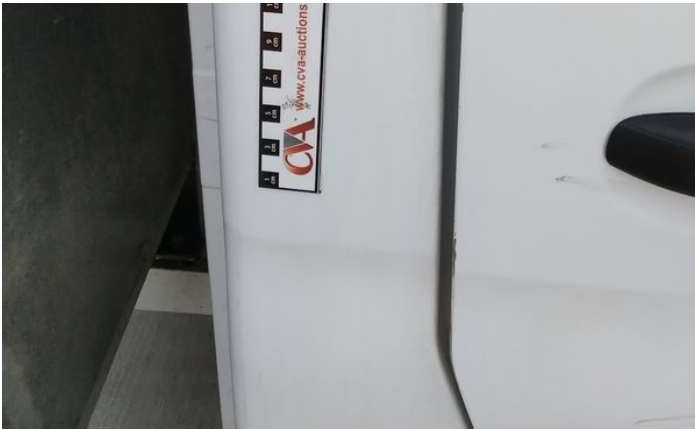
9: B Post os  
Chipped  
Multiple Chips

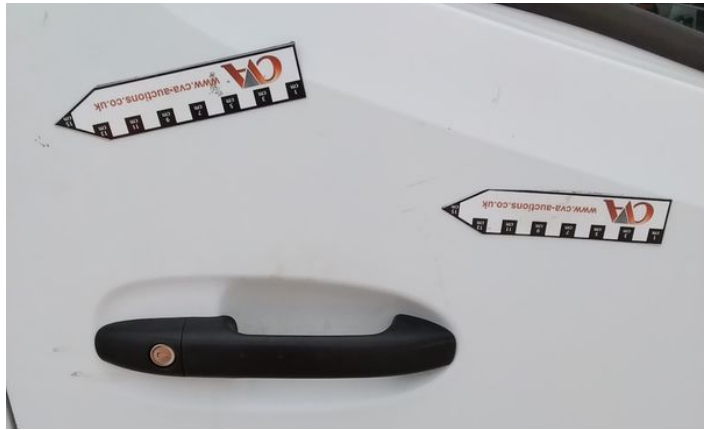
10: Door osf  
Scratched  
Over 25mm Thru Paint

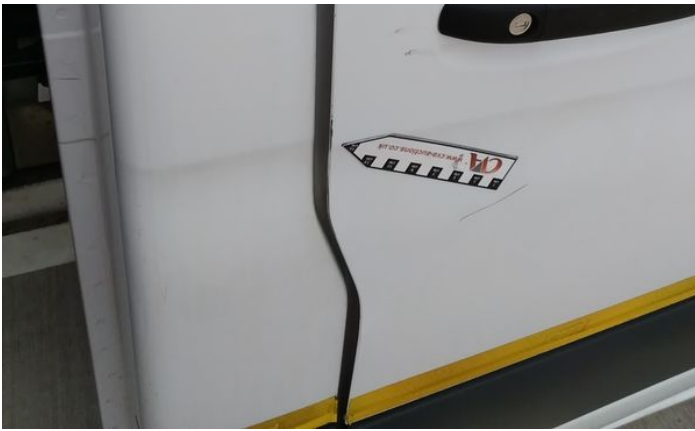
11: Door osf  
Chipped  
Multiple Chips

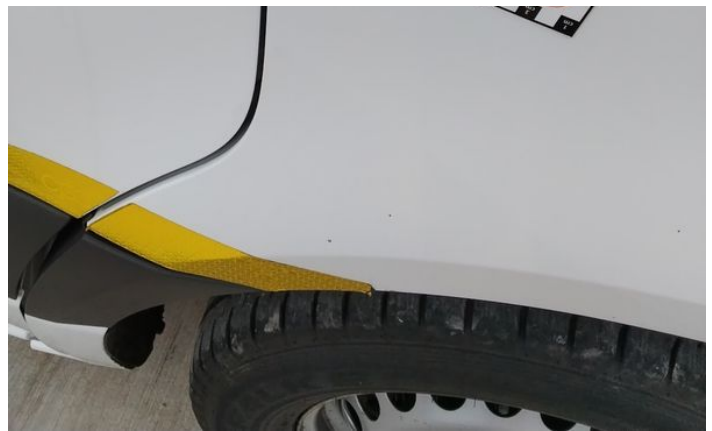
12: Wing osf  
Scratched  
Over 25mm Thru Paint

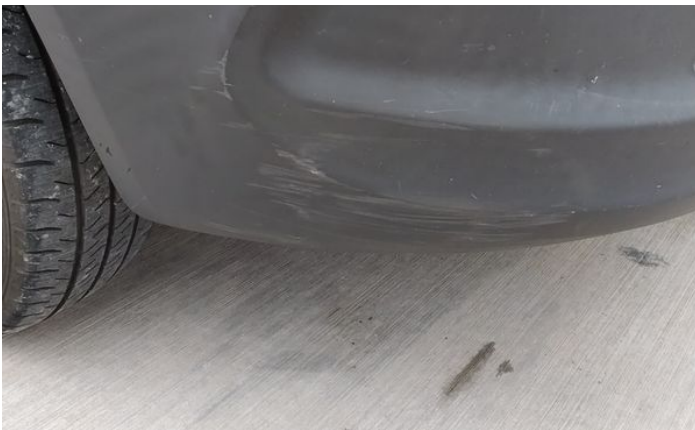
13: Bumper Front  
Scratched  
Over 100mm Thru Paint

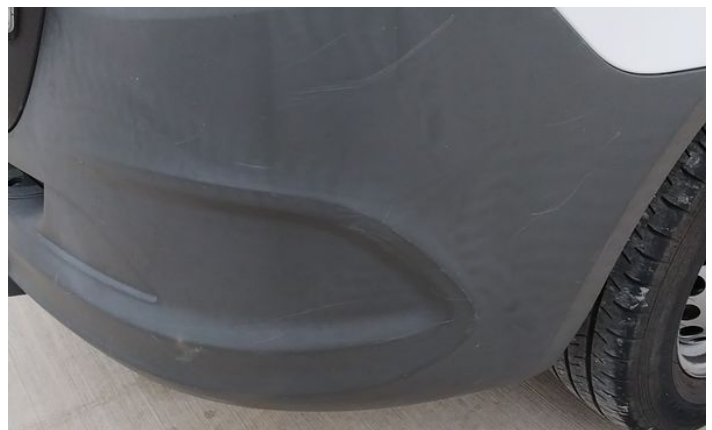
14: Bumper Front  
Scratched  
Over 100mm Thru Paint

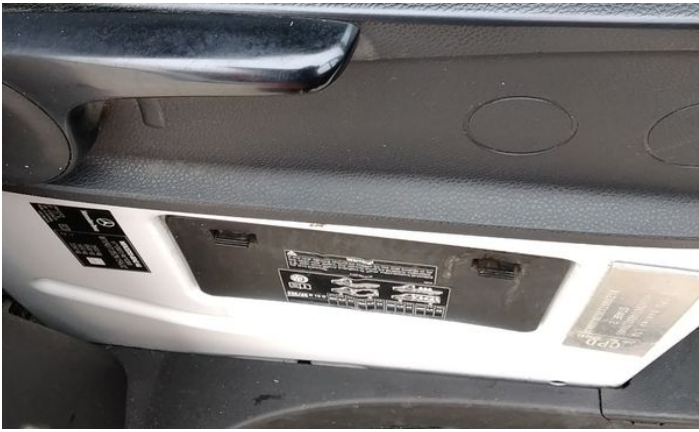
15: Seat Base Cover osf  
 Holed  
 UpTo 3mm

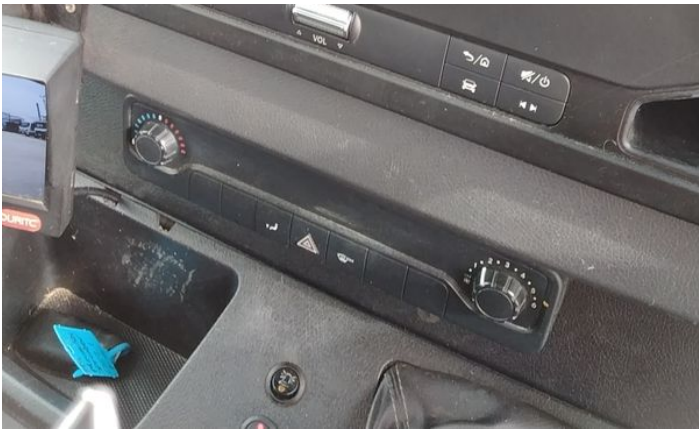
17: In Car Entertainment  
 Broken  
 Replace
