# VEHICLE INSPECTION REPORT

**CP17KPJ**

## Iveco Daily 50-150

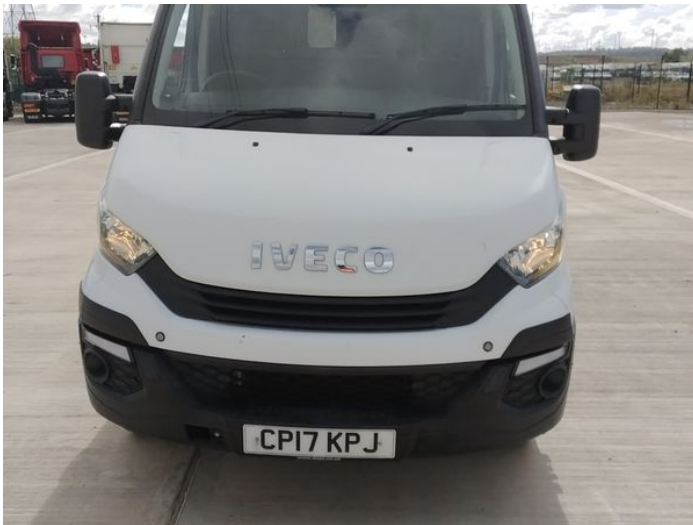
1: Bonnet  
Chipped  
Multiple Chips

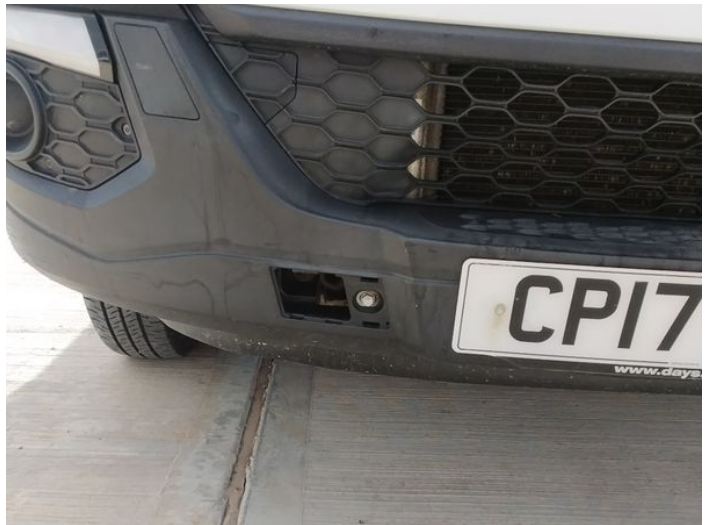
2: Front TowEye Cvr  
Missing  
Replace

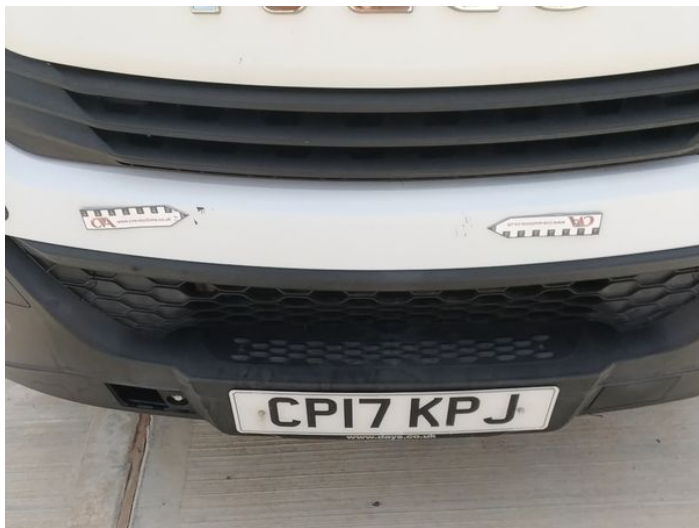
3: Bumper Front  
Scratched  
Over 100mm Thru Paint

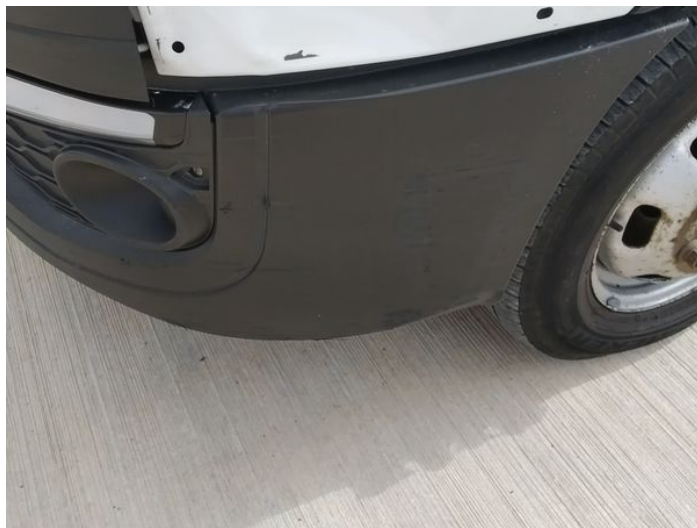
4: Wing nsf  
Dented  
Hail - Severe

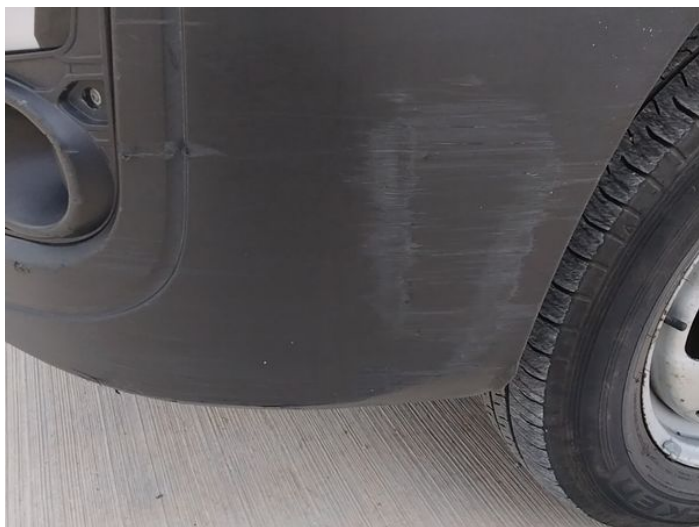
5: Bumper Front  
Scratched  
Over 100mm Thru Paint

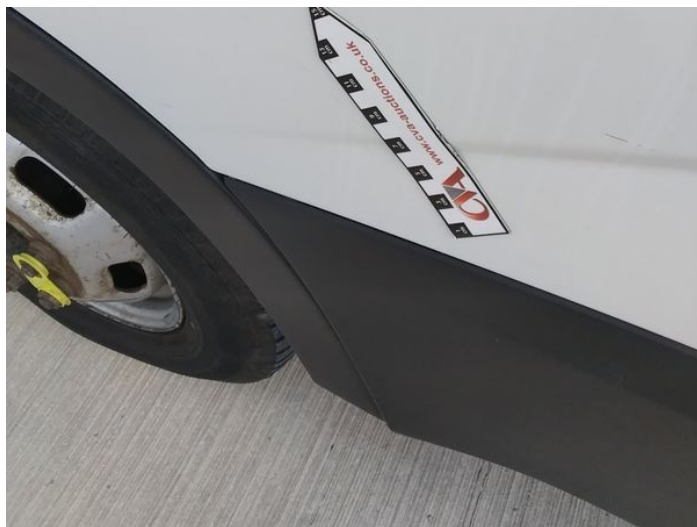
6: Door nsf  
Dented  
Over 2 UpTo 10mm

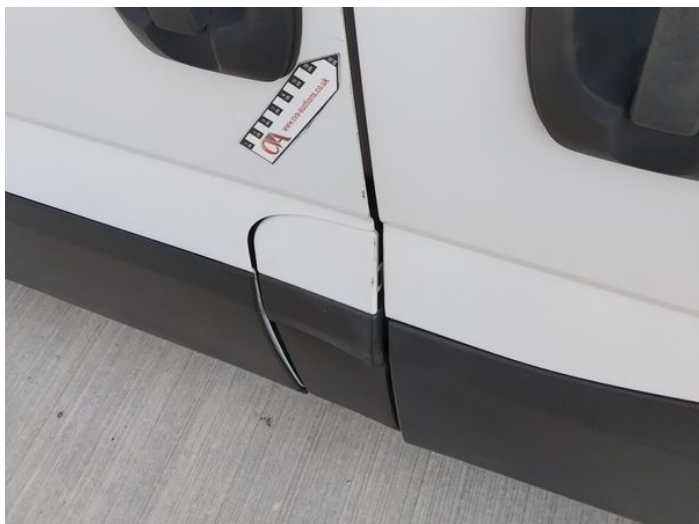
7: Door nsf  
Chipped  
Multiple Chips

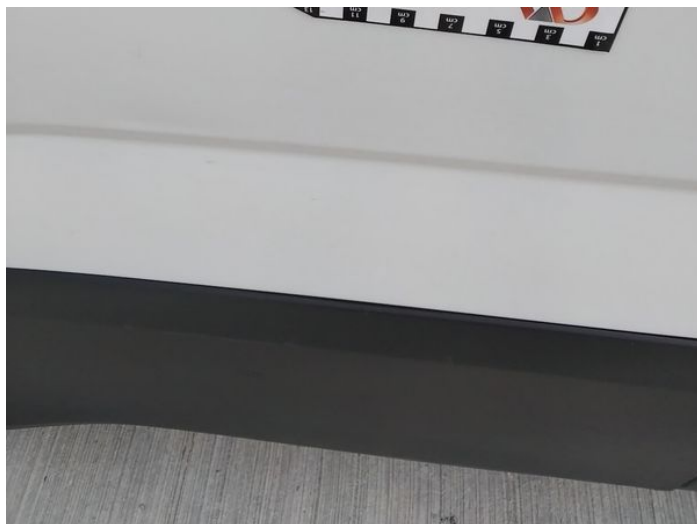
8: Door nsf  
Scratched  
Over 25mm Thru Paint

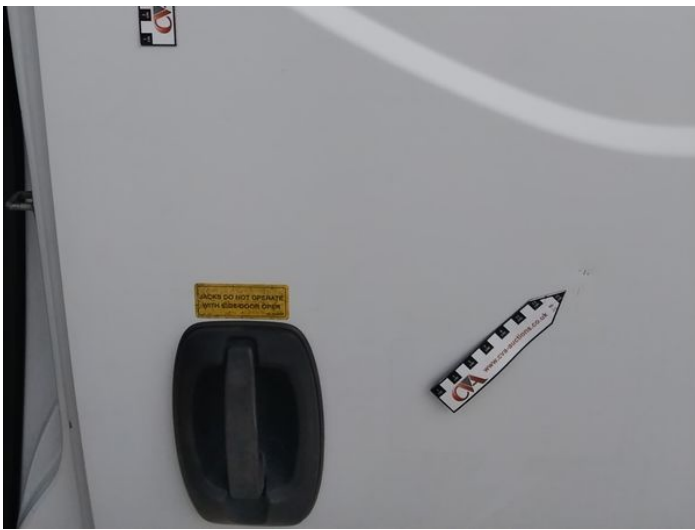
9: Qtr Panel nsr  
 Scratched  
 Over 25mm Thru Paint

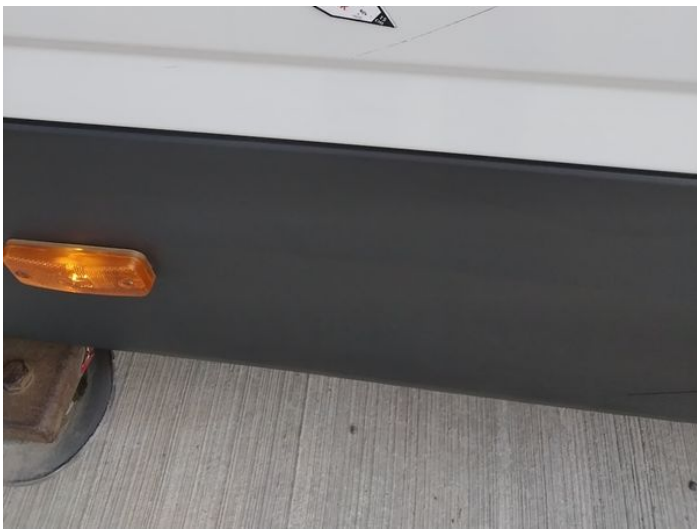
10: Qtr Panel nsr  
 Scratched  
 Over 25mm Not Thru Paint

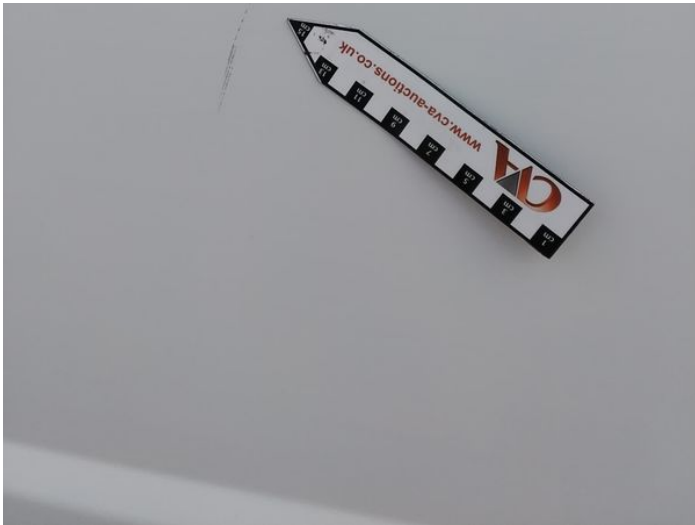
11: Qtr Panel osr  
 Scratched  
 Over 25mm Not Thru Paint

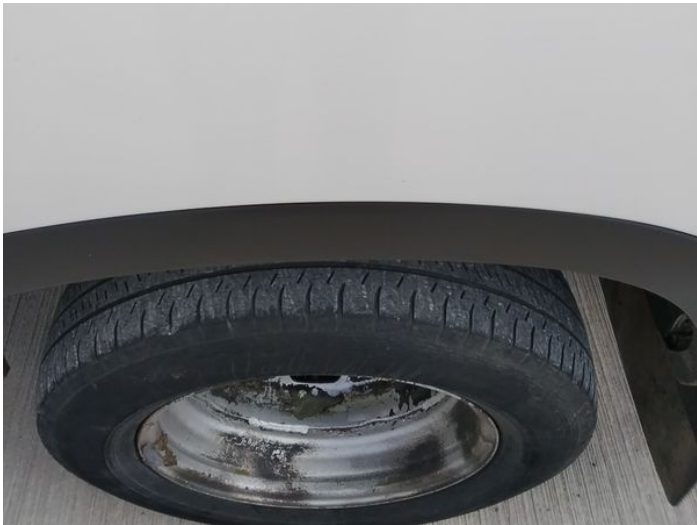
12: Qtr Panel nsr  
 Scratched  
 Over 25mm Thru Paint

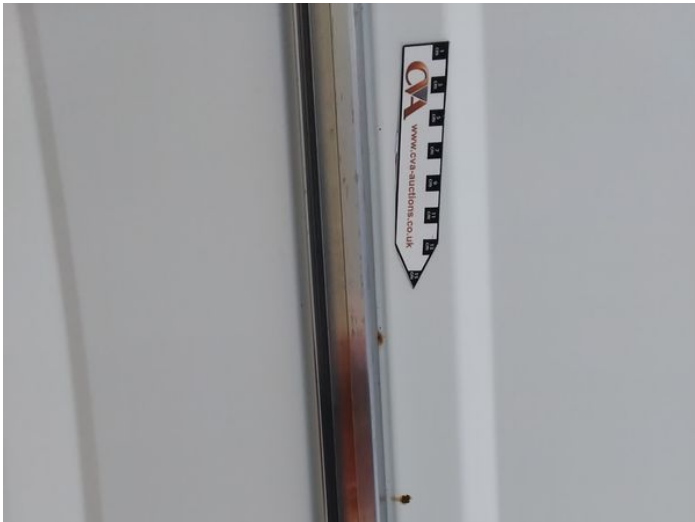
13: Qtr Panel nsr  
 Rusted  
 Over 5mm

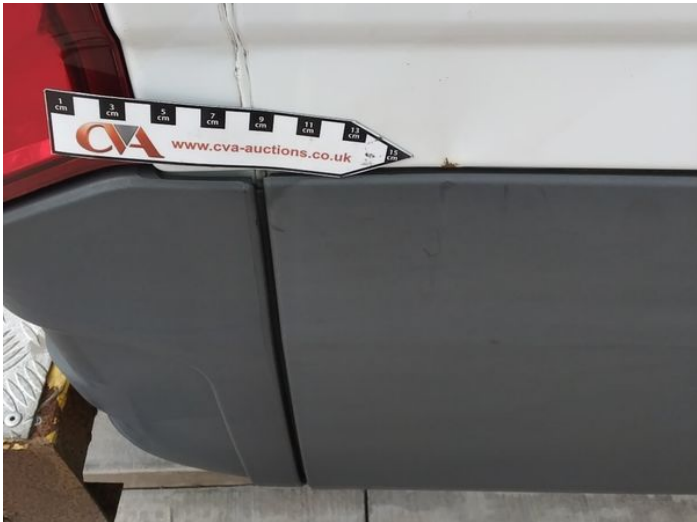
14: Qtr Panel osr  
 Dented  
 With Paint Damage

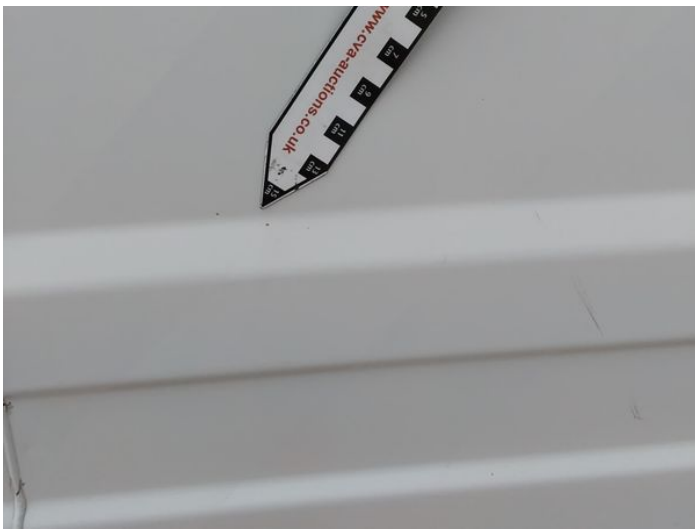
15: Qtr Panel osr  
Chipped  
Multiple Chips

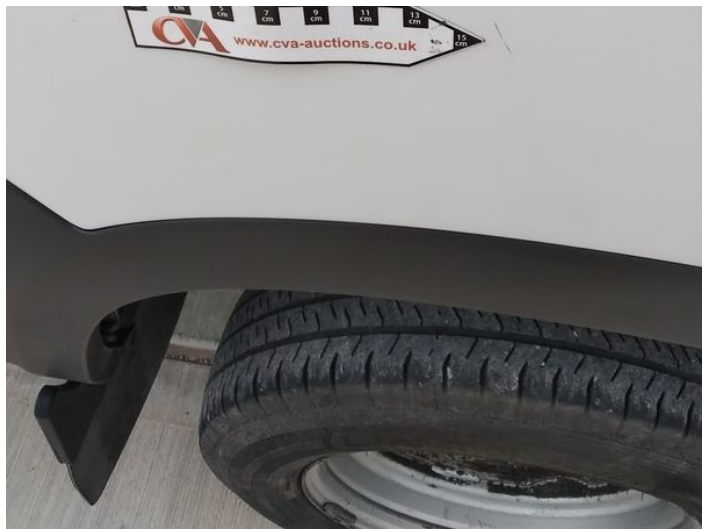
16: Qtr Panel osr  
Scratched  
Over 25mm Thru Paint

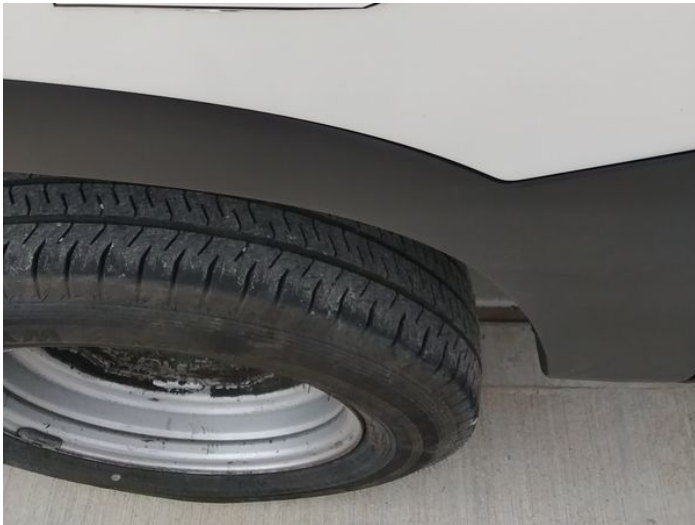
17: Qtr Panel osr  
Dented  
2 Or Less UpTo 10mm

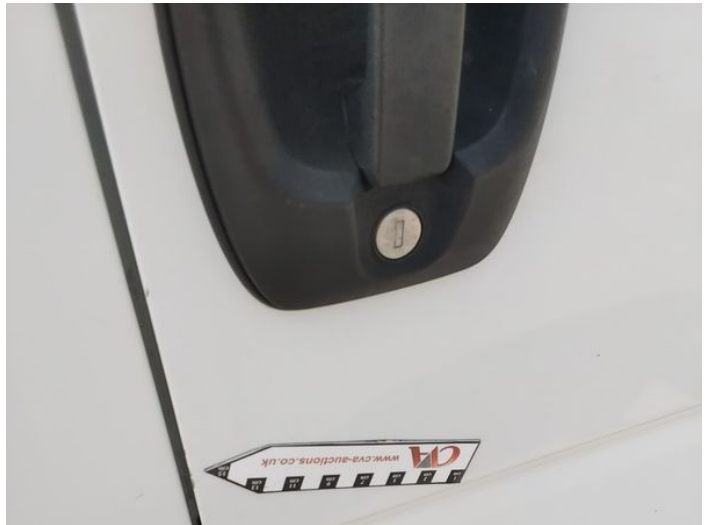
18: Door osf  
Chipped  
Multiple Chips

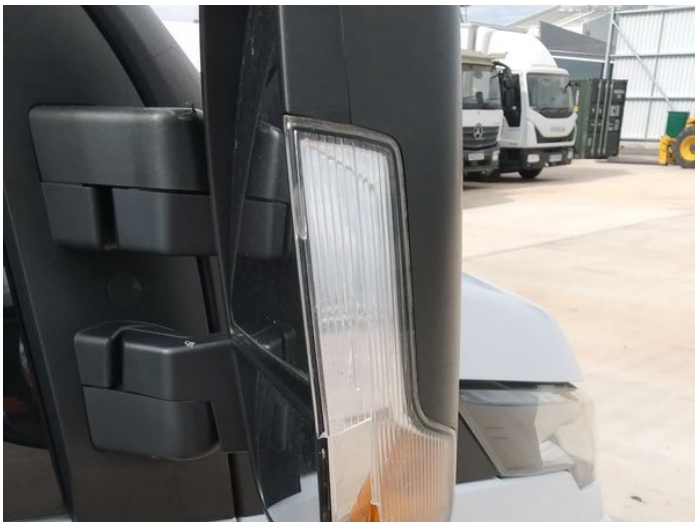
19: Door Mirror Assy osf  
Broken  
Replace

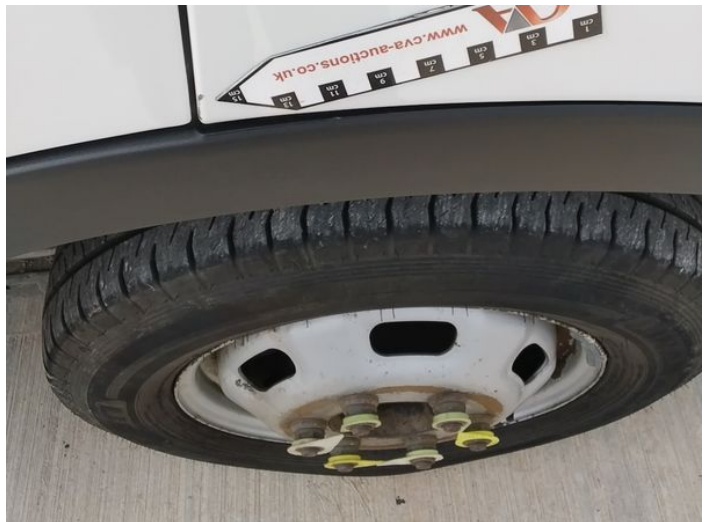
20: Wing osf  
Chipped  
1 To 5

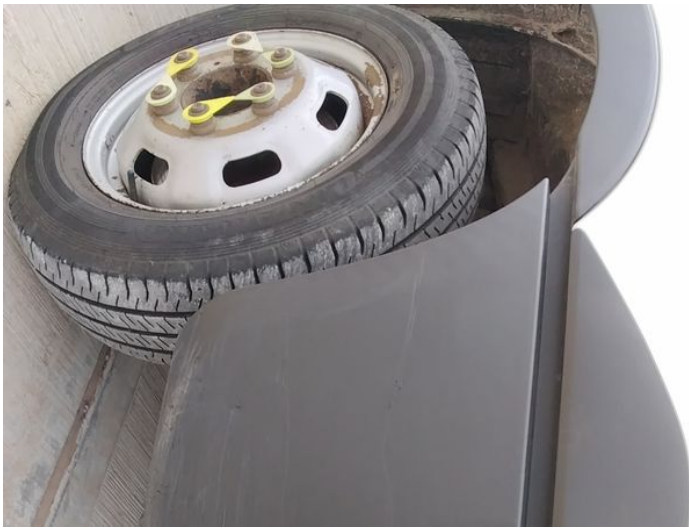
21: Bumper Front  
Scratched  
Over 100mm Thru Paint

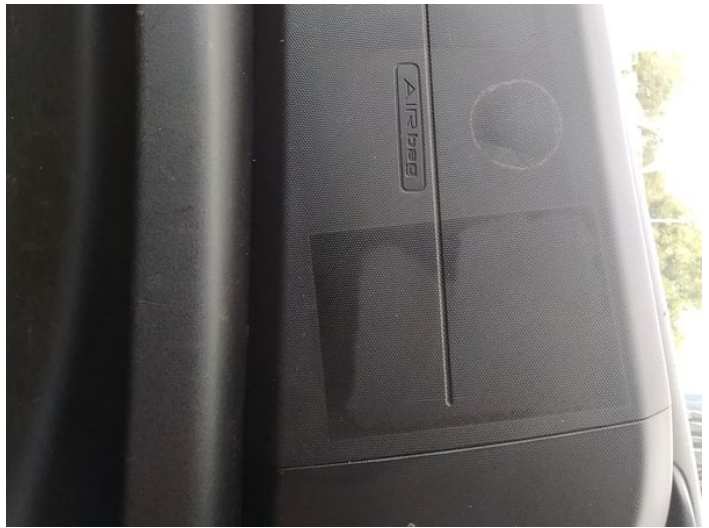
22: Centre Console Front  
Holed  
Over 3mm

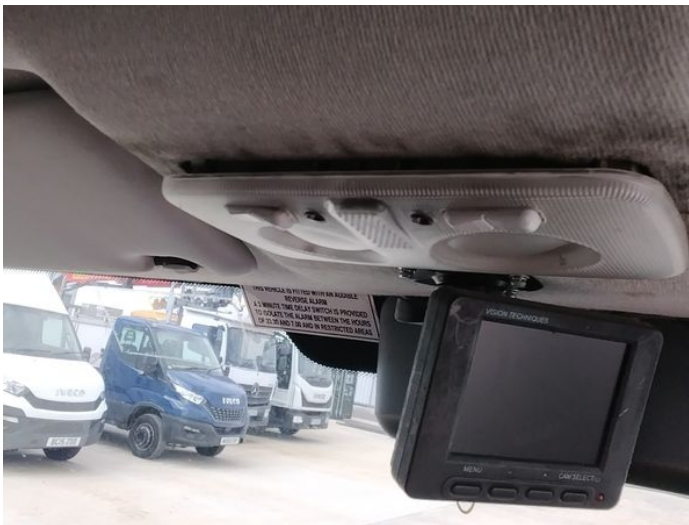
23: Fascia Trim  
Damaged  
Replace

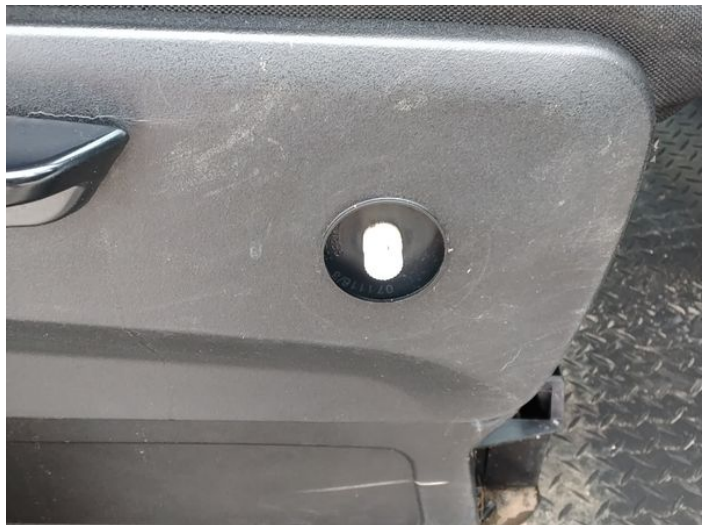
24: Fascia Trim  
Missing  
Replace

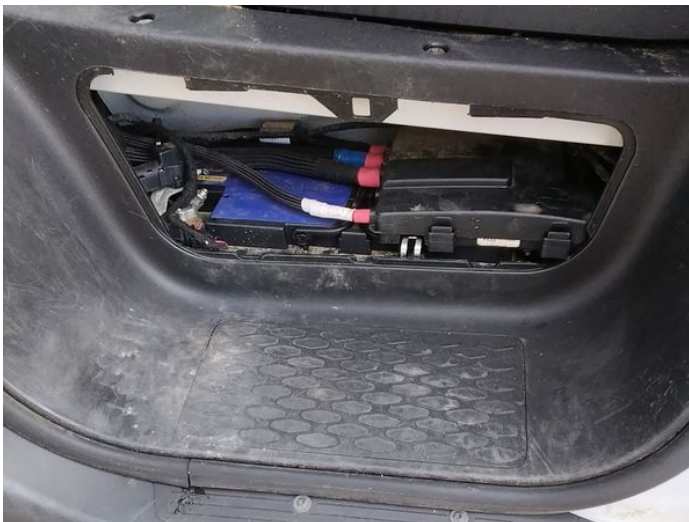
25: Fascia Panel  
Missing  
Replace

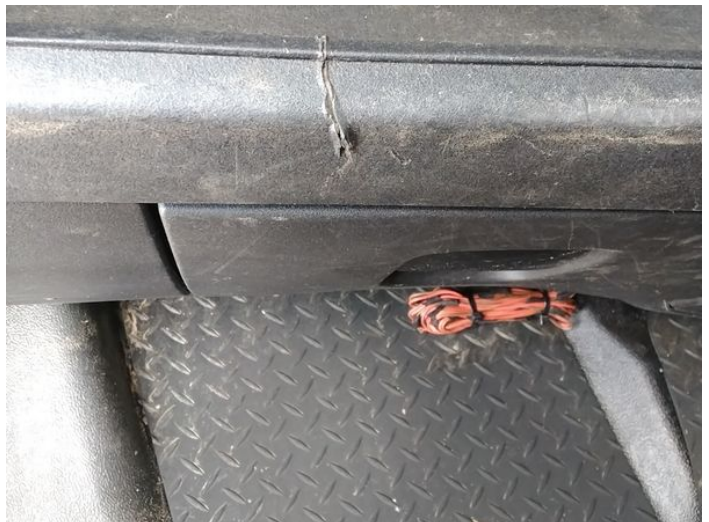
26: Centre Console Front  
Scuffed  
Over 25mm
