## VEHICLE INSPECTION REPORT

**CU15CYX**

### Ford Transit 350 2.2 TDCi 100ps

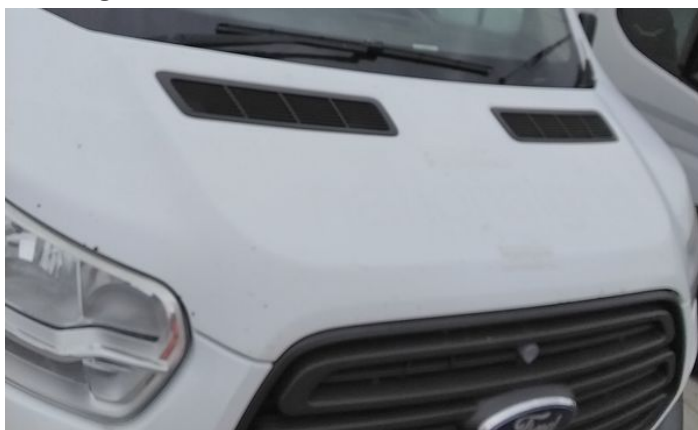
1: Bonnet  
Chipped  
Multiple Chips

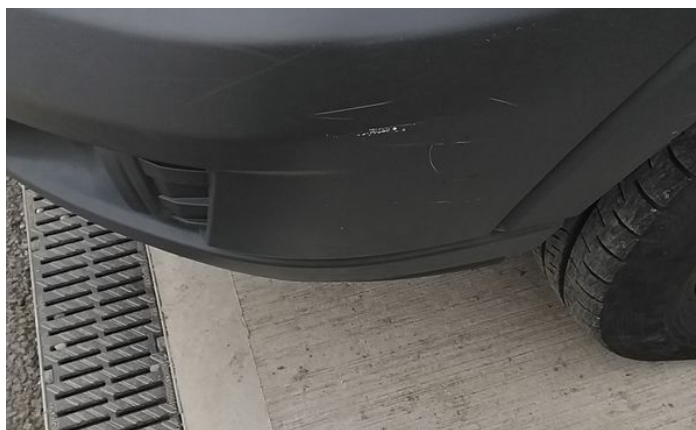
2: Bumper Front  
Scratched  
Over 100mm Thru Paint

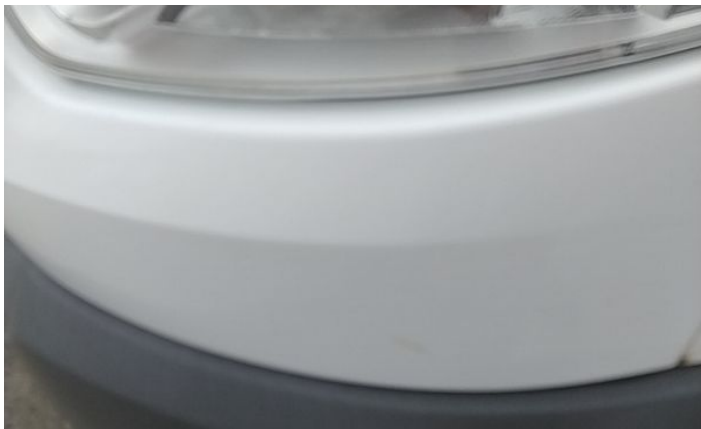
3: Panel Front  
Scratched  
Over 25mm Not Thru Paint

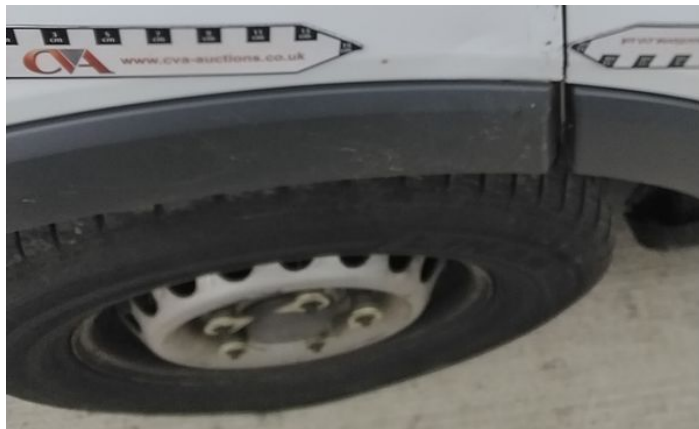
4: Wing nsf  
Dented  
With Paint Damage

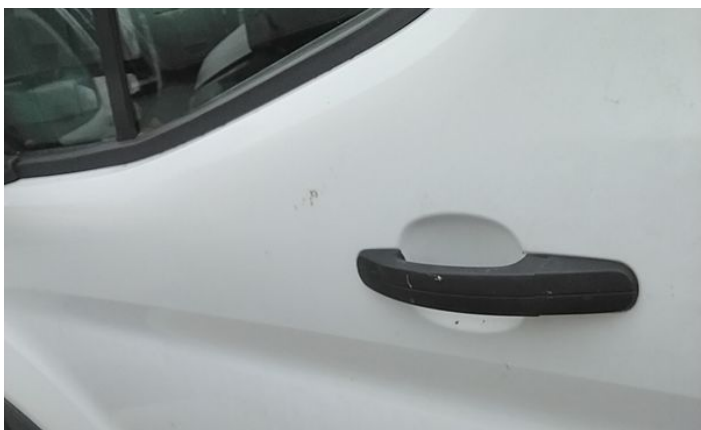
5: Door nsf  
Chipped  
Multiple Chips

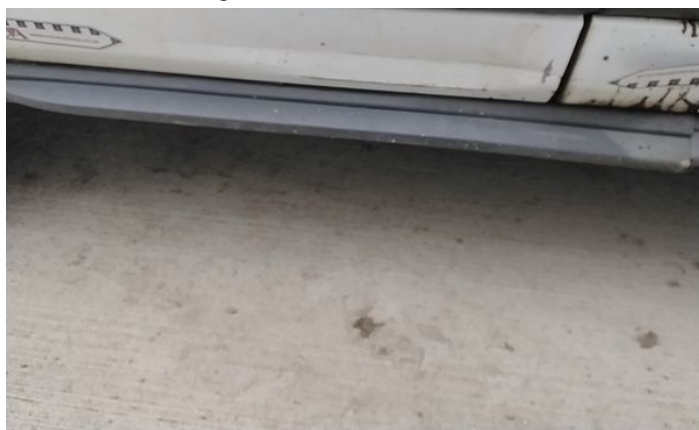
6: Door nsf  
Dented  
With Paint Damage

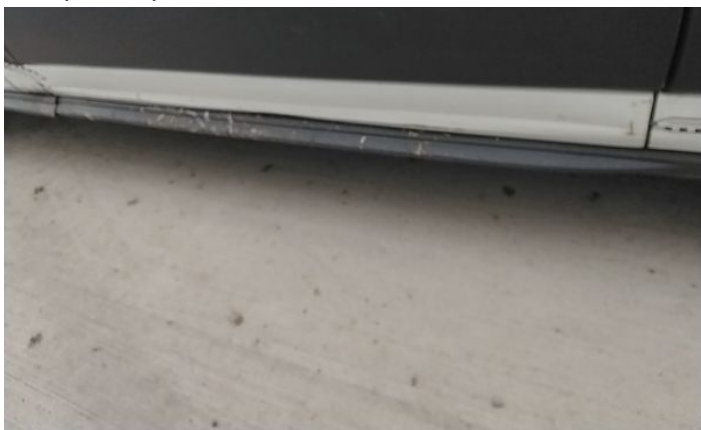
7: Qtr Panel nsr  
Dented  
With Paint Damage

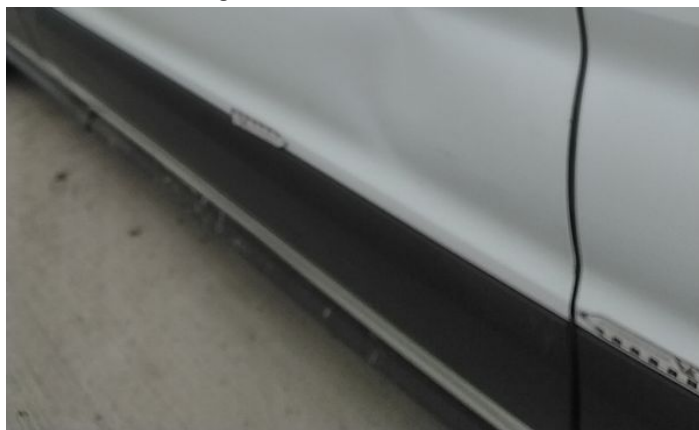
8: Qtr Panel nsr  
Dented  
With Paint Damage

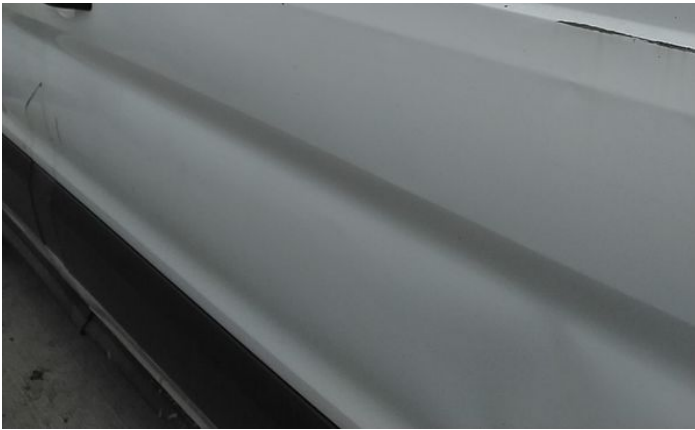
9: Qtr Panel nsr  
Chipped  
Multiple Chips

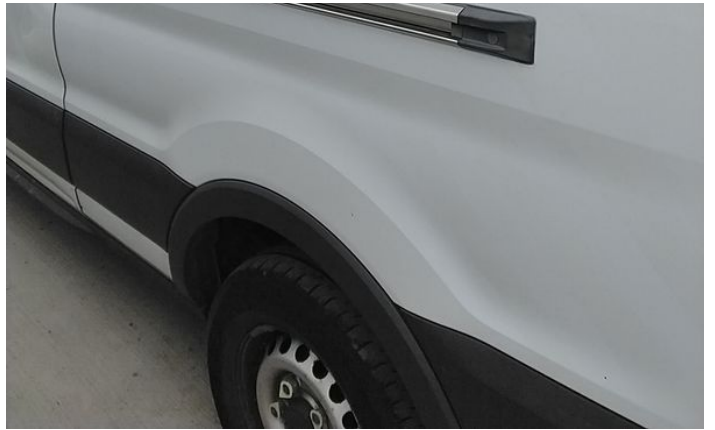
10: Qtr Panel nsr  
Chipped  
Multiple Chips

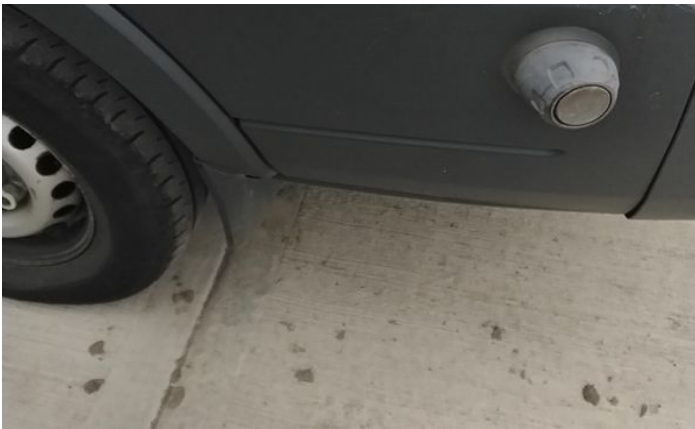
11: Qtr Panel Moulding ns  
Scuffed (Unpainted)  
Over 100mm

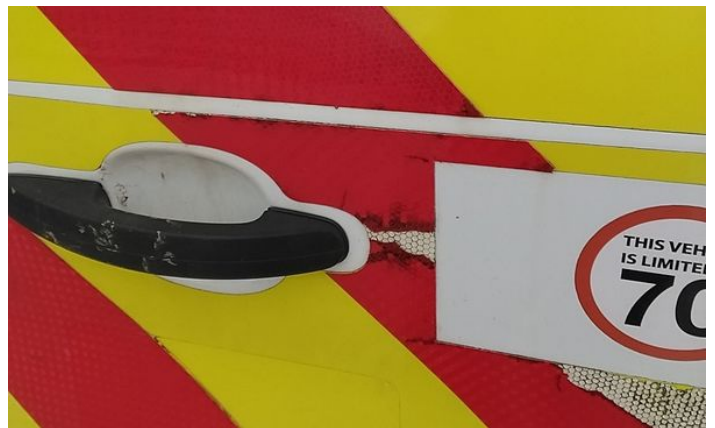
12: Door osr  
Scratched  
Over 25mm Thru Paint

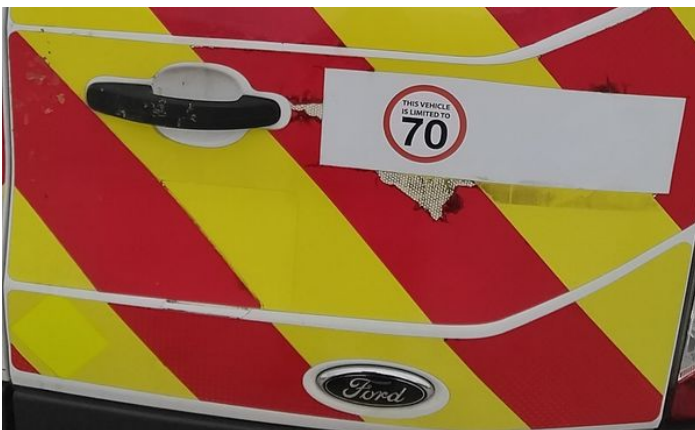
13: Door osr  
Chipped  
Multiple Chips

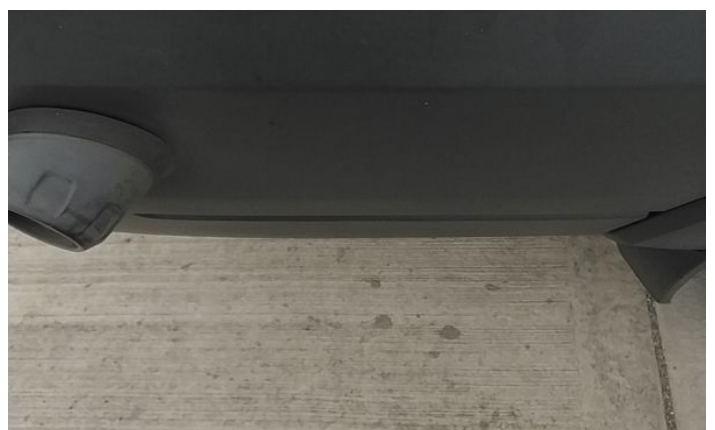
14: Qtr Panel osr  
Scratched  
Over 25mm Thru Paint

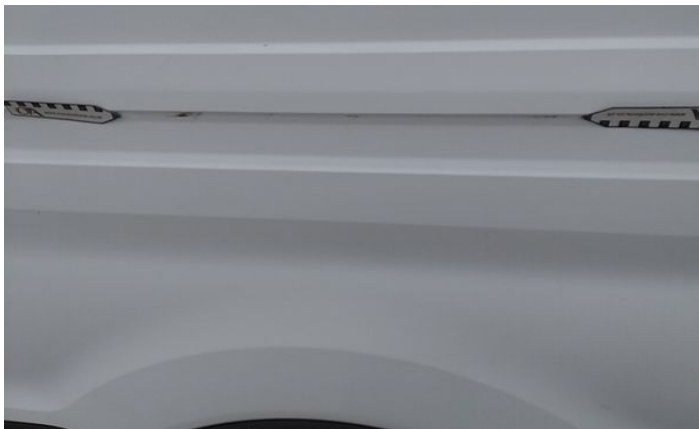
15: Qtr Panel osr  
Scratched  
Over 25mm Thru Paint

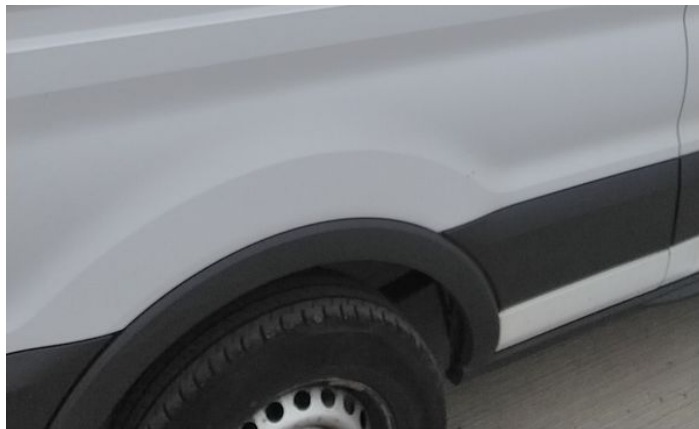
16: Qtr Panel osr  
Chipped  
Multiple Chips

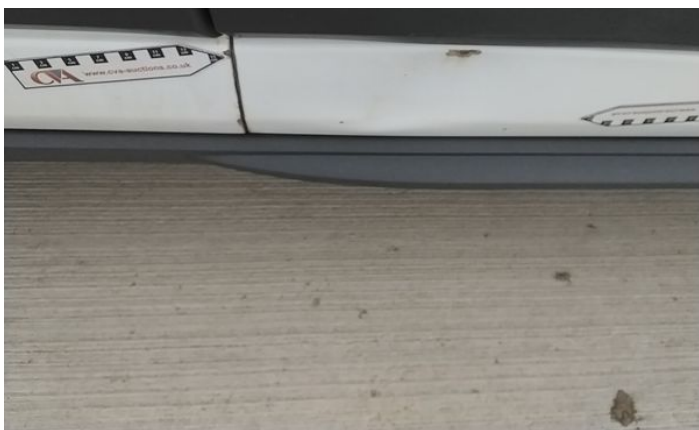
17: Qtr Panel osr  
Dented  
With Paint Damage

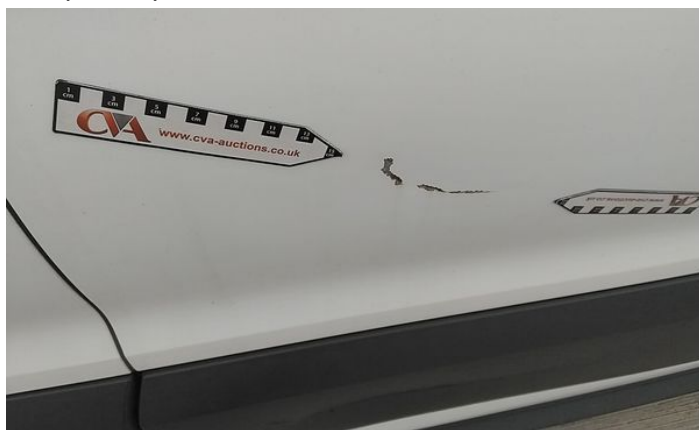
18: Qtr Panel osr  
Dented  
With Paint Damage

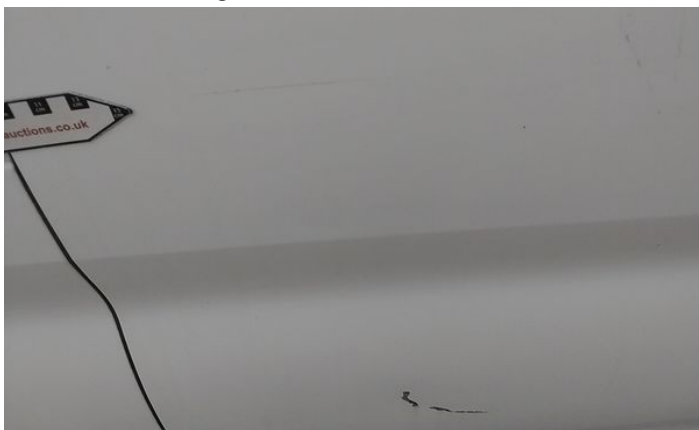
19: Qtr Panel osr  
Scratched  
Over 25mm Thru Paint

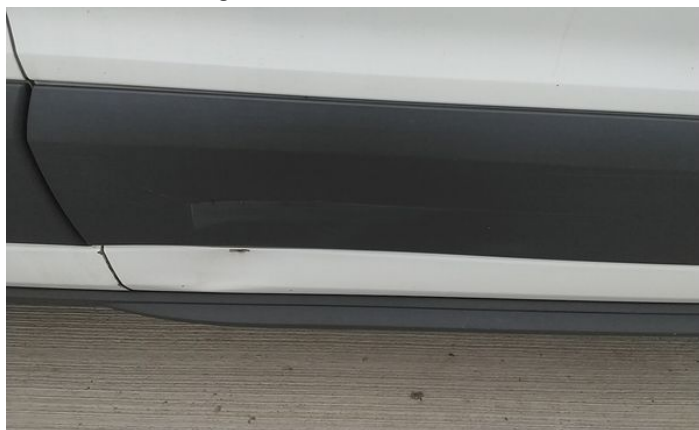
20: Qtr Panel Moulding os  
Scuffed (Unpainted)  
Over 100mm

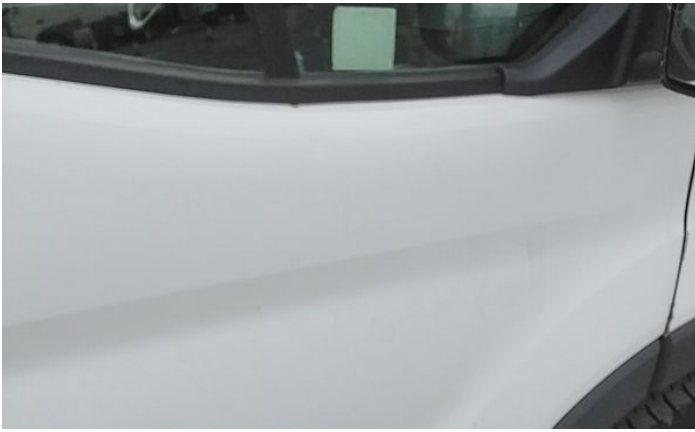
21: Door osf  
Chipped  
Multiple Chips

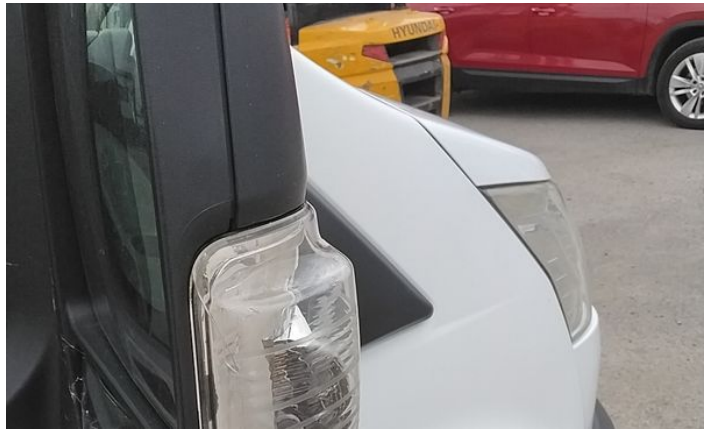
22: Door Mirror Assy osf  
Broken  
Replace

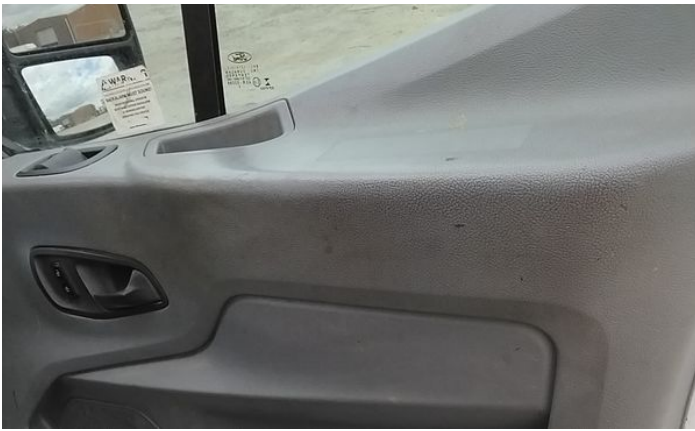
23: Door Pad osf  
Soiled  
Heavy

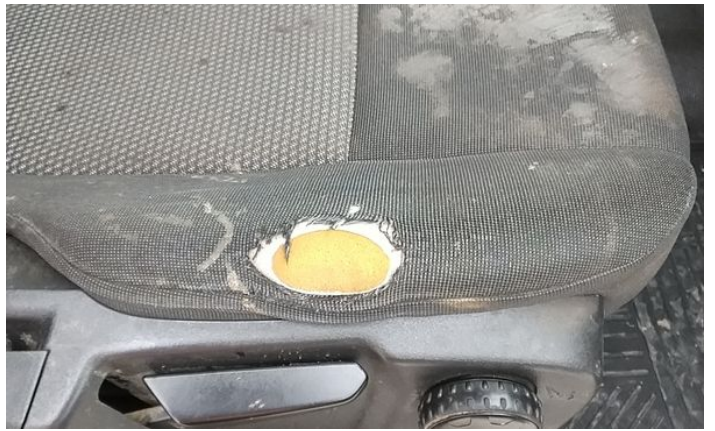
24: Seat Base Cover osf  
Holed  
Over 3mm

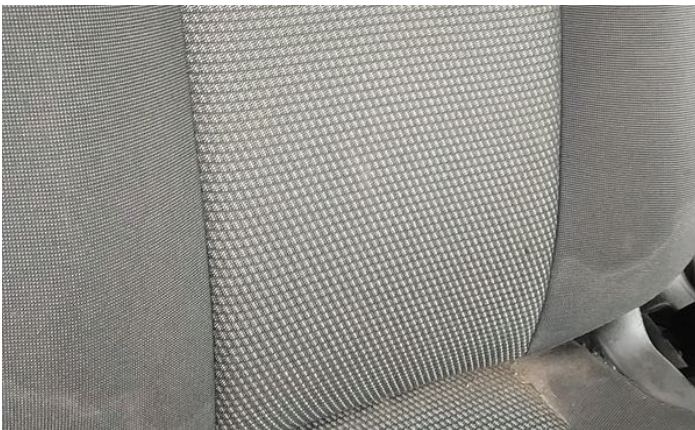
25: Seat Back Cover osf  
Soiled  
Heavy

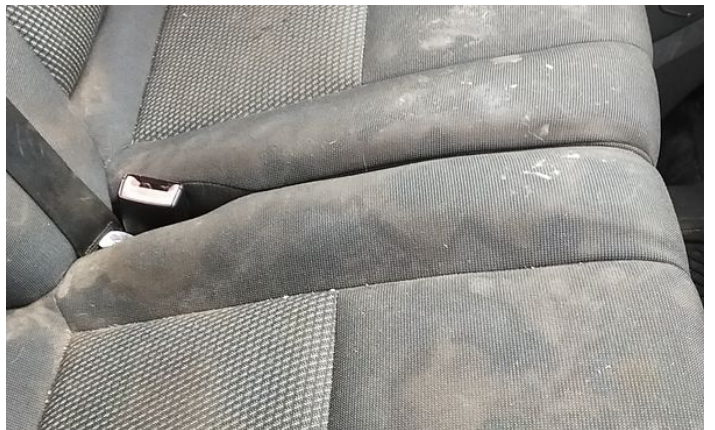
26: Seat Base Cover nsf  
Soiled  
Heavy

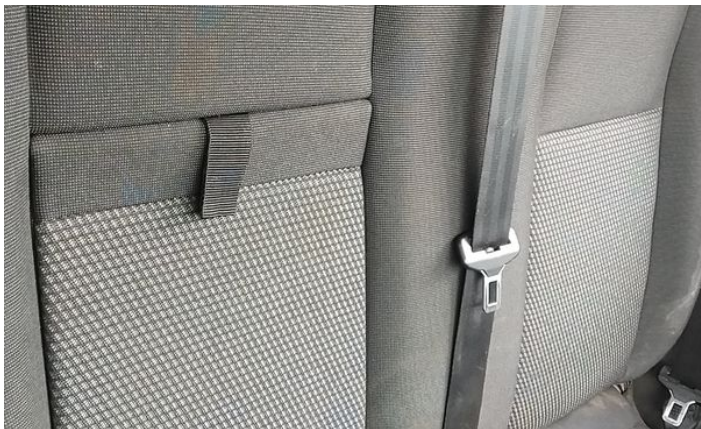
27: Seat Back Cover nsf  
Soiled  
Heavy

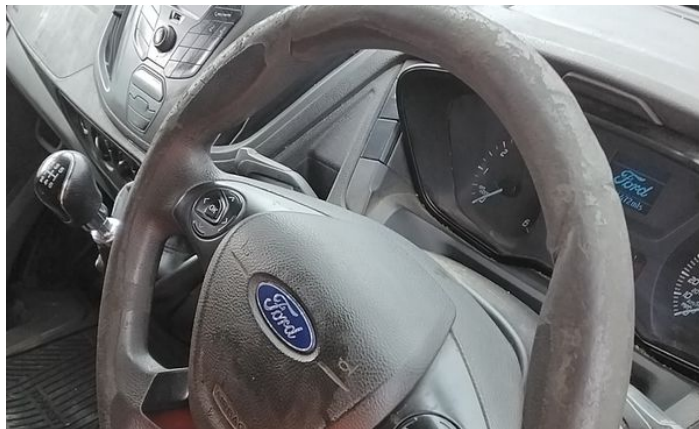
28: Steering Wheel  
Damaged  
Replace

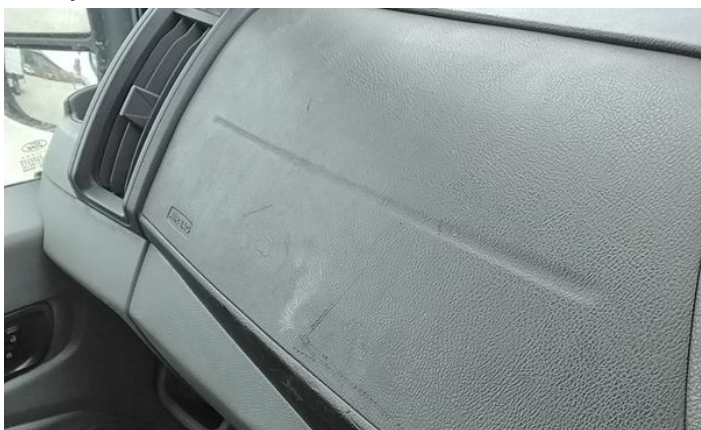
29: Fascia Panel  
Scuffed  
Over 25mm

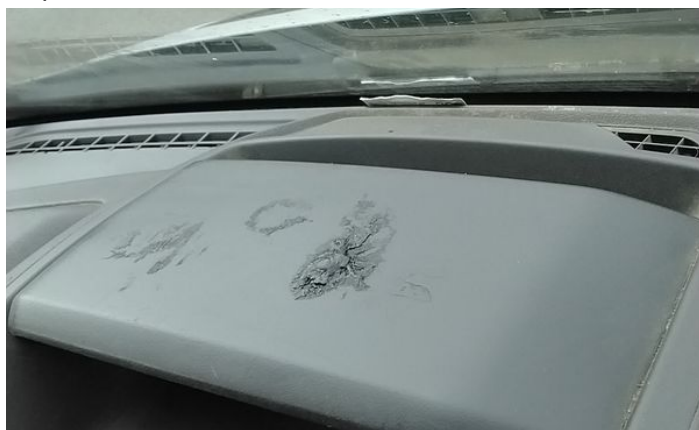
30: Fascia Panel  
Scuffed  
Over 25mm
