# VEHICLE INSPECTION REPORT

**KX67AKK**

## Isuzu D-Max 2.5

\*COLLECTED WITH MAJOR BOOM ISSUES\* V5 NEW KEEPER DOCUMENT REFERENCE NUMBER AVAILABLE FOR TAXATION PURPOSES, PALFINGER P130A PLATFORM (YEAR 2017)

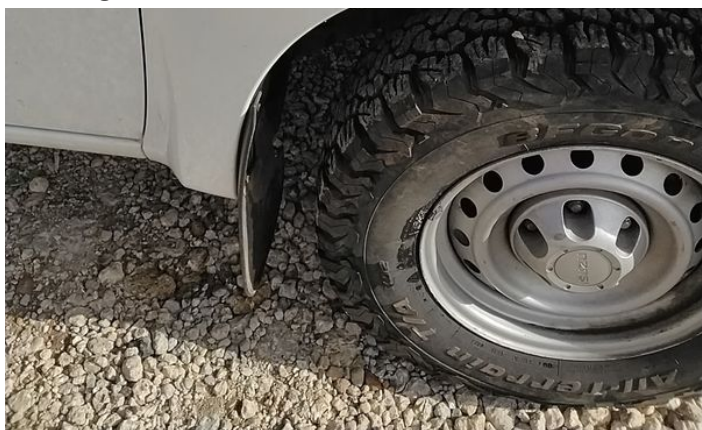
1: Wing osf  
Dented  
Between 10mm + 30mm

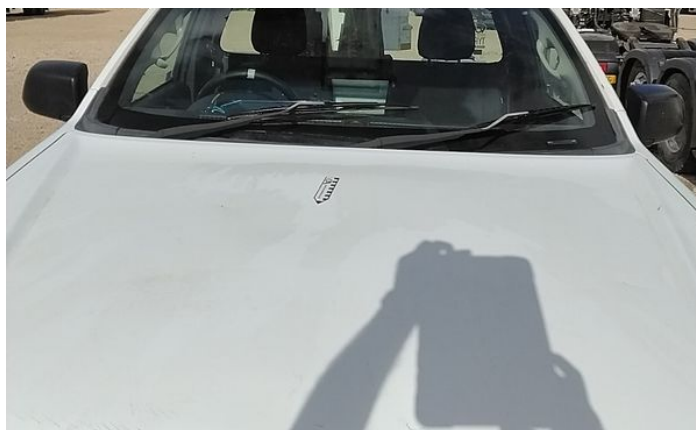
2: Bonnet  
Scratched  
Over 25mm Thru Paint

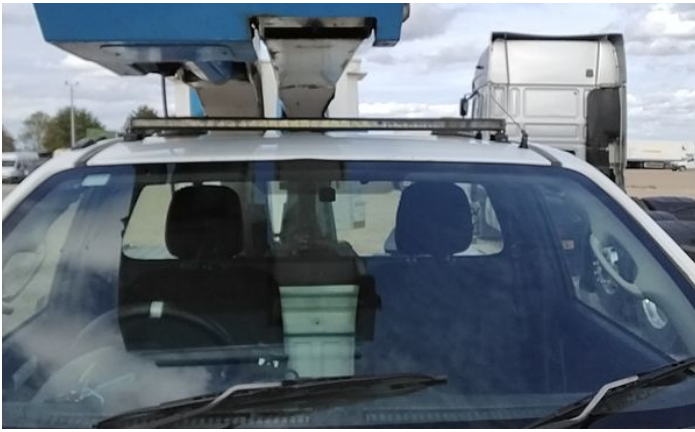
3: Roof  
Rusted  
Over 5mm

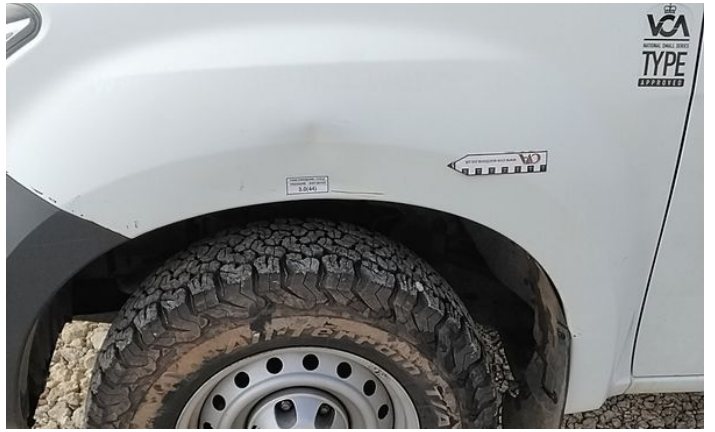
4: Wing nsf  
Dented  
With Paint Damage

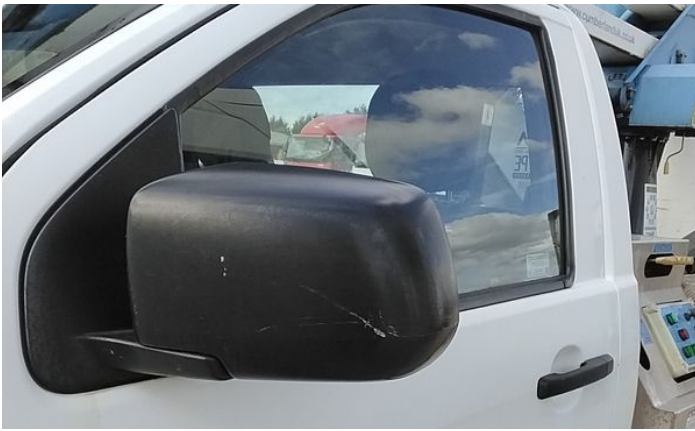
5: Door Mirror Assy nsf  
Scuffed (Unpainted)  
Over 100mm

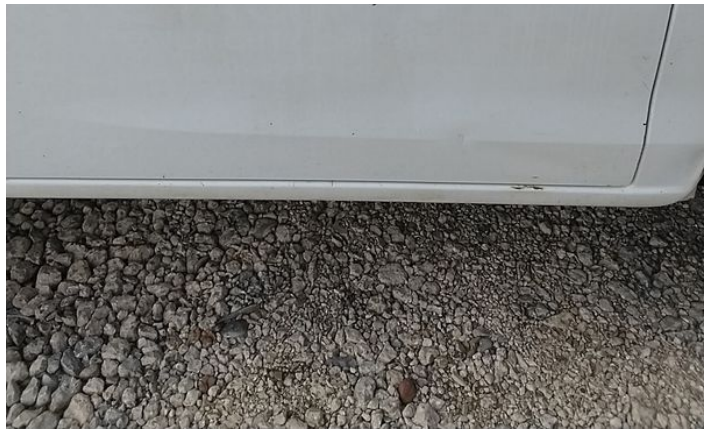
6: Door nsf  
Dented  
With Paint Damage

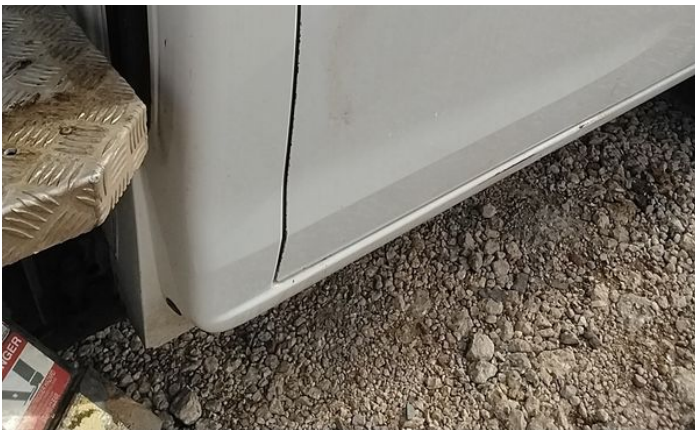
7: Door osf  
Chipped  
Edge Chip

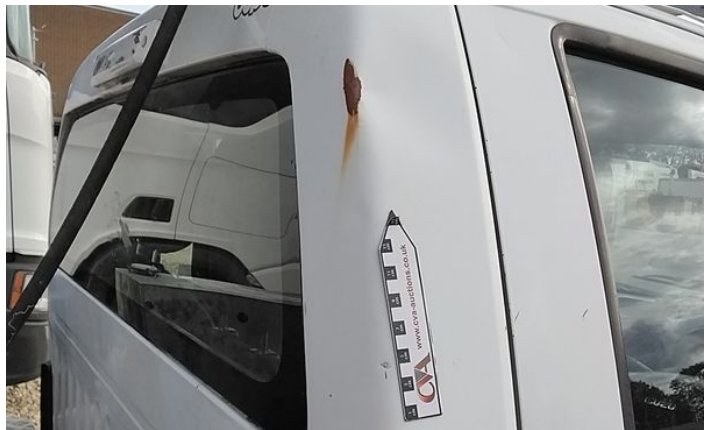
8: B Post os  
Dented  
With Paint Damage

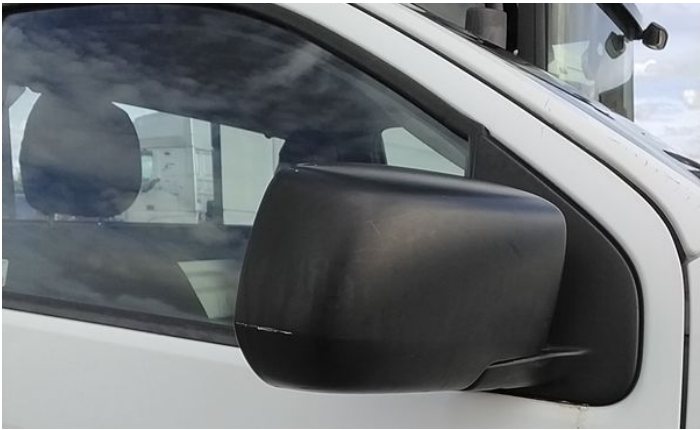
9: Door Mirror Assy osf  
Scuffed (Unpainted)  
UpTo 100mm

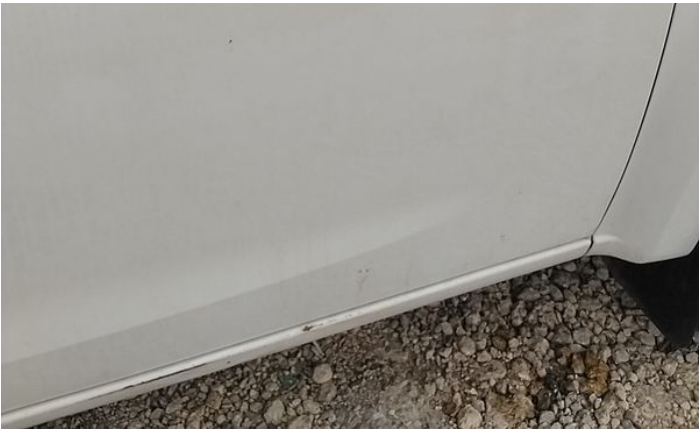
10: Door osf  
Scratched  
Over 25mm Thru Paint
