# VEHICLE INSPECTION REPORT

**FL69XGJ**

## Vauxhall Vivaro 2900 1.5d 100PS Edition

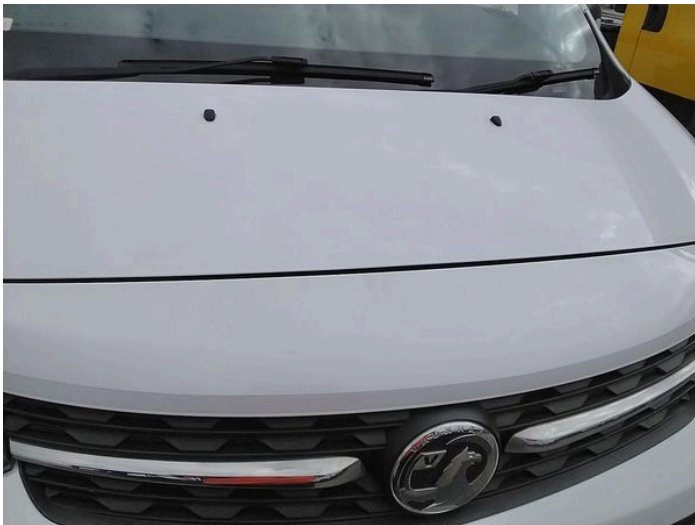
1: Bonnet  
Chipped  
Multiple Chips

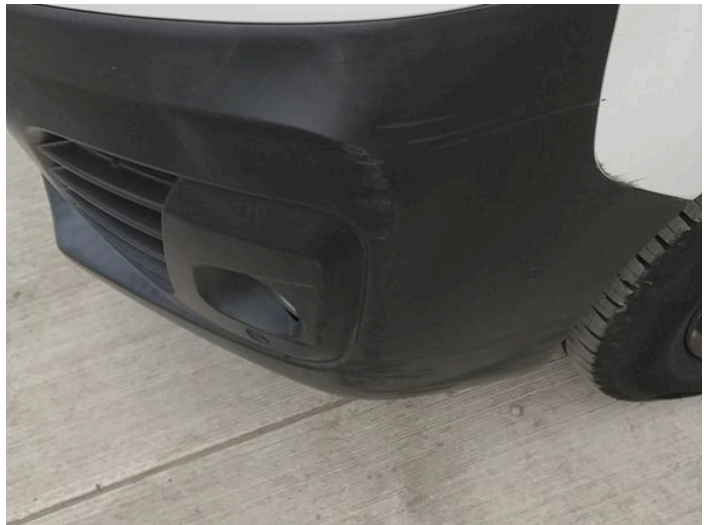
2: Bumper Front  
Scratched  
Over 100mm Thru Paint

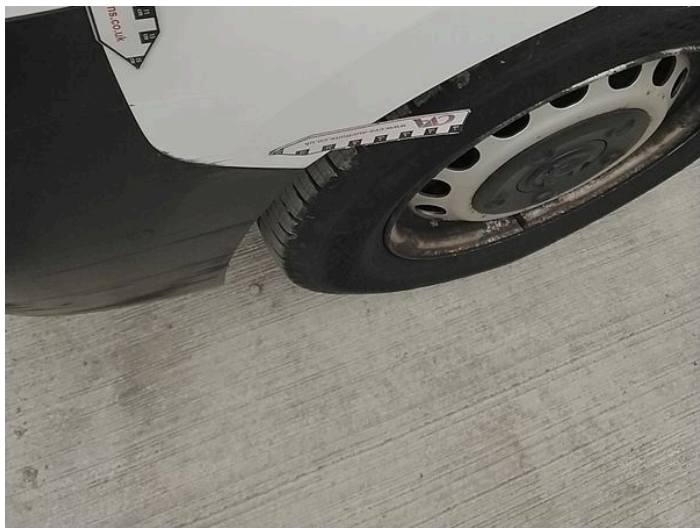
3: Wing nsf  
Scratched  
Over 25mm Thru Paint

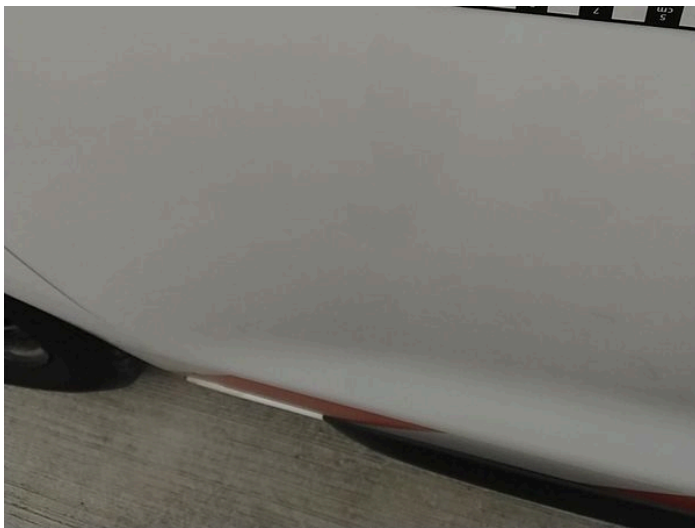
4: Door nsf  
Dented  
With Paint Damage

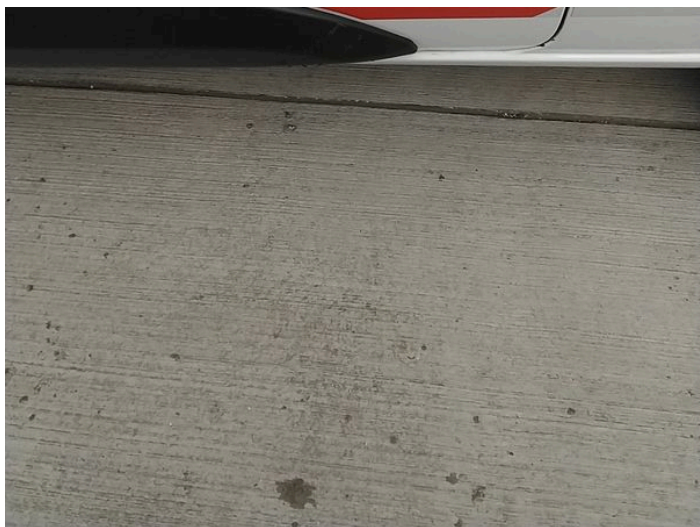
5: Qtr Panel nsr  
Dented  
With Paint Damage

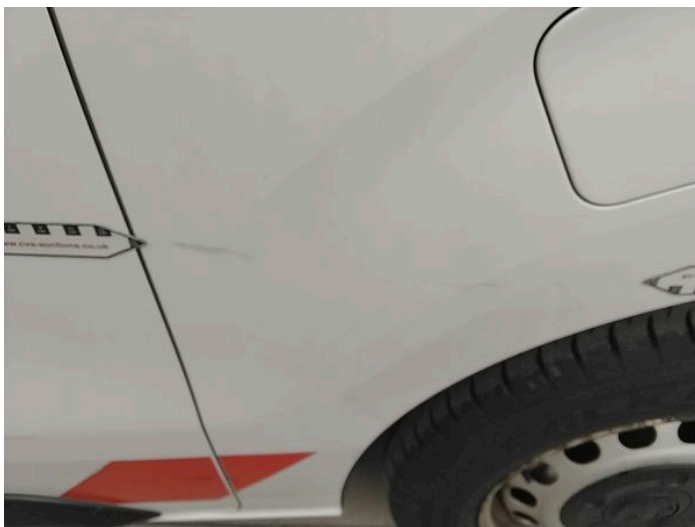
6: Qtr Panel nsr  
Scratched  
Over 25mm Thru Paint

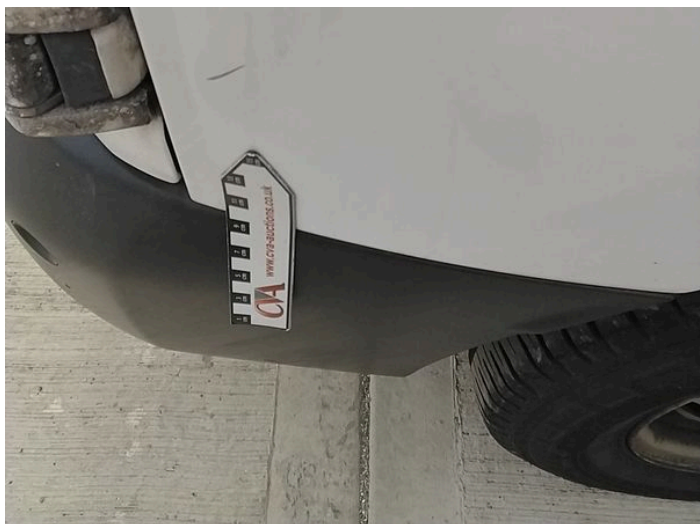
7: Qtr Panel osr  
Dented  
With Paint Damage

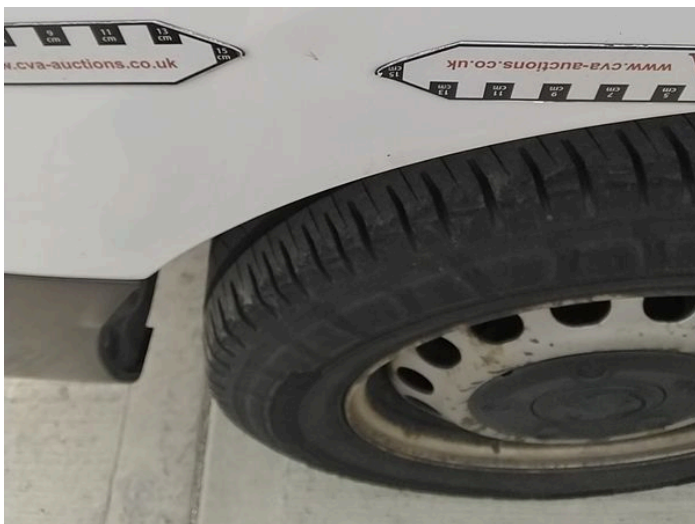
8: Qtr Panel osr  
Dented  
With Paint Damage

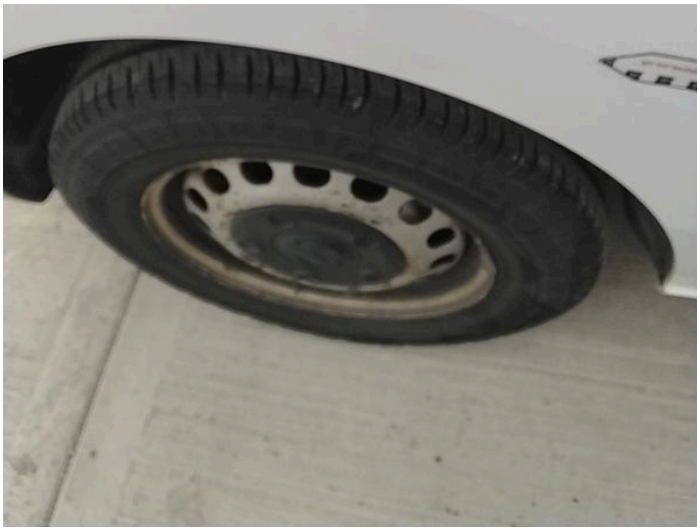
9: Qtr Panel osr  
Scratched  
Over 25mm Thru Paint

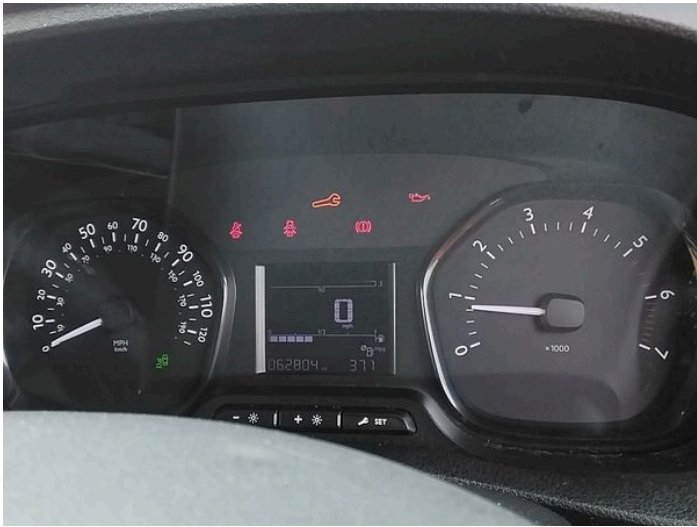
\*WARNING LIGHT ON DASH\* TWIN SIDE LOAD DOOR, E/MIRRORS, AD-BLUE

11: Dash Warning Lights  
Displayed  
No Action

| Carpet Condition | | Upholstery Condition | |
|---|---|---|---|
| EML light illuminated | OK | Oil warning light illuminated | Fault |
| | | Service indicator light illuminated | Fault |

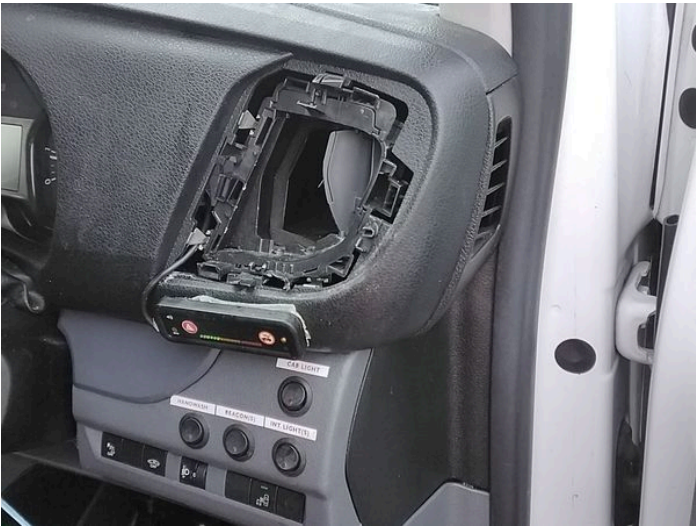
12: Air Vents osf  
Missing  
Replace

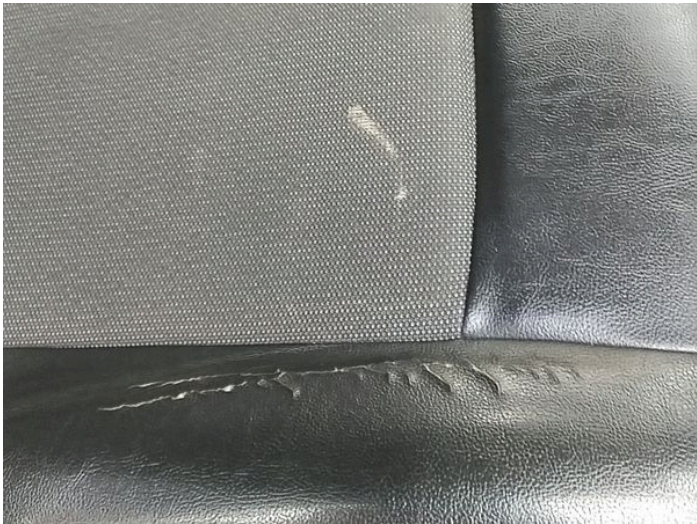
13: Seat Base Cover osf  
Torn  
Over 3mm
