# VEHICLE INSPECTION REPORT

**BD68YGX**

## Iveco Daily 35-120

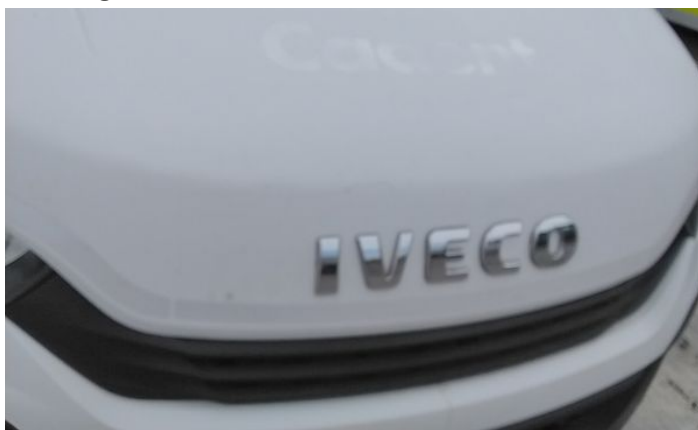
1: Bonnet  
Chipped  
Multiple Chips

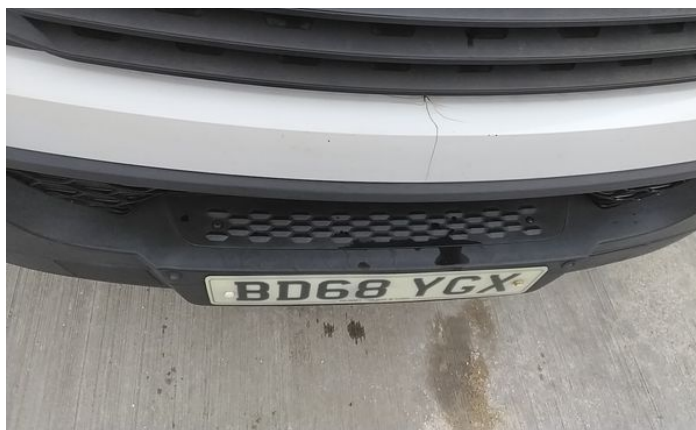
2: Panel Front  
Cracked  
Replace

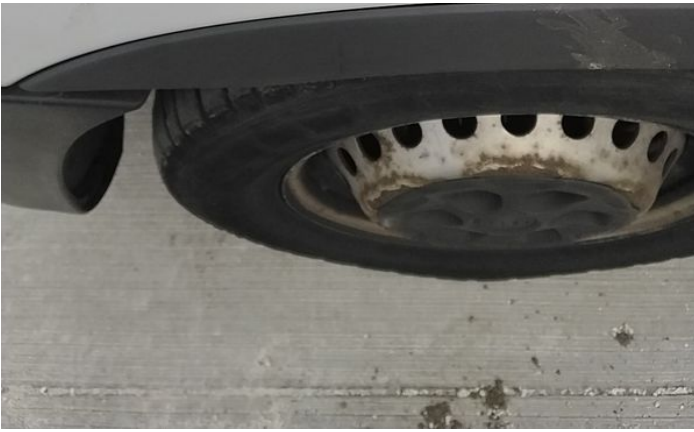
3: Wing nsf  
 Scratched  
 Over 25mm Thru Paint

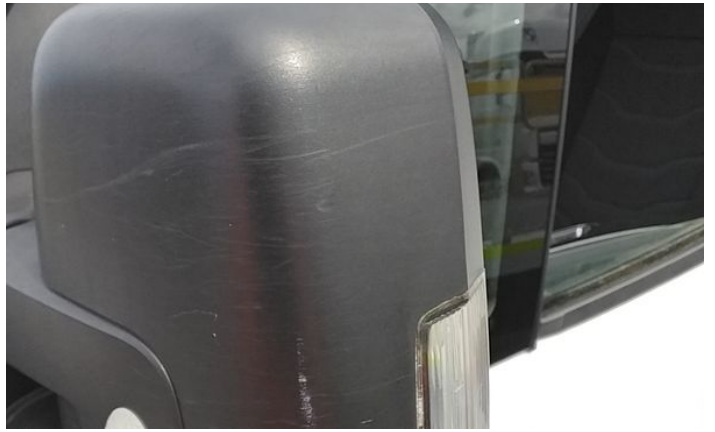
4: Door Mirror Assy nsf  
 Scuffed (Unpainted)  
 Over 100mm

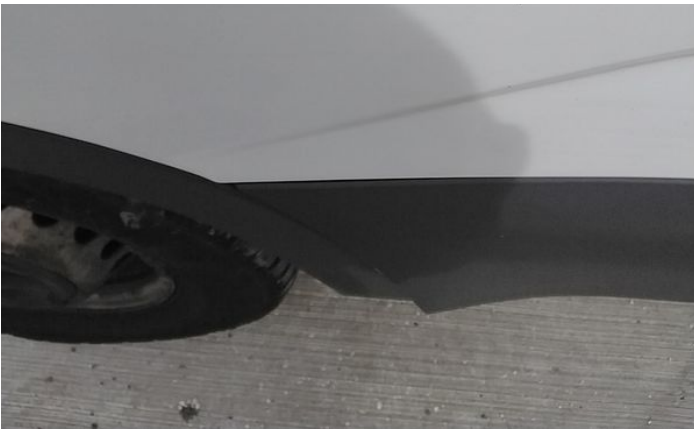
5: Door nsf  
 Scratched  
 Over 25mm Thru Paint

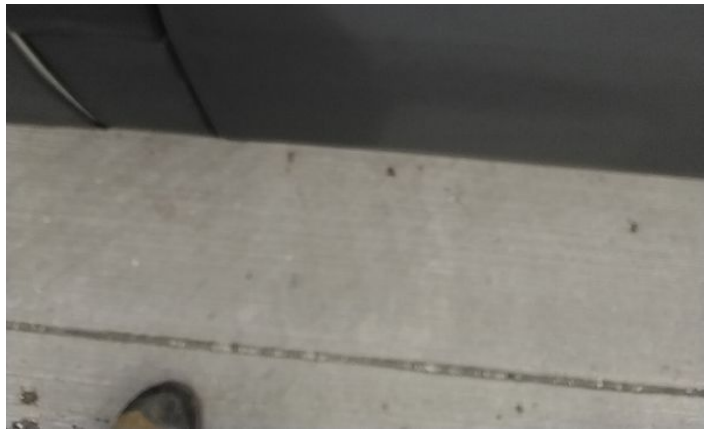
6: Qtr Panel nsr  
 Dented  
 Over 30mm

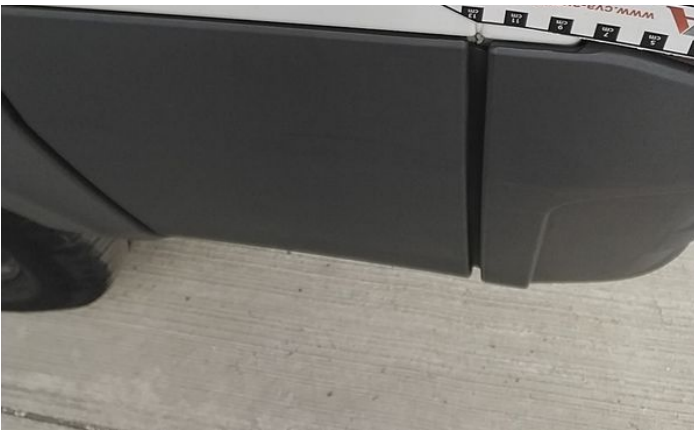
7: Qtr Panel nsr  
 Scratched  
 Over 25mm Thru Paint

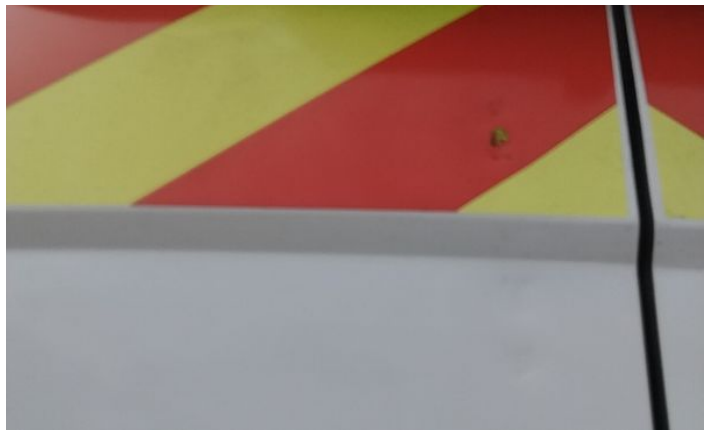
8: Door nsr  
 Dented  
 With Paint Damage

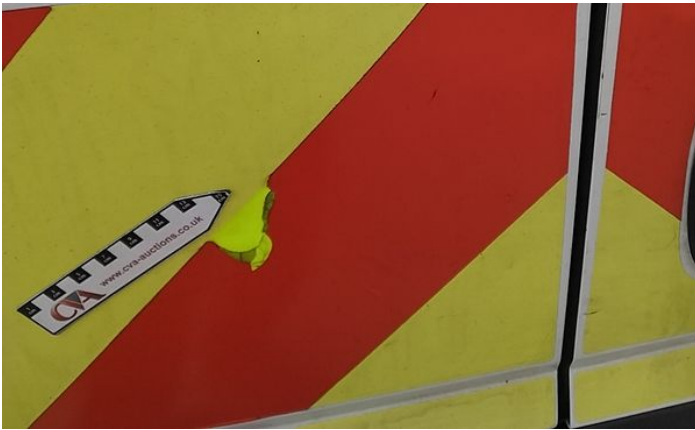
9: Door nsr  
Dented  
Over 30mm

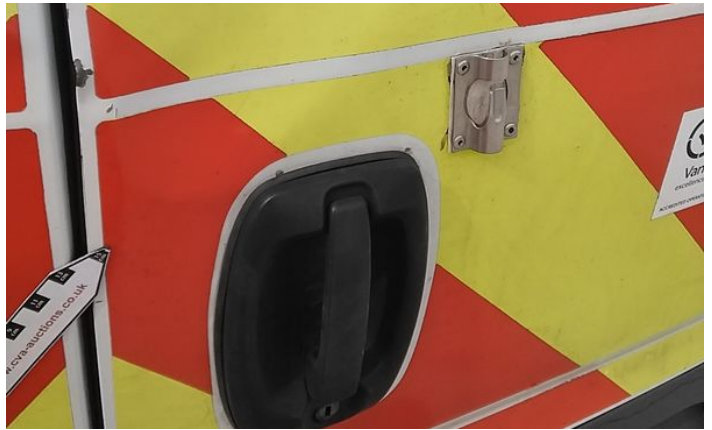
10: Door osr  
Dented  
Over 30mm

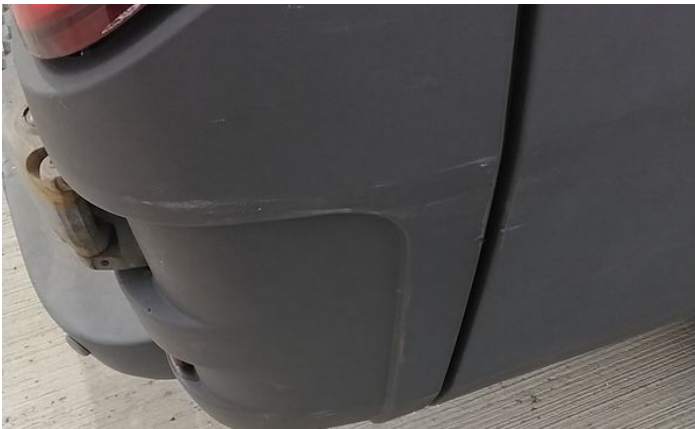
11: Bumper Rear Moulding  
Scuffed (Unpainted)  
Over 100mm

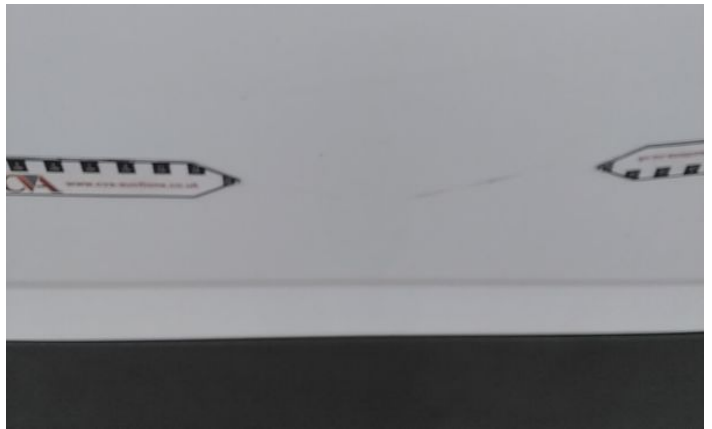
12: Qtr Panel osr  
Scratched  
Over 25mm Thru Paint

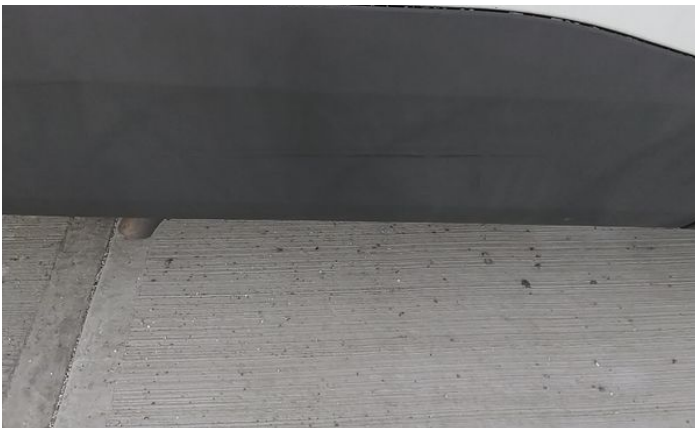
13: Qtr Panel Moulding os  
Scuffed (Unpainted)  
Over 100mm

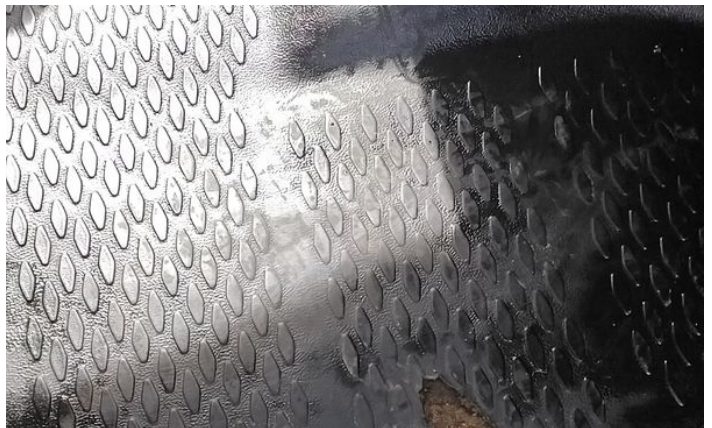
14: Carpets Front  
Holed  
Over 3mm

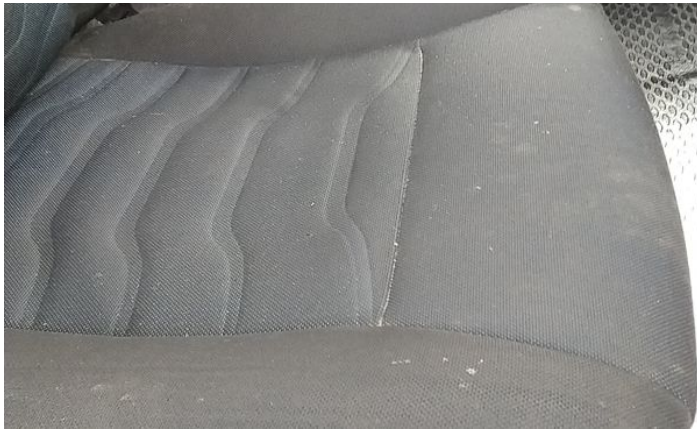
15: Seat Base Cover osf  
Torn  
Over 3mm

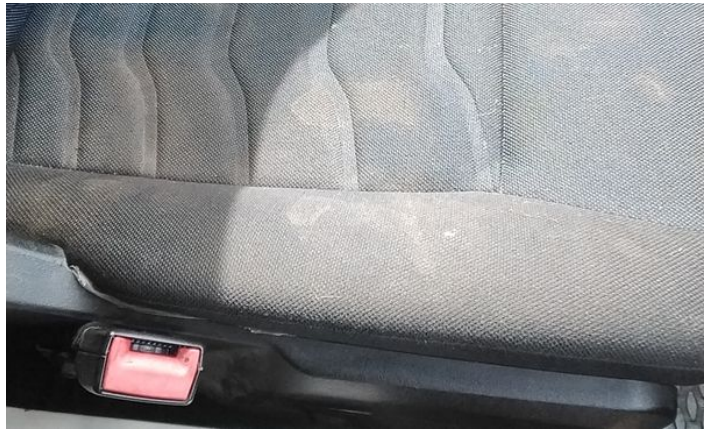
16: Seat Base Cover nsf  
Soiled  
Heavy
