# VEHICLE INSPECTION REPORT

**G18TPT**

## Mercedes-Benz Actros 2630

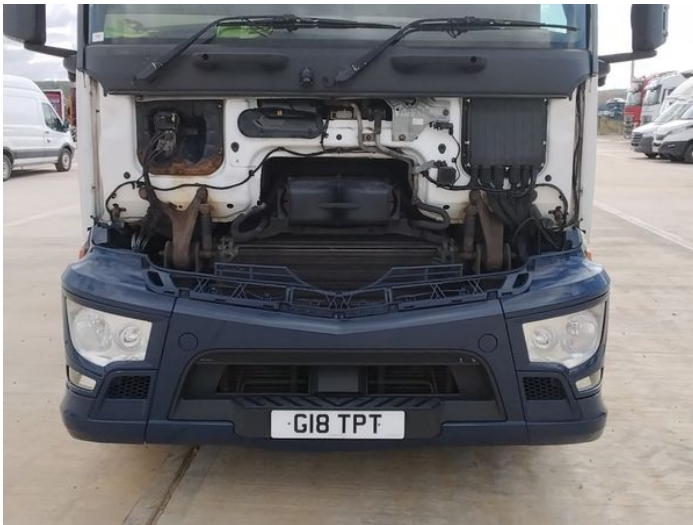
1: Bonnet  
Missing  
Replace

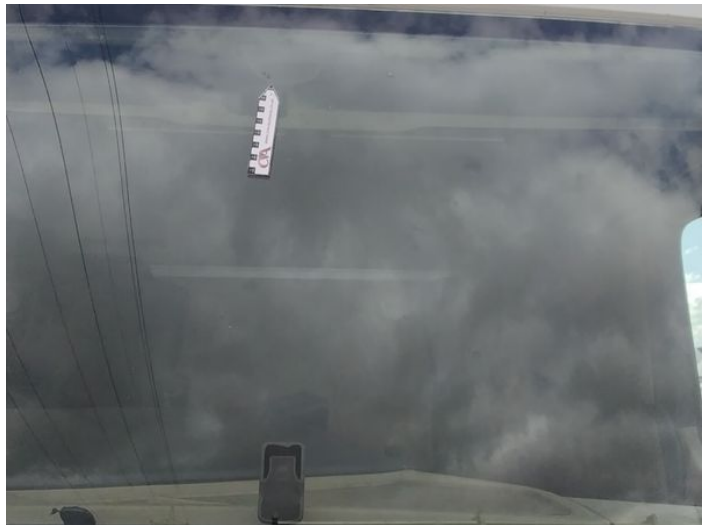
2: Screen Front  
Chipped  
Over 10mm

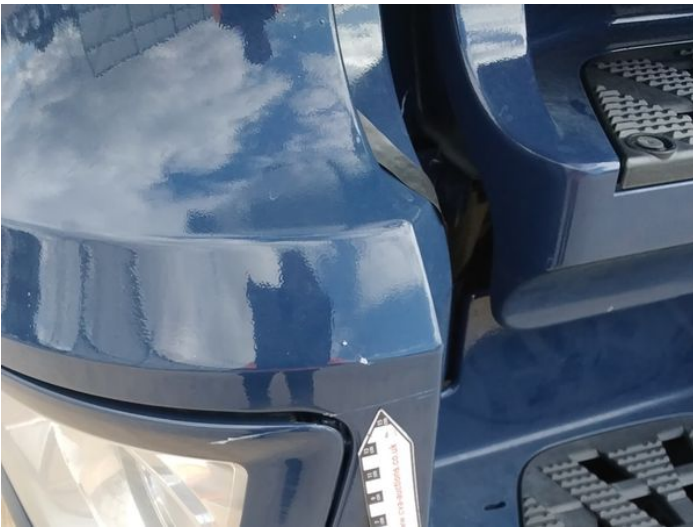
3: Bumper Front  
Scratched  
25 to 100mm Thru Paint

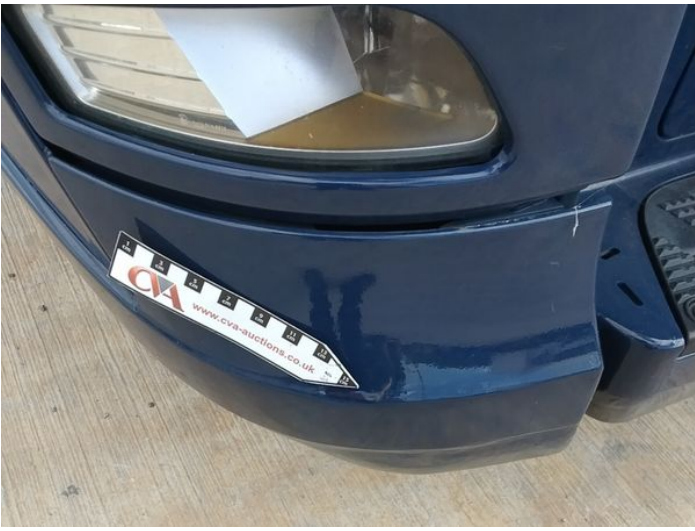
4: Bumper Front  
Scratched  
25 to 100mm Thru Paint

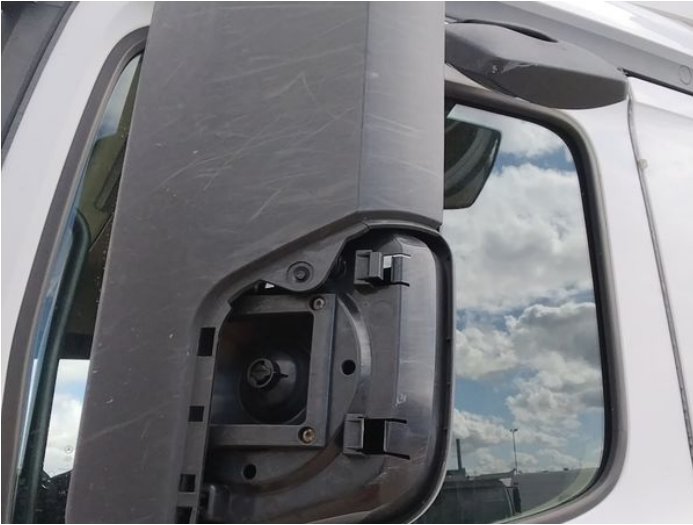
5: Door Mirror Assy nsf  
Broken  
Replace

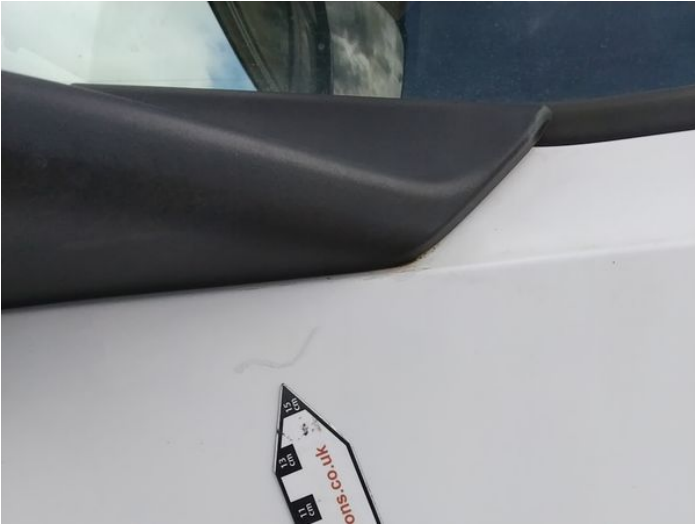
6: Door nsf  
Scratched  
Over 25mm Thru Paint

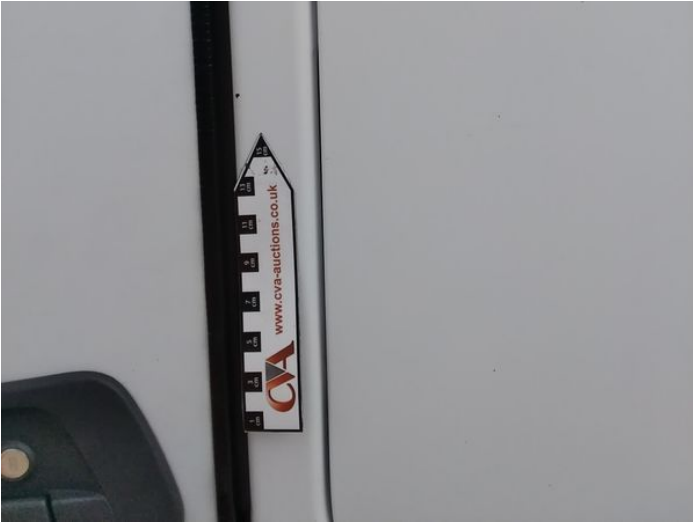
7: Qtr Panel nsr  
Chipped  
Multiple Chips

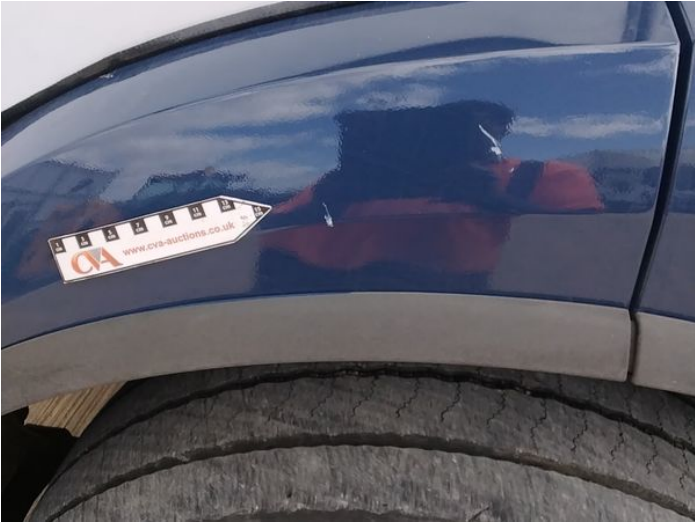
8: Wing Front Arch Extension ns  
Scratched (Painted)  
Over 25mm Thru Paint

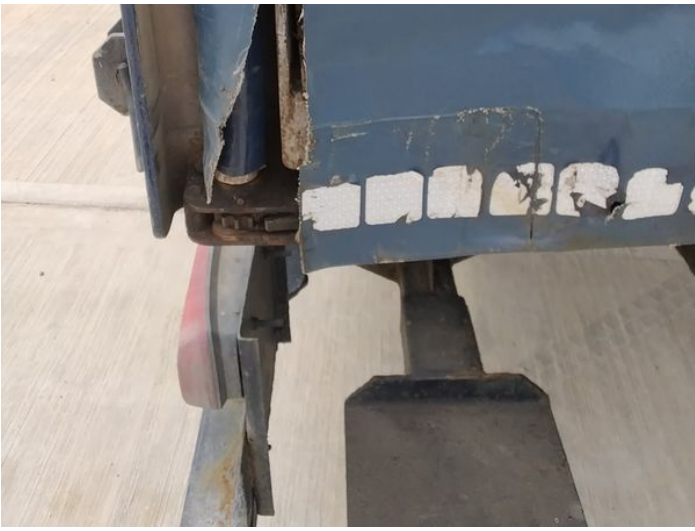
9: Qtr Panel osr  
Hole  
Over 10mm

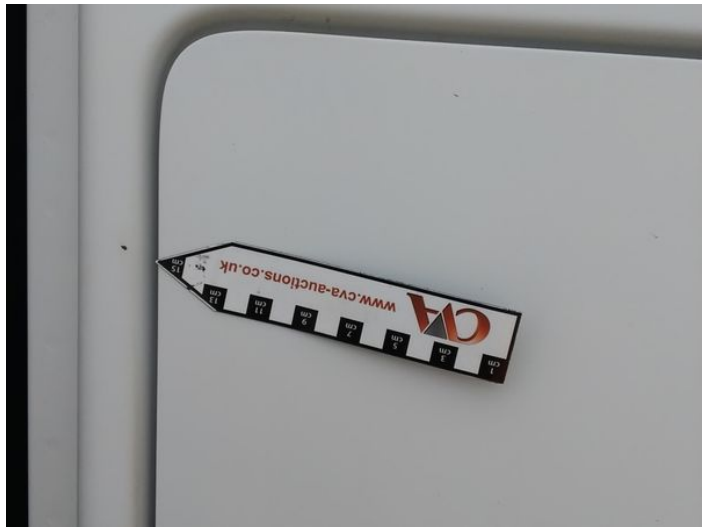
10: Qtr Panel osr  
Chipped  
Multiple Chips

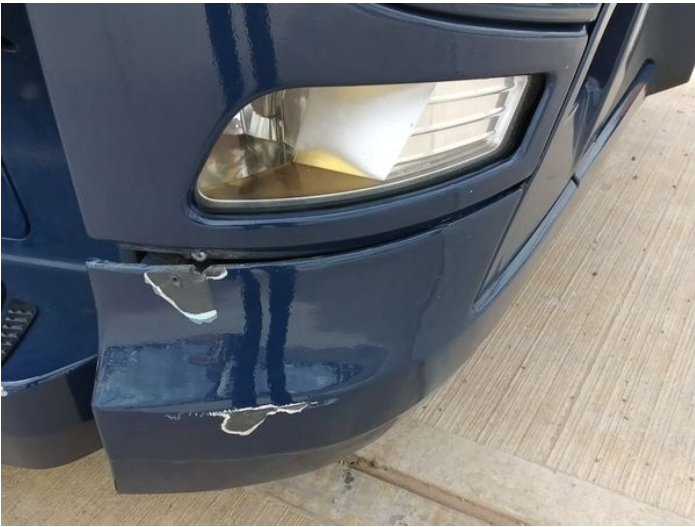
11: Bumper Front  
Scratched  
Over 100mm Thru Paint

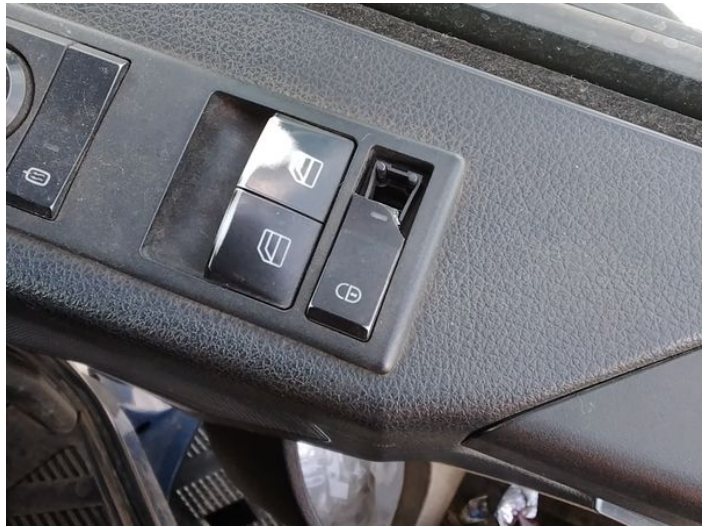
12: Fascia Trim  
Damaged  
Replace

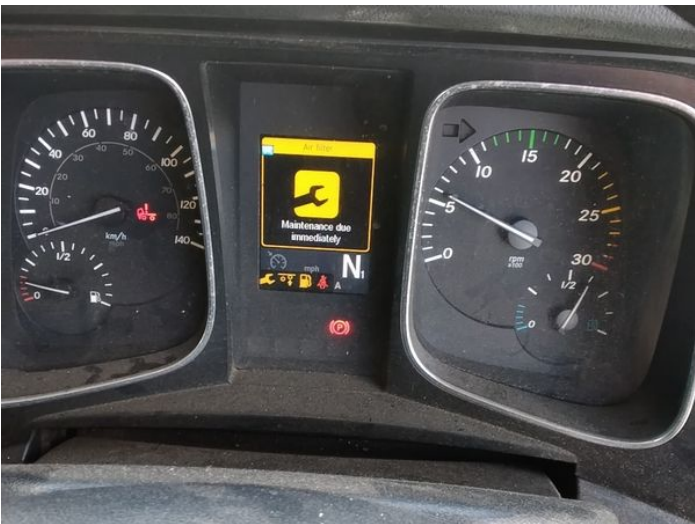
\*WARNING LIGHTS ON DASH\* REAR-LIFT, SURROUND CAMERA SYSTEM, FORKLIFT BRACKET

13: Dash Warning Lights  
Displayed  
No Action

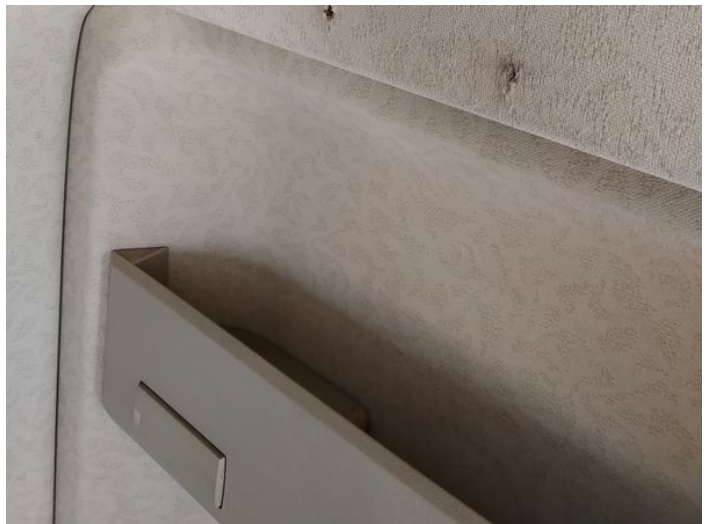
14: Roof Lining  
Holed  
Over 3mm
