# VEHICLE INSPECTION REPORT

**YO190VC**

## Ford Transit Connect 240 1.5 ECOBLUE 100PS

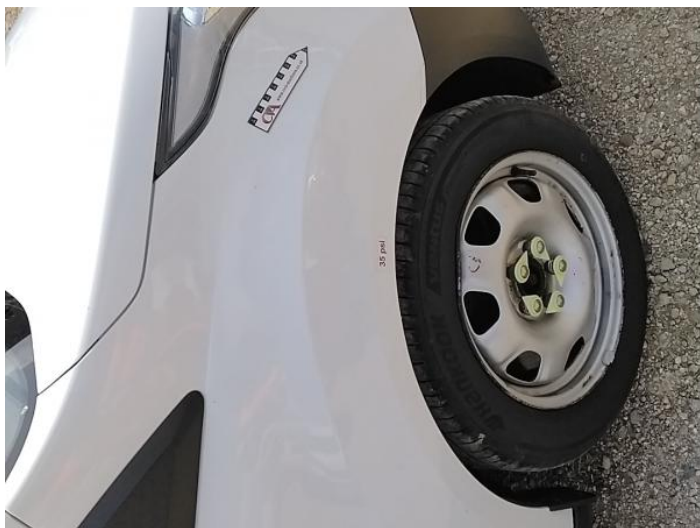
1: Wing osf  
Chipped  
Multiple Chips

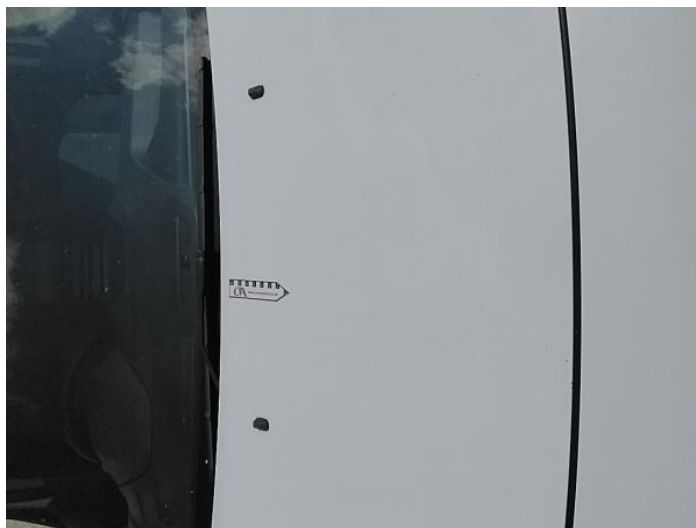
2: Bonnet  
Chipped  
Multiple Chips

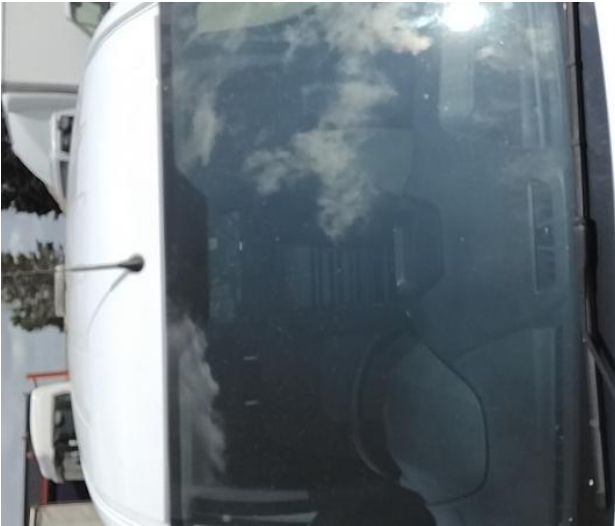
3: Screen Front  
Chipped  
UpTo 10mm

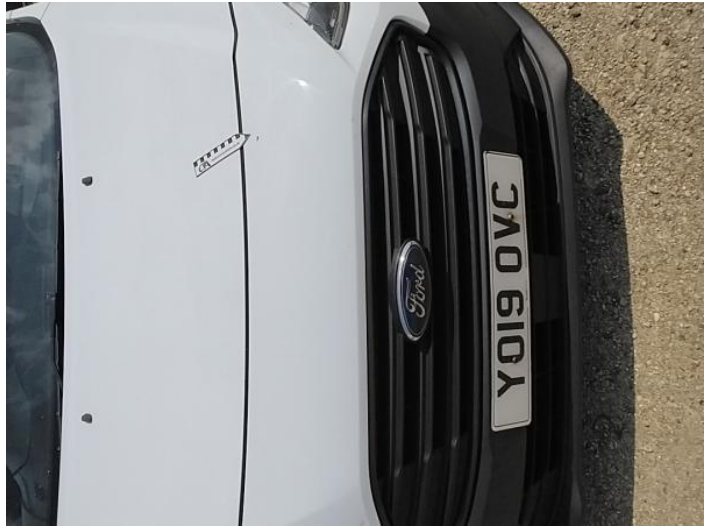
4: General Exterior  
Soiled  
Light

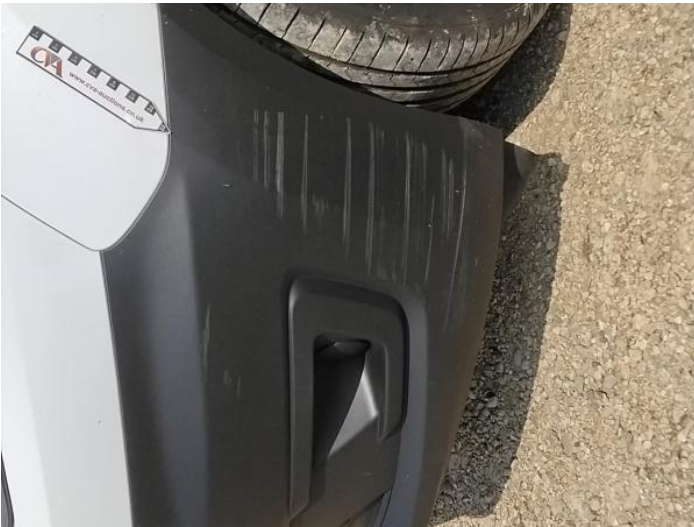
5: Bumper Front  
Scratched  
Over 25mm Not Thru Paint

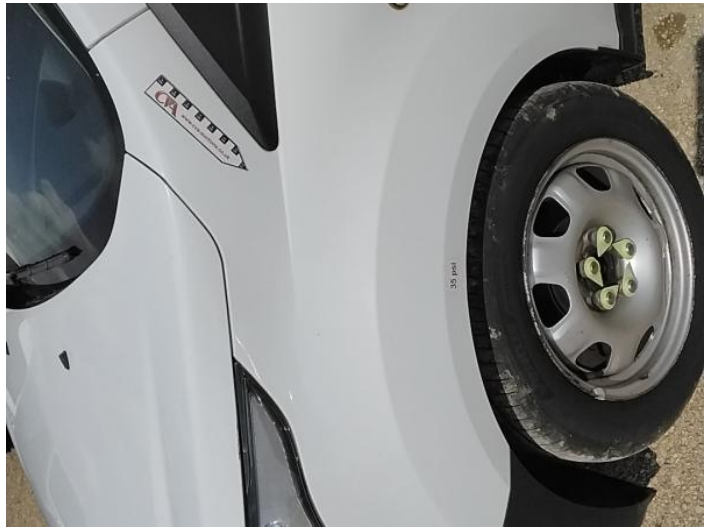
6: Wing nsf  
Chipped  
Multiple Chips

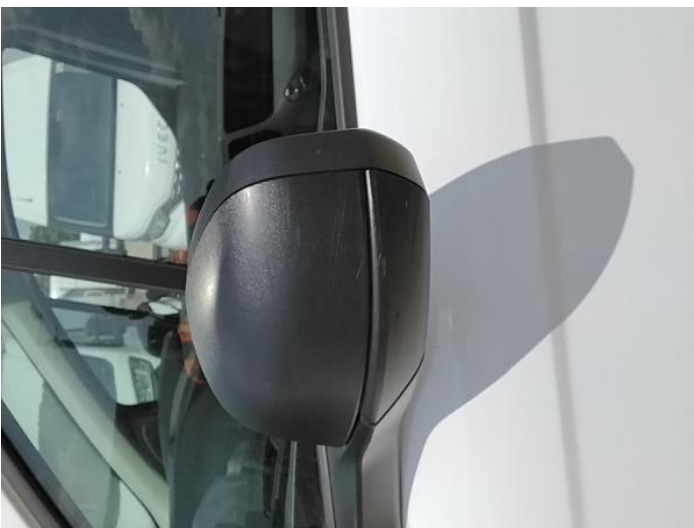
7: Door Mirror Assy nsf  
Scuffed (Unpainted)  
Over 100mm

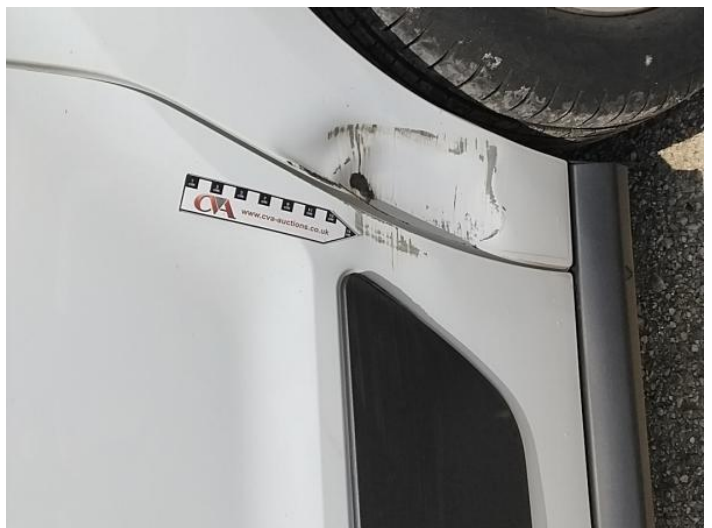
8: Door nsr  
Dented  
With Paint Damage

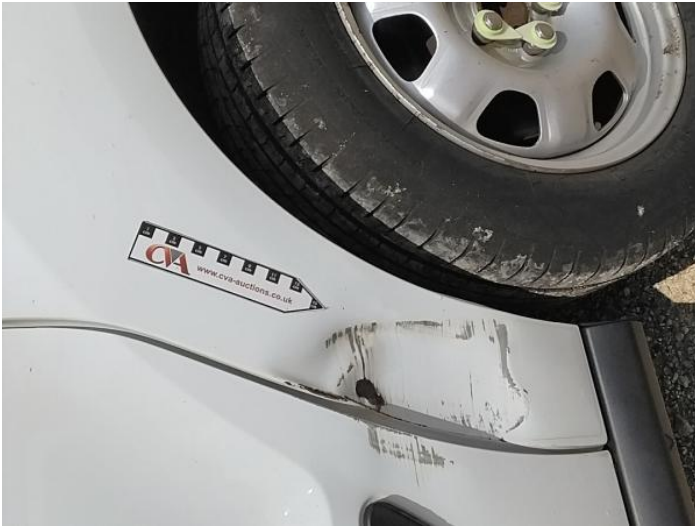
9: Qtr Panel nsr  
Dented  
With Paint Damage

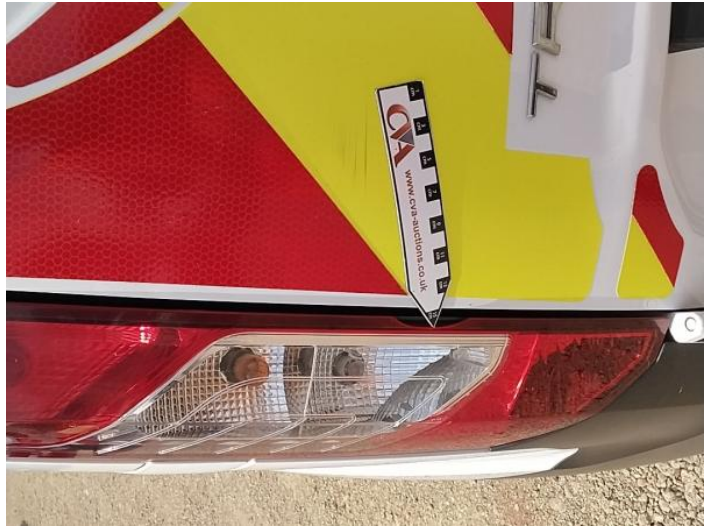
10: Lamp nsr  
Broken  
Replace

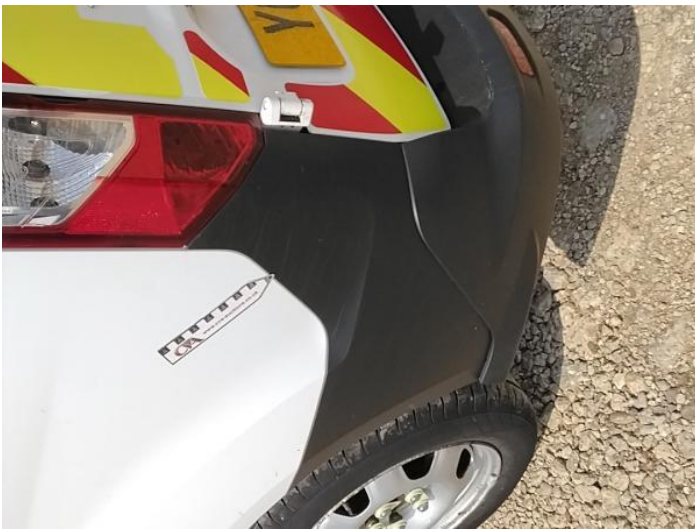
11: Qtr Panel Arch Extension ns  
Scuffed (Unpainted)  
Over 100mm

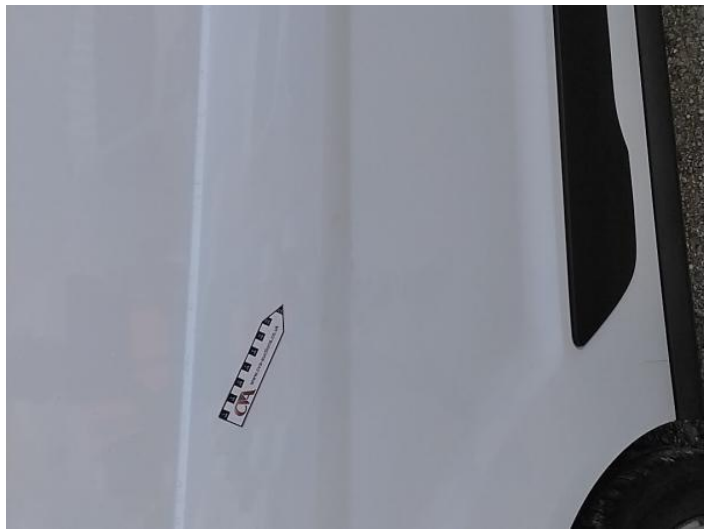
12: Qtr Panel osr  
Dented  
2 Or Less UpTo 10mm

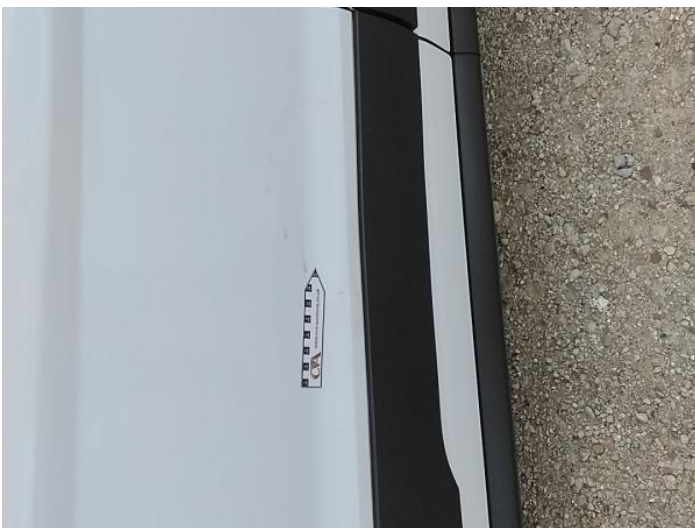
13: Qtr Panel osr  
Dented  
Over 30mm

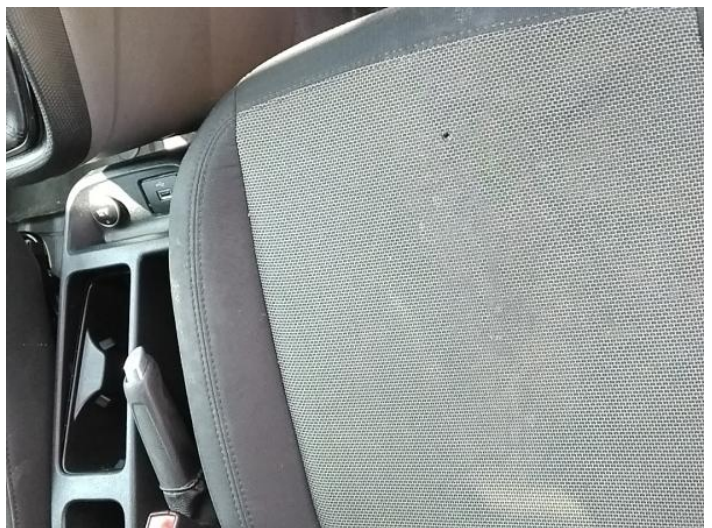
14: Seat Base Cover osf  
Holed  
Over 3mm

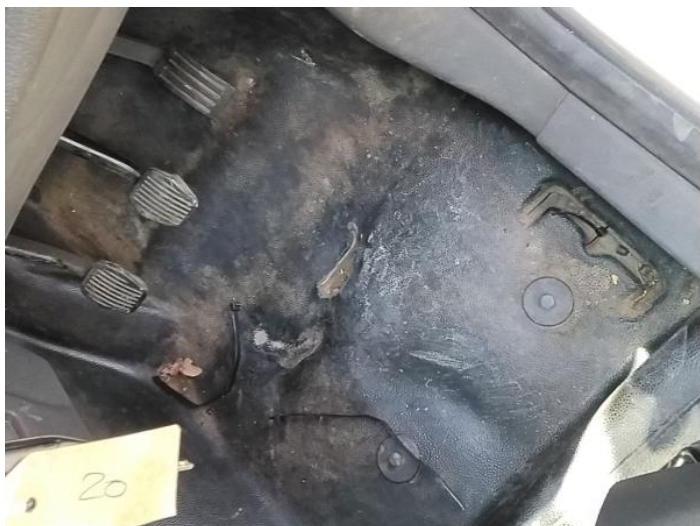
15: Carpets Front  
Holed  
Over 3mm
