# VEHICLE INSPECTION REPORT

**NK20GZO**

## Land Rover Discovery 3.0 SD6 LANDMARK

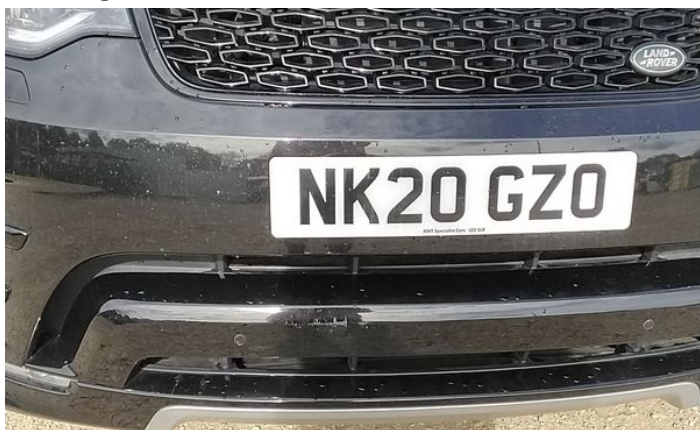
1: Bumper Front Moulding  
Scuffed (Unpainted)  
UpTo 100mm

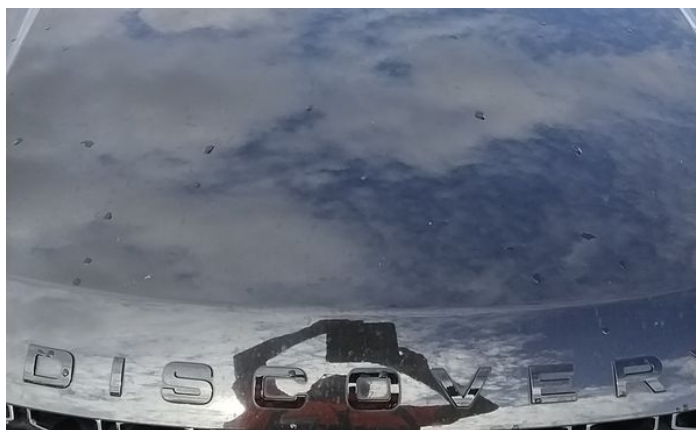
2: Bonnet  
Chipped  
Multiple Chips

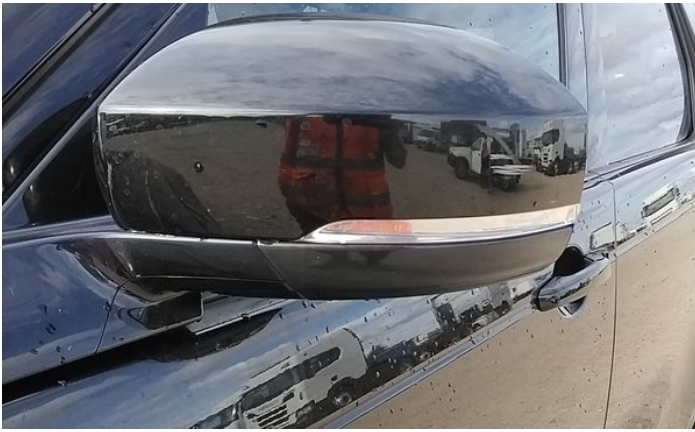
3: Door Mirror Assy nsf  
Scratched (Painted)  
UpTo 25mm Thru Paint

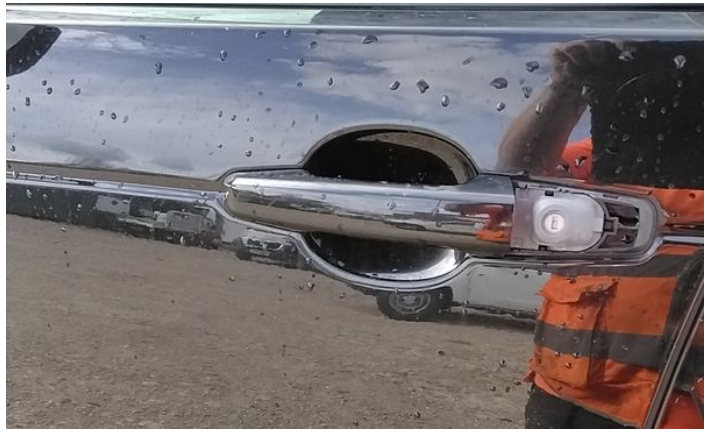
4: Handle Outer nsf  
Broken  
Replace

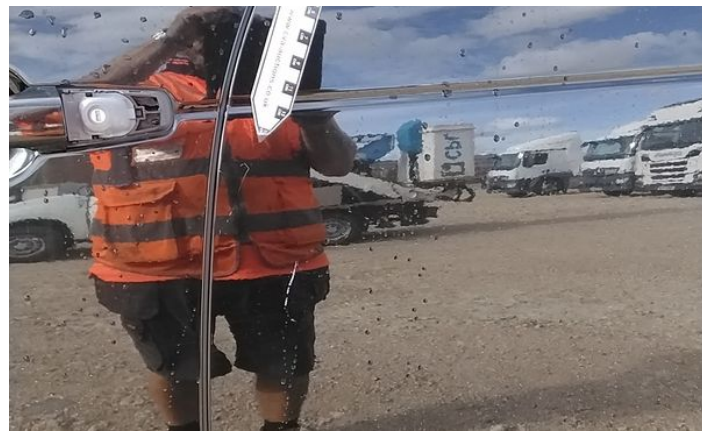
5: Door nsr  
Scratched  
UpTo 25mm Thru Paint

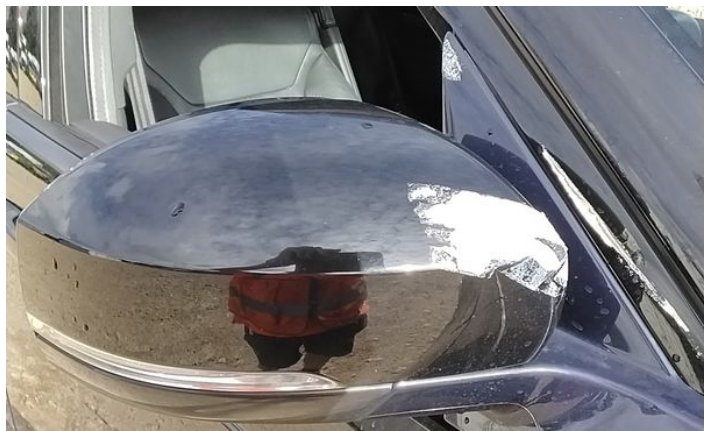
6: Door Mirror Assy osf  
Broken  
Replace
