# VEHICLE INSPECTION REPORT

**BT17ONH**

## Iveco Daily 70-180

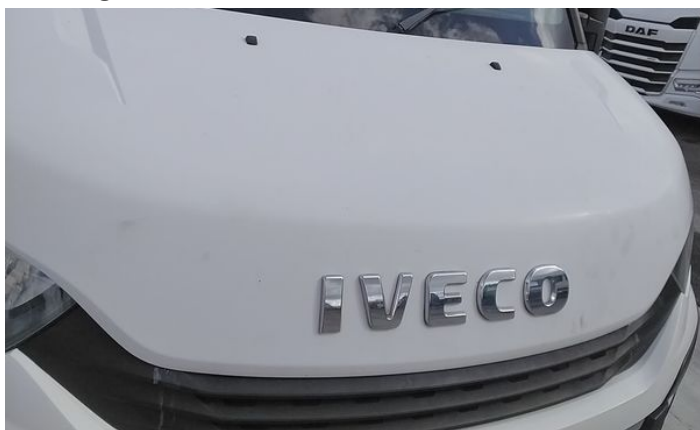
1: Bonnet  
Chipped  
Multiple Chips

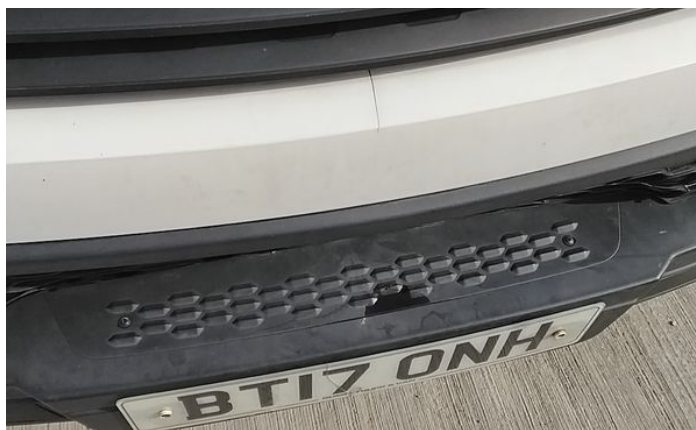
2: Panel Front  
Cracked  
Replace

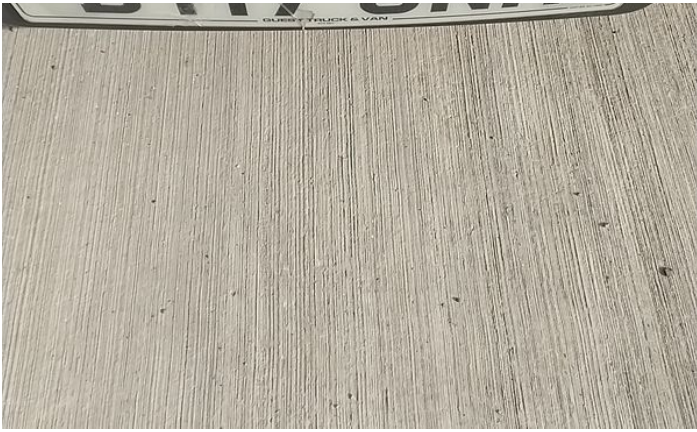
3: Number Plate Front  
Broken  
Replace

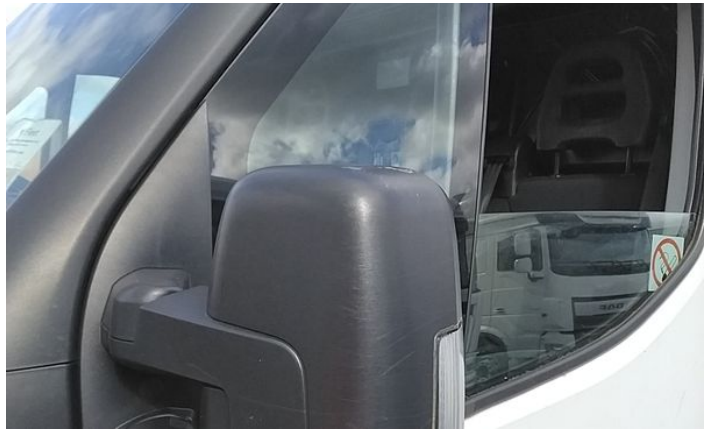
4: Door Mirror Assy nsf  
Scuffed (Unpainted)  
UpTo 100mm

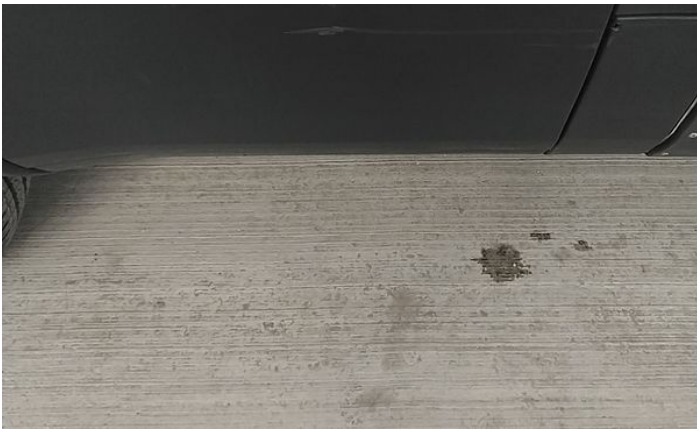
5: Door Moulding nsf  
Scuffed (Unpainted)  
Over 100mm

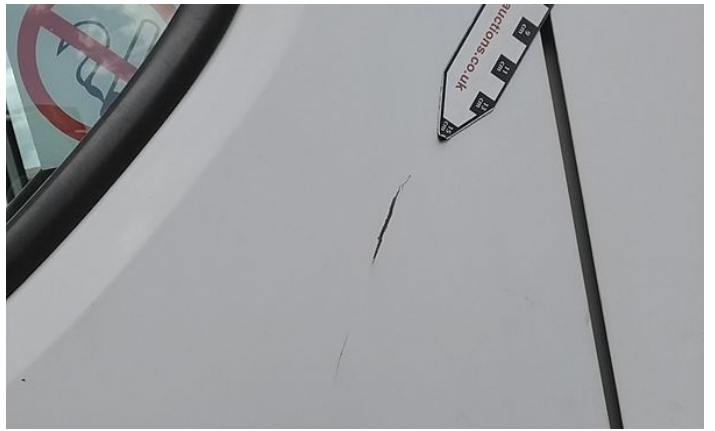
6: Door nsf  
Scratched  
Over 25mm Thru Paint

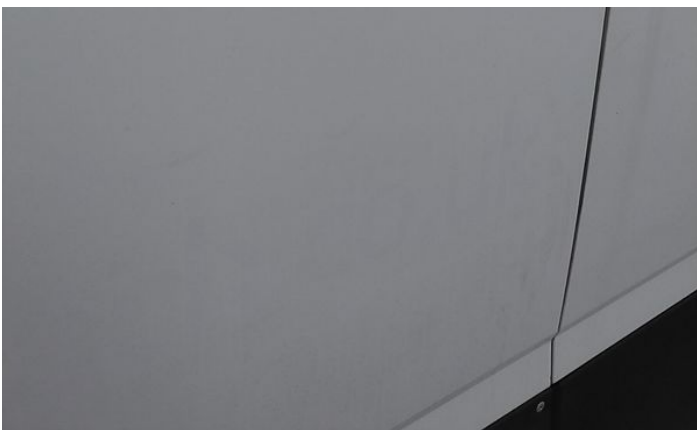
7: Qtr Panel nsr  
Dented  
Over 30mm

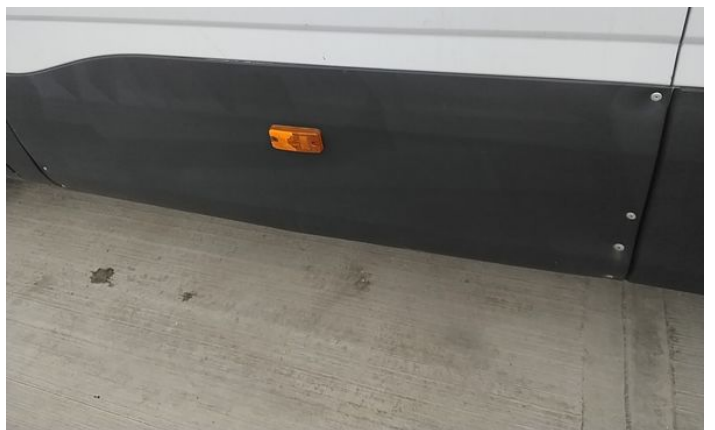
8: Qtr Panel Moulding ns  
Broken  
Replace

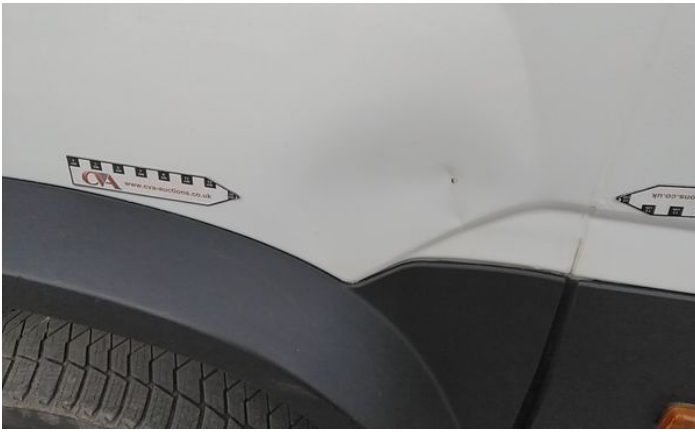
9: Qtr Panel nsr  
Dented  
With Paint Damage

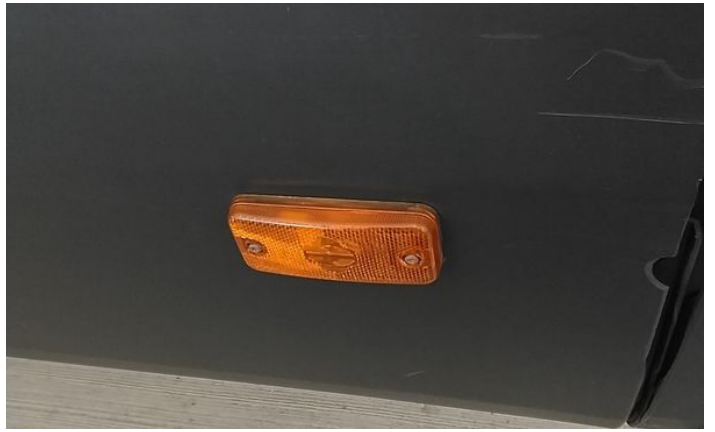
10: Qtr Panel Moulding ns  
Scuffed (Unpainted)  
UpTo 100mm

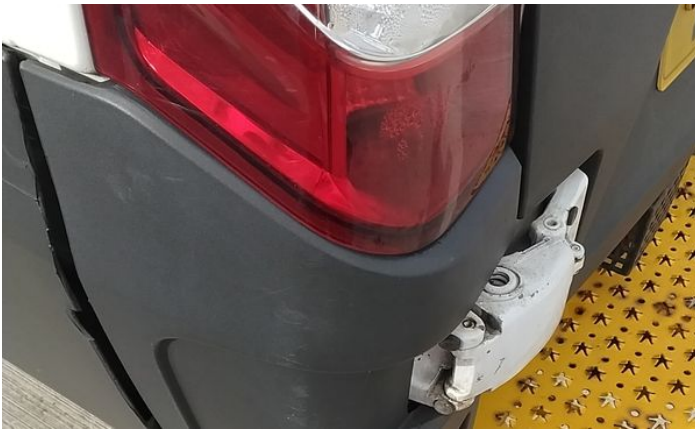
11: Bumper Rear Moulding  
Broken  
Replace

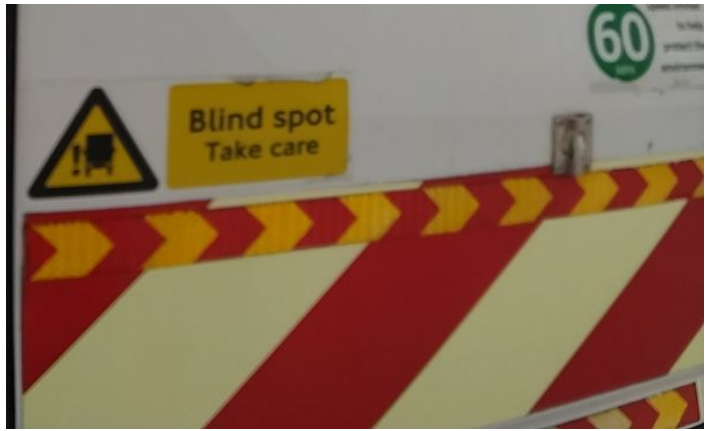
12: Door nsr  
Chipped  
Multiple Chips

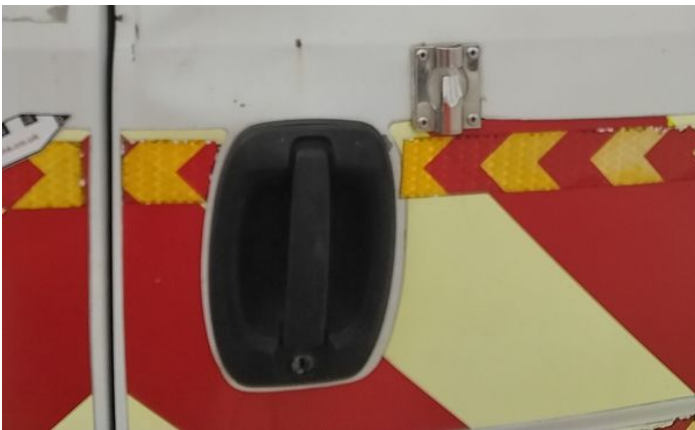
13: Door osr  
Dented  
With Paint Damage

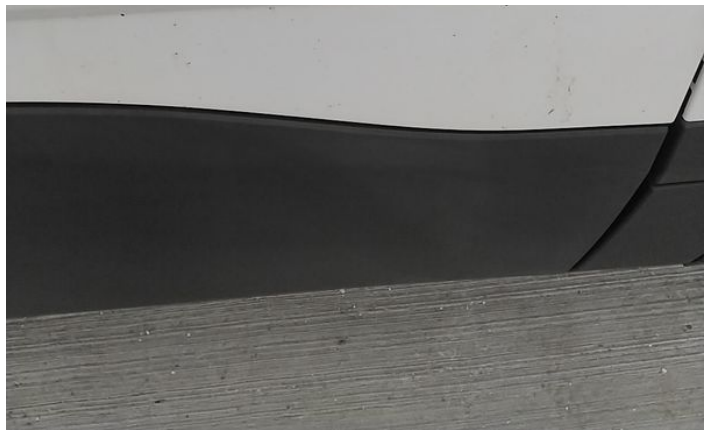
14: Qtr Panel osr  
Dented  
With Paint Damage

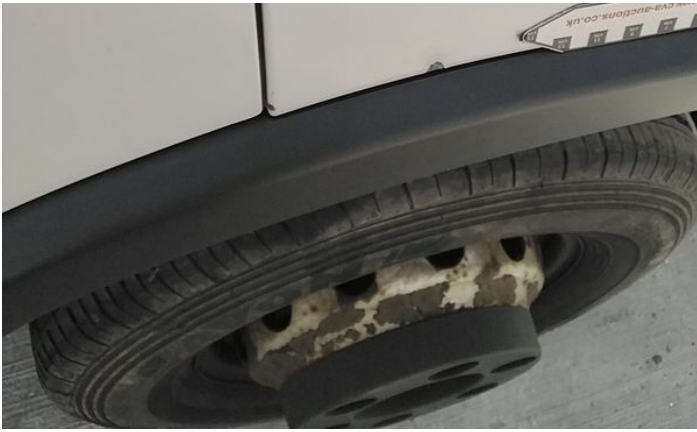
15: Wing osf  
Dented  
With Paint Damage

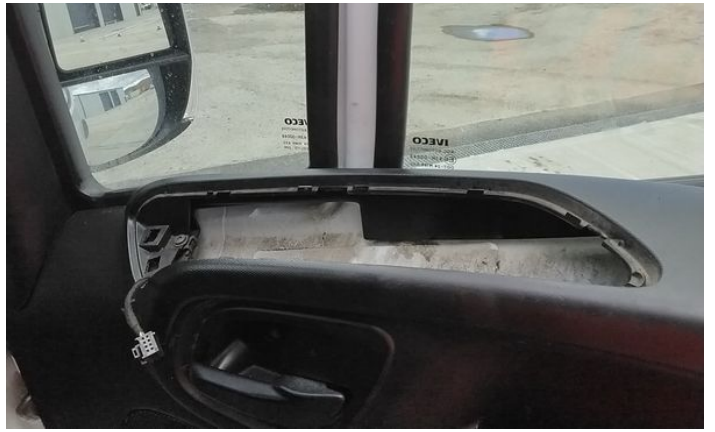
16: Door Pad osf  
Broken  
Replace

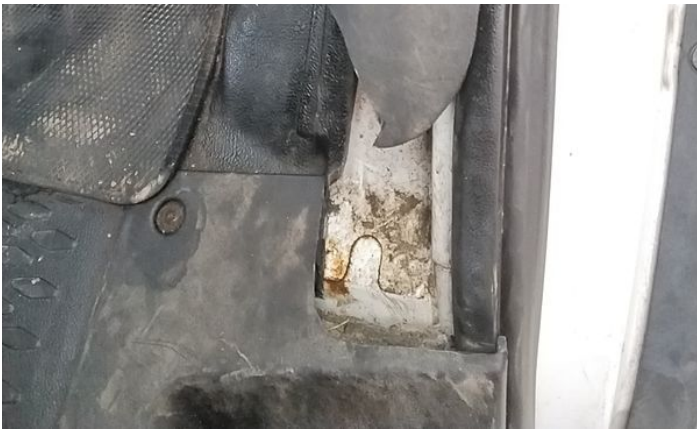
17: Fascia Trim  
Damaged  
Replace

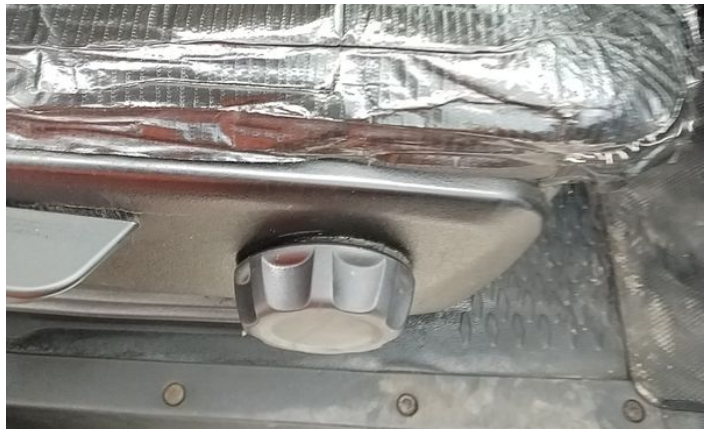
18: Seat Base Cover osf  
Holed  
Over 3mm

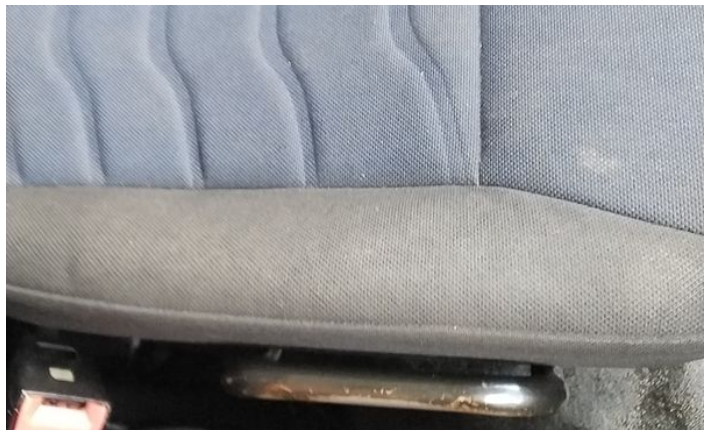
20: Seat Base Cover nsf  
Soiled  
Heavy

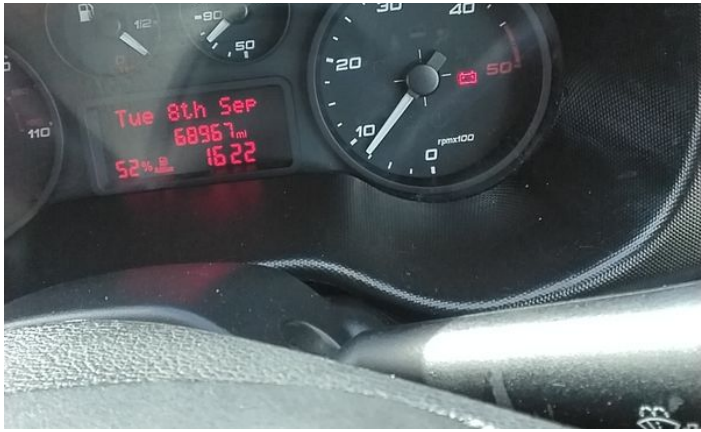
21: Dash Warning Lights  
Displayed  
No Action
