# VEHICLE INSPECTION REPORT

**KR68OSL**

## Mercedes-Benz Sprinter 3.5t H2 Van

### Inspection

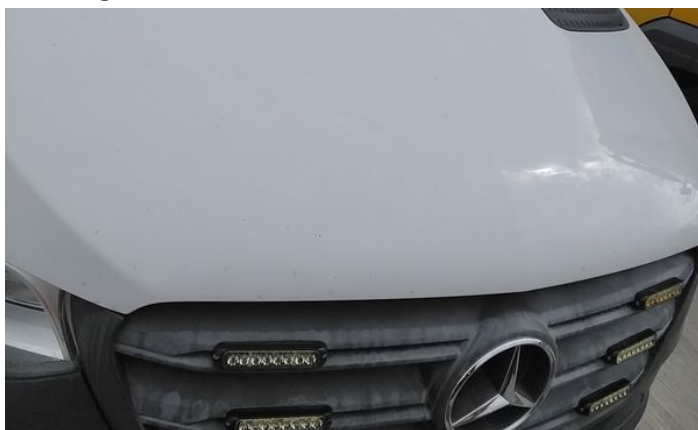
1: Bonnet  
Chipped  
Multiple Chips

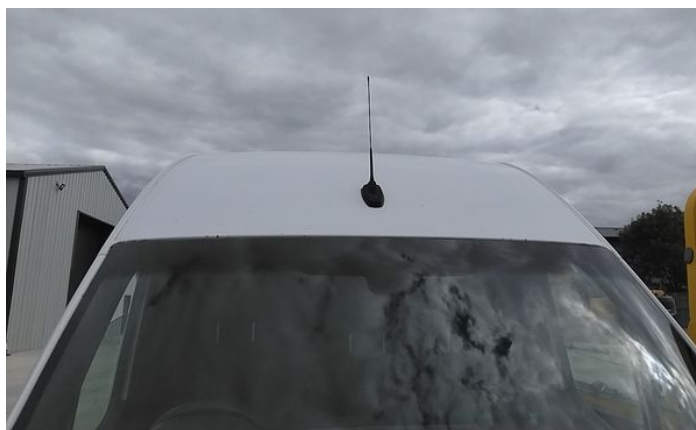
2: Roof  
Chipped  
Multiple Chips

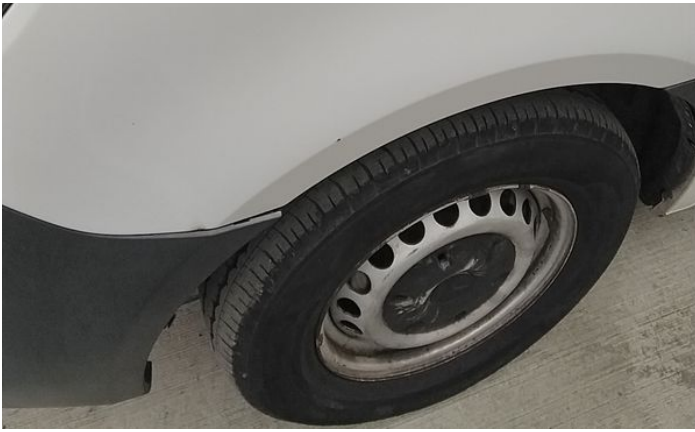
3: Wing nsf  
Chipped  
Multiple Chips

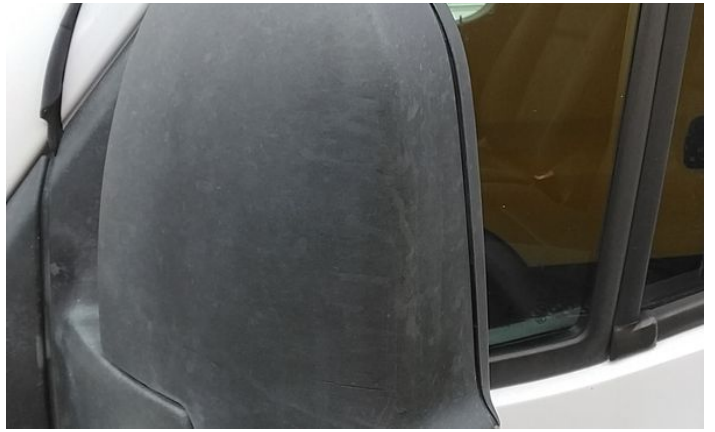
4: Door Mirror Assy nsf  
Scuffed (Unpainted)  
UpTo 100mm

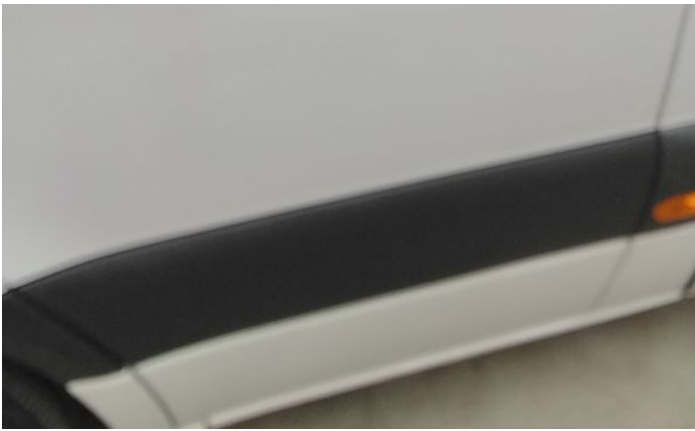
5: Door nsf  
Chipped  
Multiple Chips

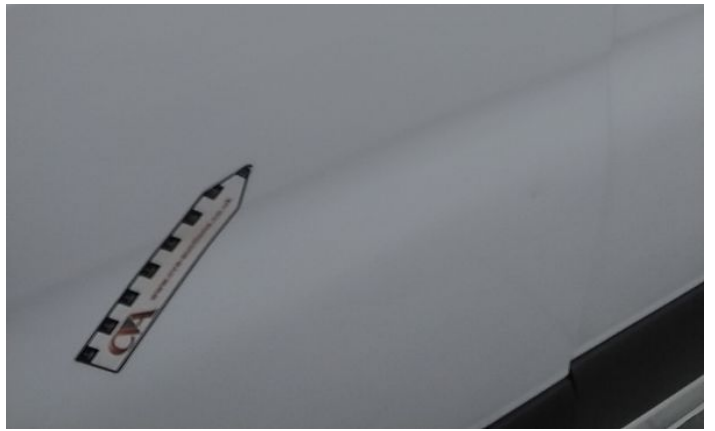
6: Qtr Panel nsr  
Dented  
Over 30mm

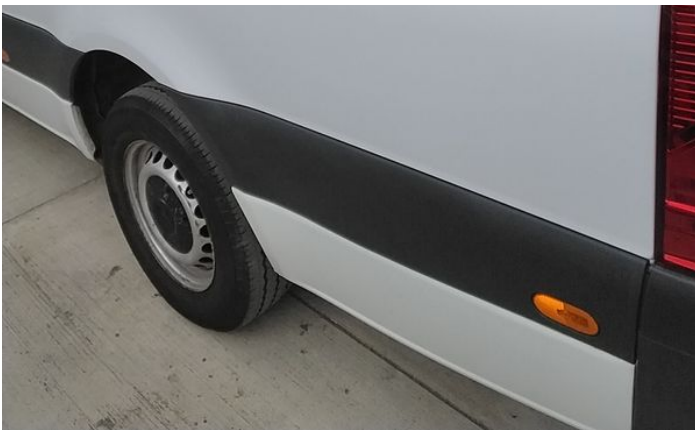
7: Qtr Panel nsr  
Chipped  
Multiple Chips

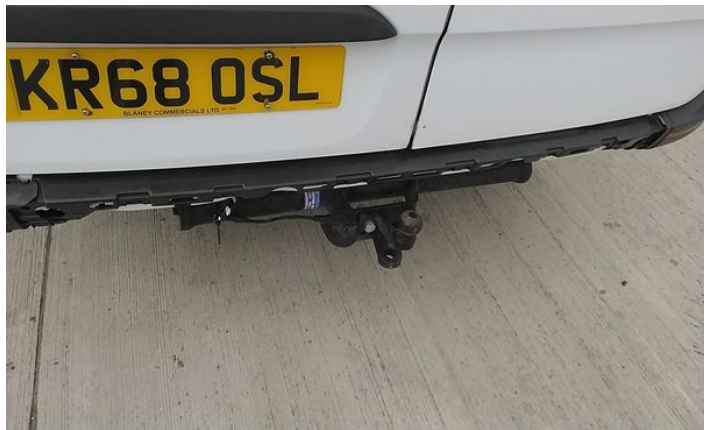
8: Bumper Rear Moulding  
Missing  
Replace

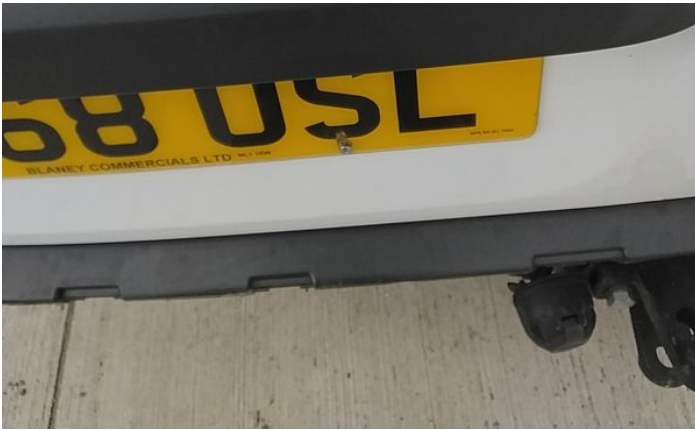
9: Door nsr  
Scratched  
Over 25mm Thru Paint

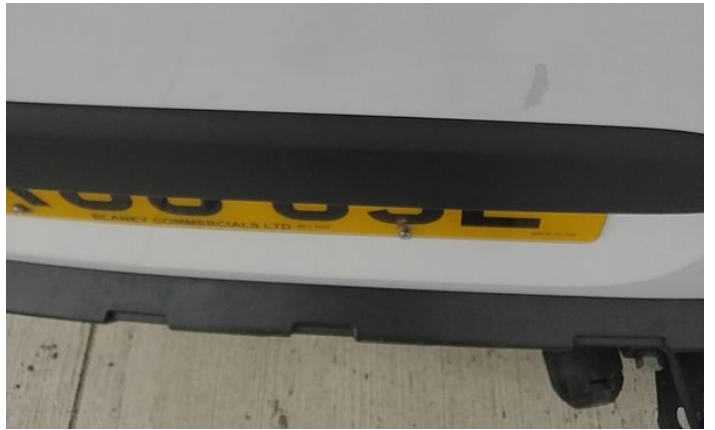
10: Door nsr  
Dented  
Over 30mm

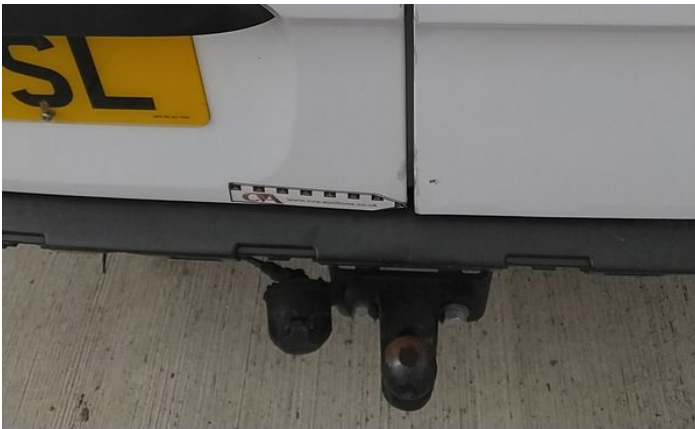
11: Door osr  
Scratched  
Over 25mm Thru Paint

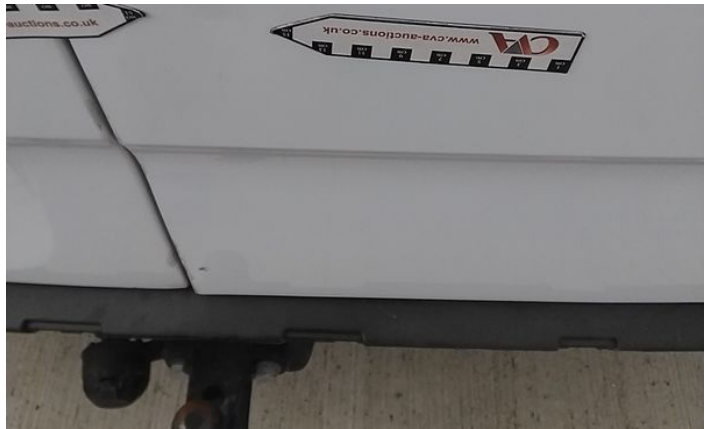
12: Door osr  
Dented  
Over 30mm

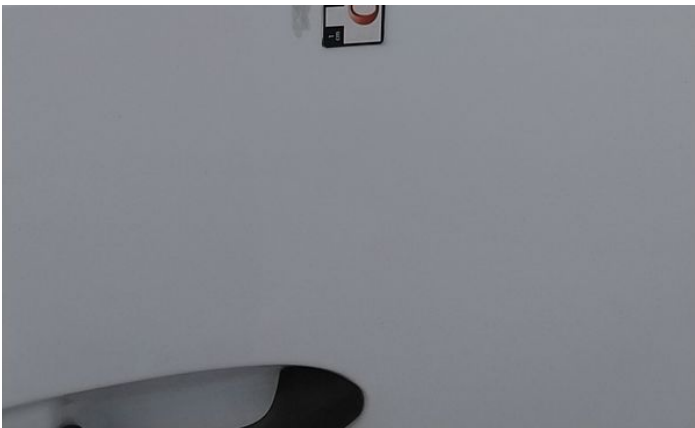
13: Door osr  
Scratched  
Over 25mm Thru Paint

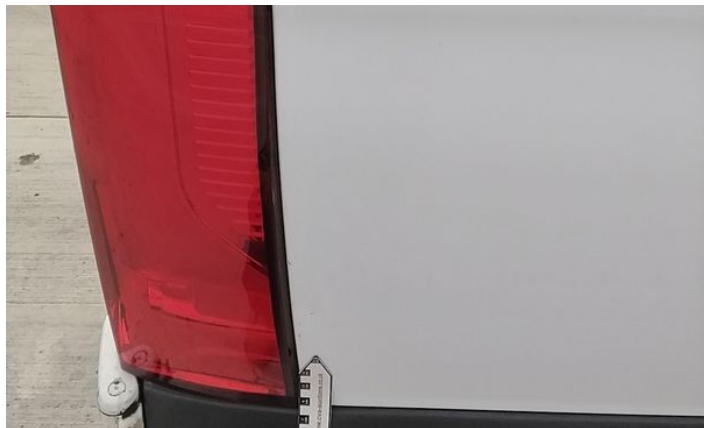
14: Qtr Panel osr  
Scratched  
Over 25mm Thru Paint

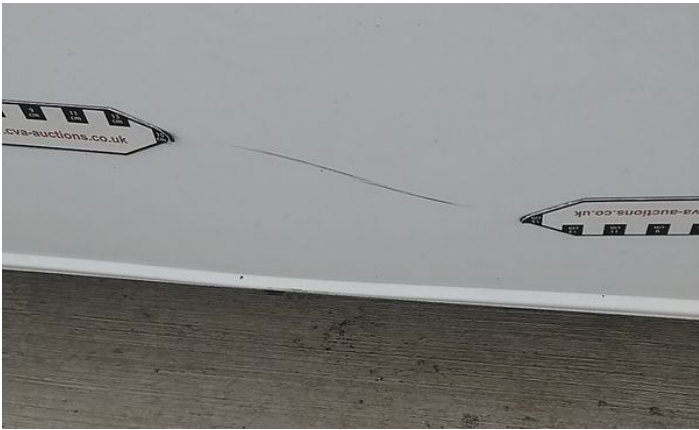
15: Qtr Panel osr  
 Scratched  
 Over 25mm Thru Paint

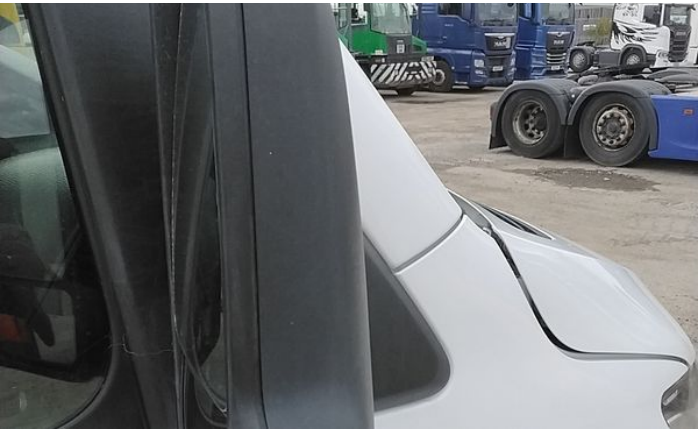
16: Door Mirror Assy osf  
 Broken  
 Replace

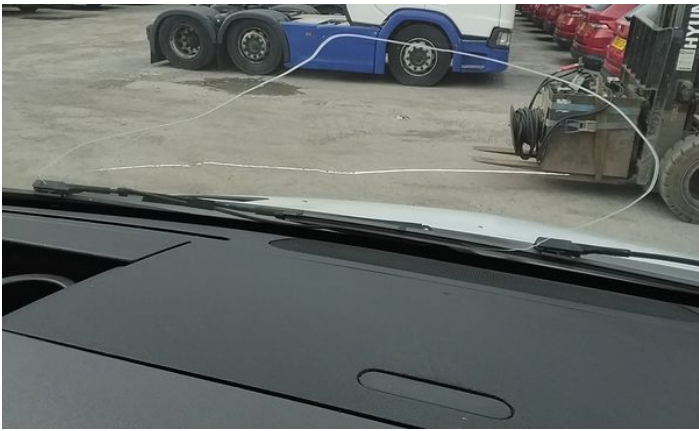
17: Screen Front  
 Cracked  
 Replace

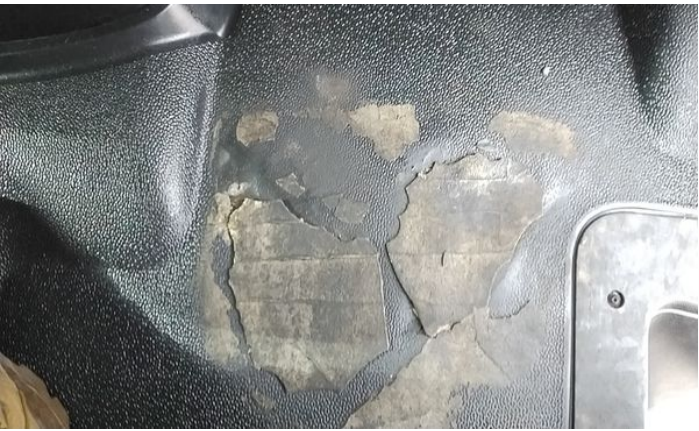
18: Carpets Front  
 Holed  
 Over 3mm
