# VEHICLE INSPECTION REPORT

**PE17HUA**

## Daf CF 440

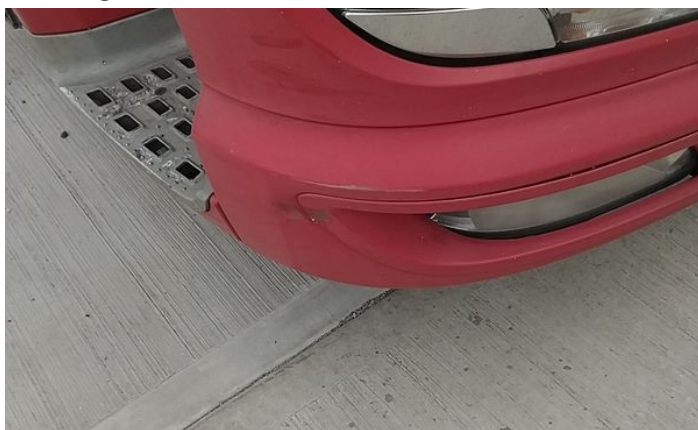
1: Bumper Front  
Dented  
With Paint Damage

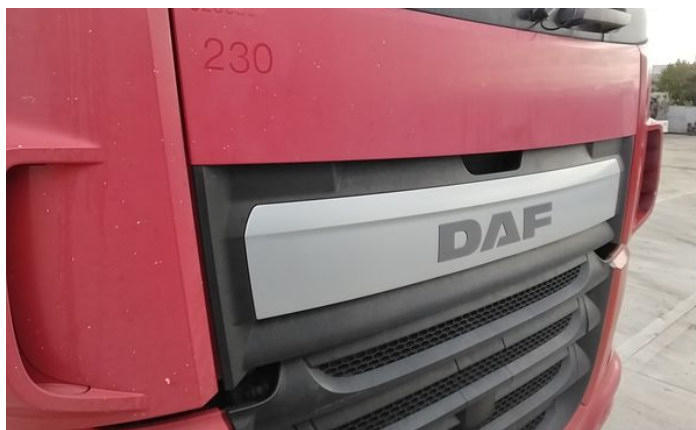
2: Bonnet  
Chipped  
Multiple Chips

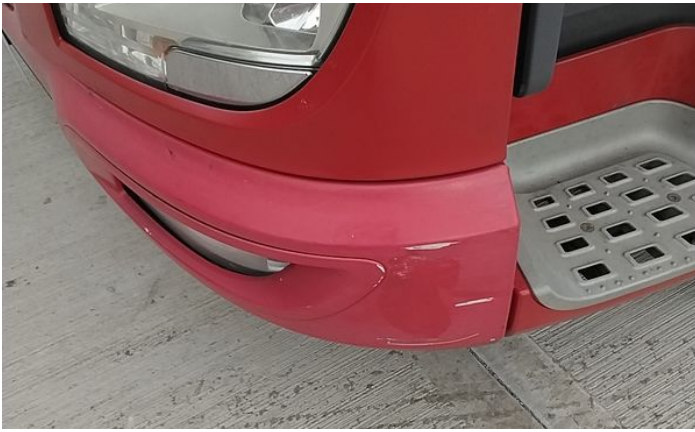
3: Bumper Front  
Scratched  
Over 100mm Thru Paint

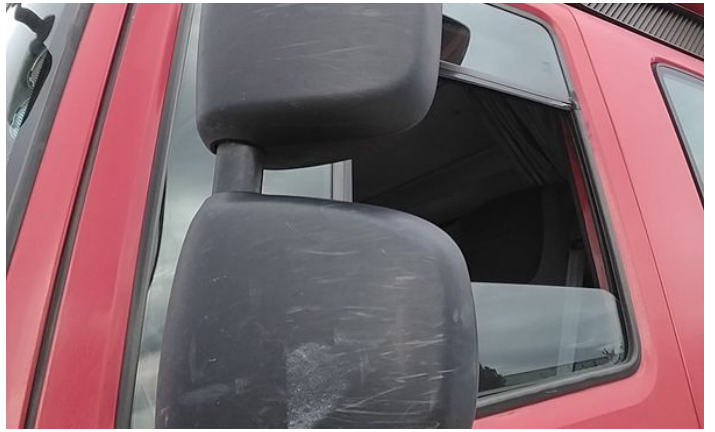
4: Door Mirror Assy nsf  
Scuffed (Unpainted)  
Over 100mm

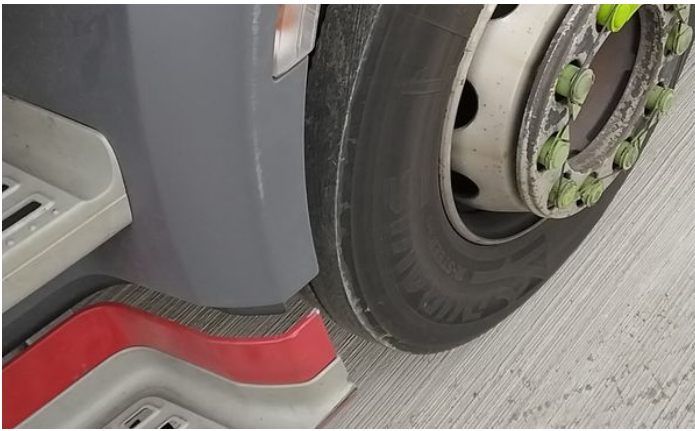
5: Wing nsf  
Scratched  
Over 25mm Thru Paint

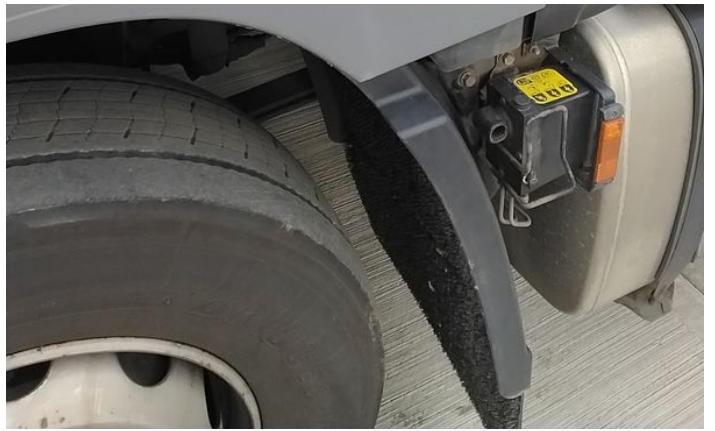
6: Qtr Panel Moulding ns  
Scuffed (Unpainted)  
Over 100mm

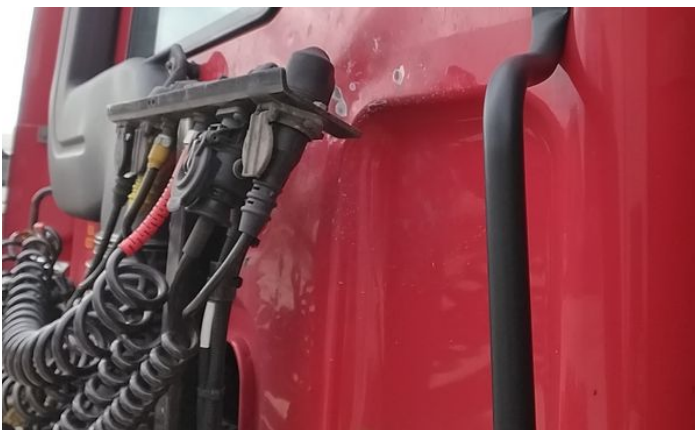
7: Panel Rear  
Dented  
With Paint Damage

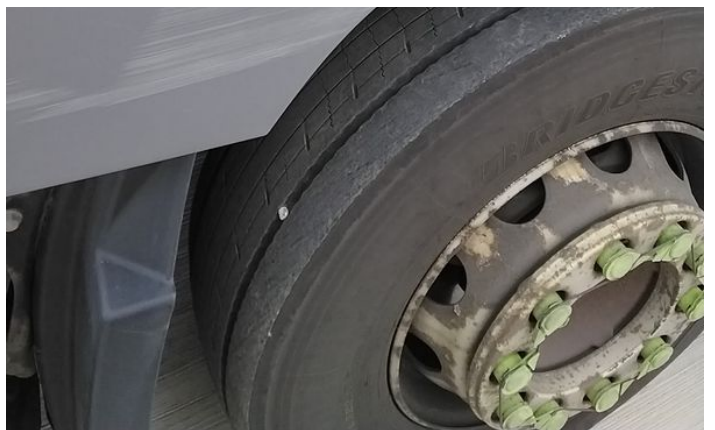
8: Qtr Panel Moulding os  
Scuffed (Unpainted)  
Over 100mm

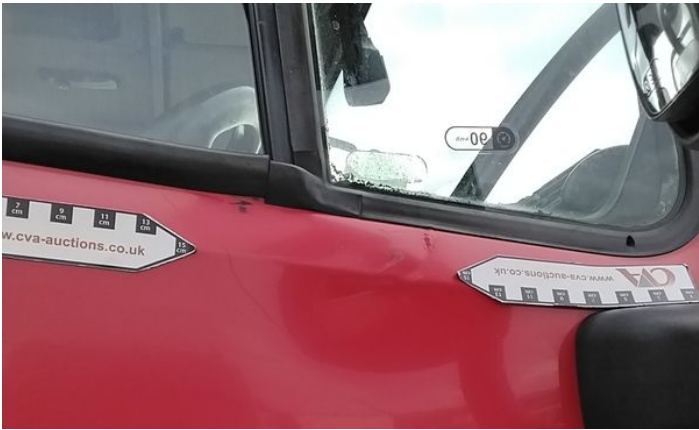
9: Door osf  
Dented  
With Paint Damage

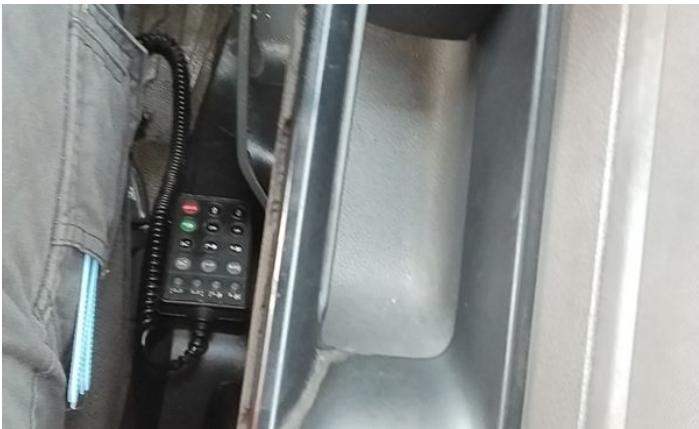
11: Door Pad osf  
Broken  
Replace

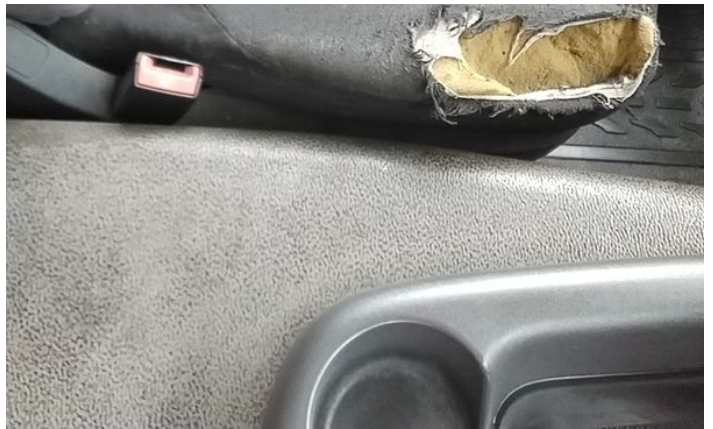
12: Seat Base Cover nsf  
Holed  
Over 3mm
