# VEHICLE INSPECTION REPORT

**SG68XYJ**

## Fiat Ducato 42 2.3 Multijet II 180ps

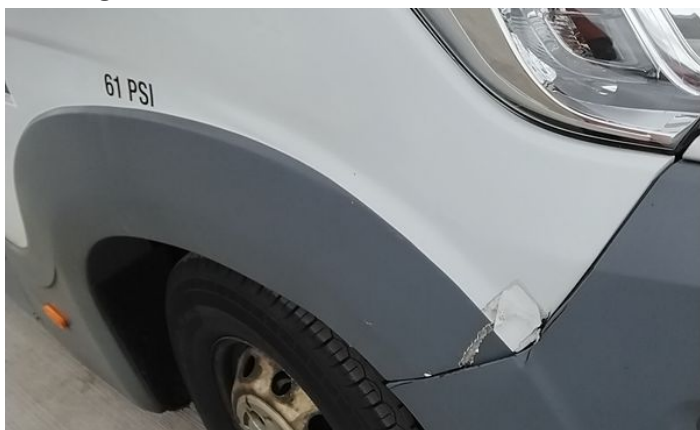
1: Wing osf  
Cracked  
Replace

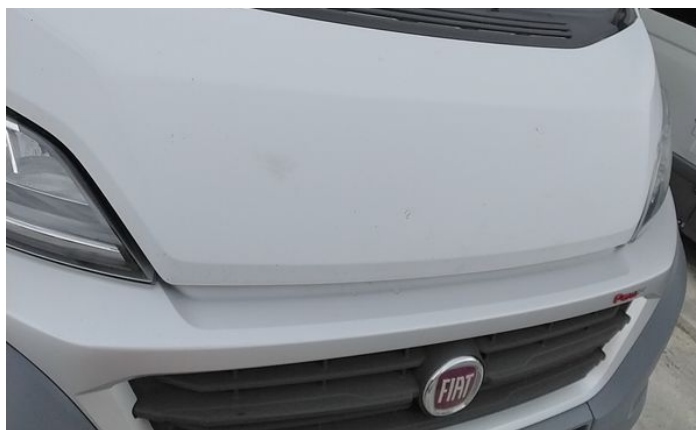
2: Bonnet  
Chipped  
Multiple Chips

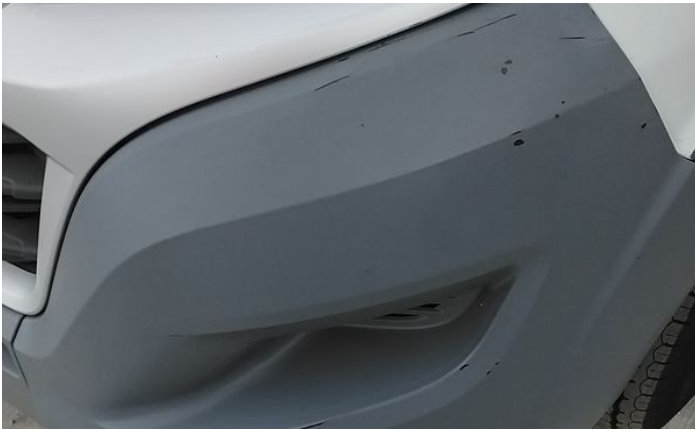
3: Bumper Front Moulding  
Scuffed (Unpainted)  
Over 100mm

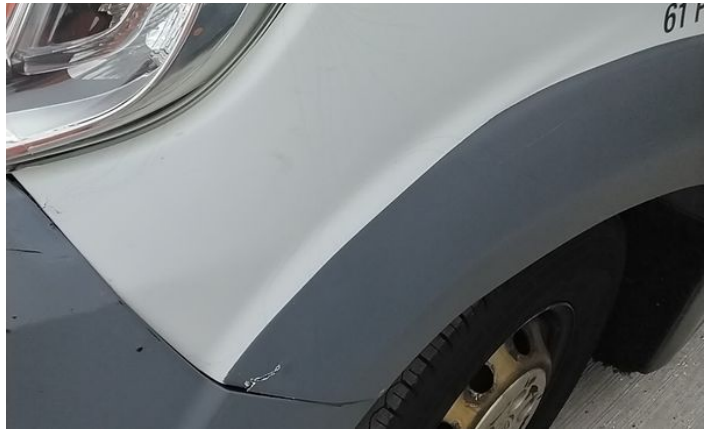
4: Wing nsf  
Cracked  
Replace

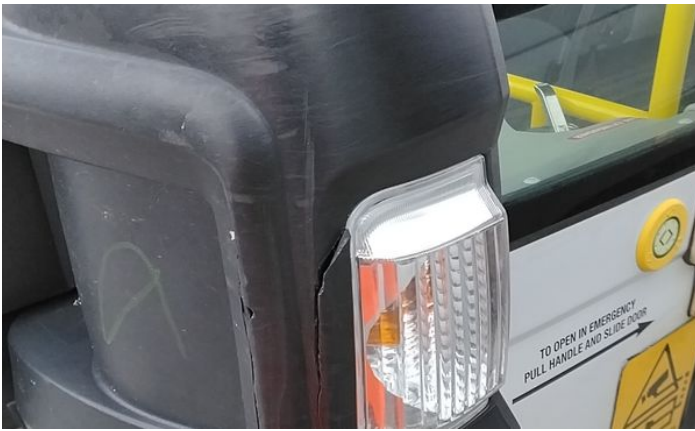
5: Door Mirror Assy nsf  
Broken  
Replace

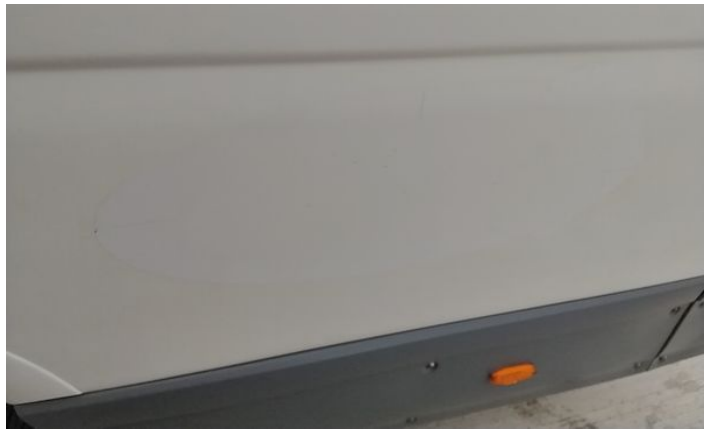
6: Qtr Panel nsr  
Scratched  
Over 25mm Thru Paint

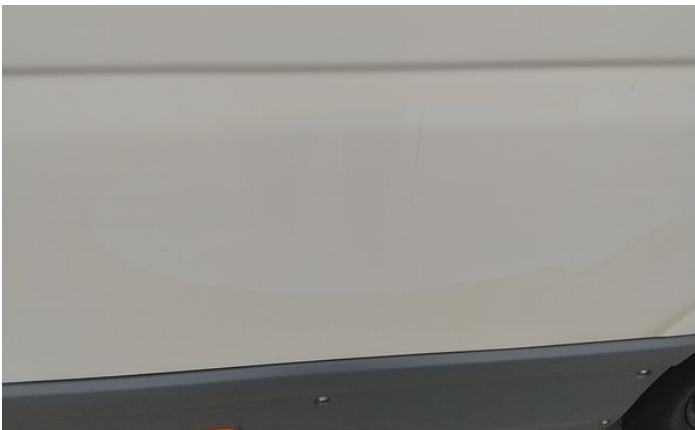
7: Qtr Panel osr  
Scratched  
Over 25mm Thru Paint

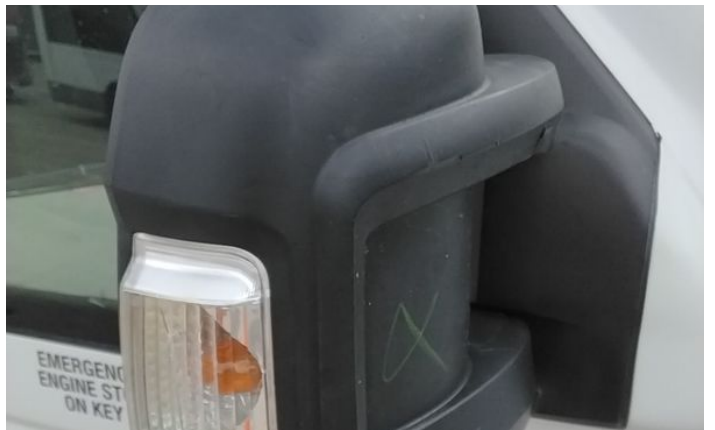
8: Door Mirror Assy osf  
Broken  
Replace

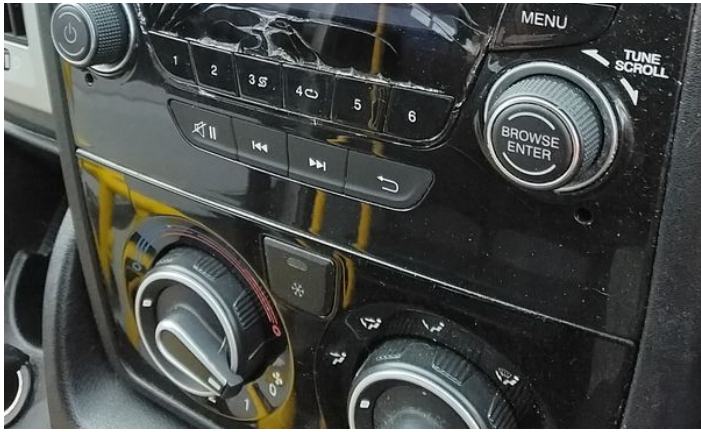
9: Fascia Panel  
 Broken  
 Replace
