## VEHICLE INSPECTION REPORT

**SL62XEF**

### Volkswagen Crafter CR35 2.0 TDI 109PS

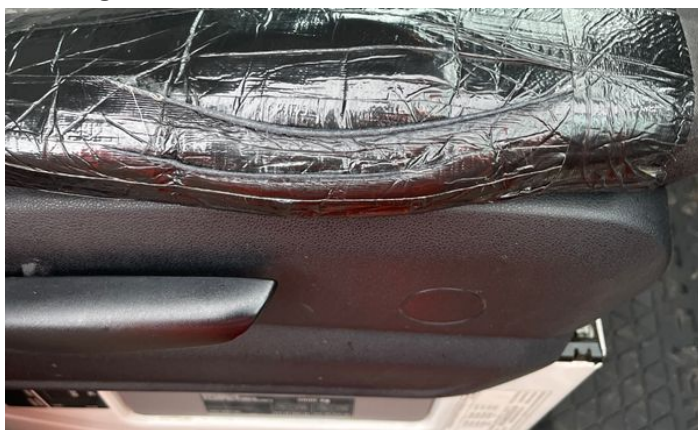
1: Seat Base Cover nsr  
Torn  
Over 3mm

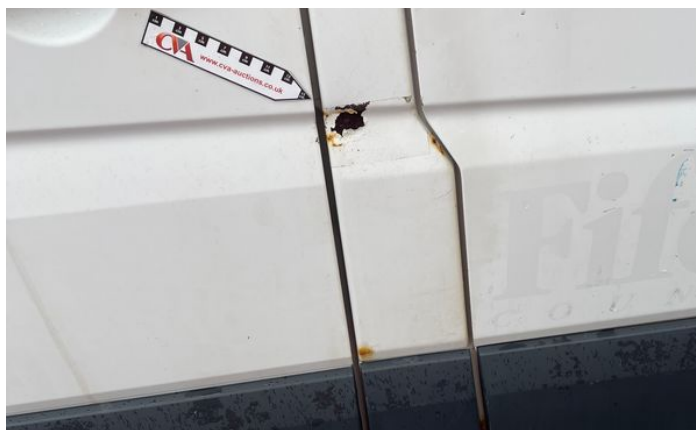
2: Panel Front  
Rusted  
Over 5mm

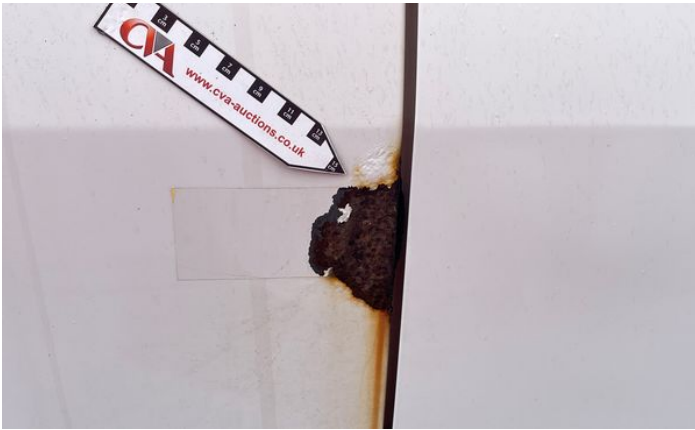
3: Panel Rear  
Rusted  
Over 5mm

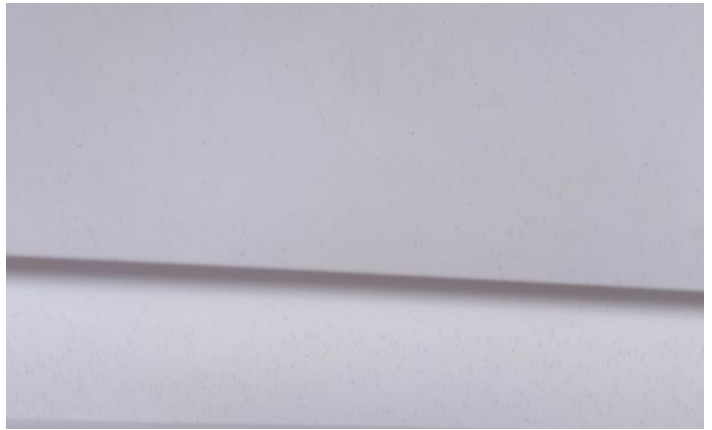
4: Door nsf  
Dented  
Over 30mm

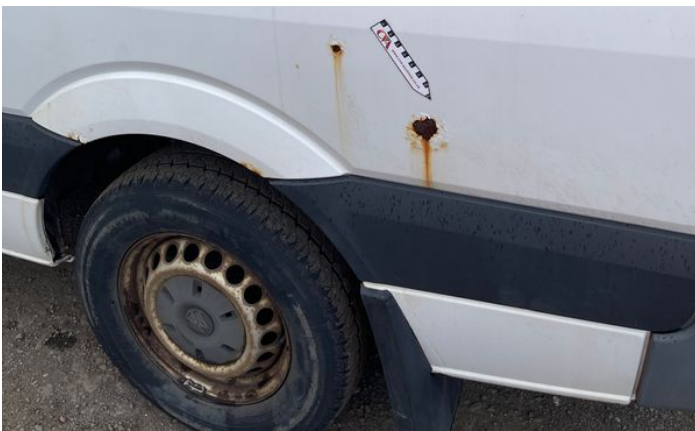
5: Panel Rear  
Rusted  
Over 5mm

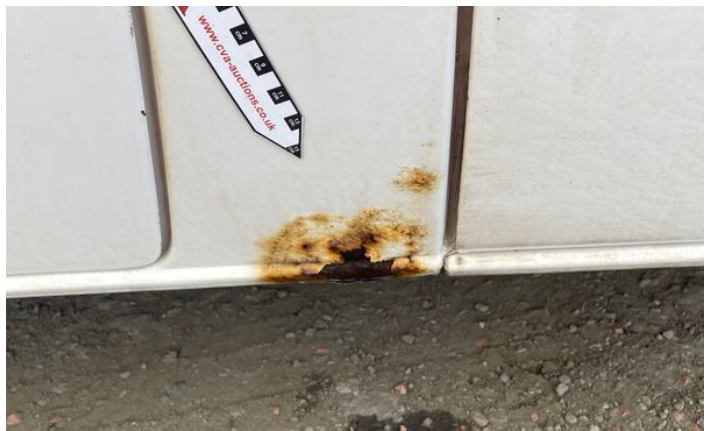
6: Panel Front  
Rusted  
Over 5mm
