# VEHICLE INSPECTION REPORT

**PF66KKR**

## Daf CF 440

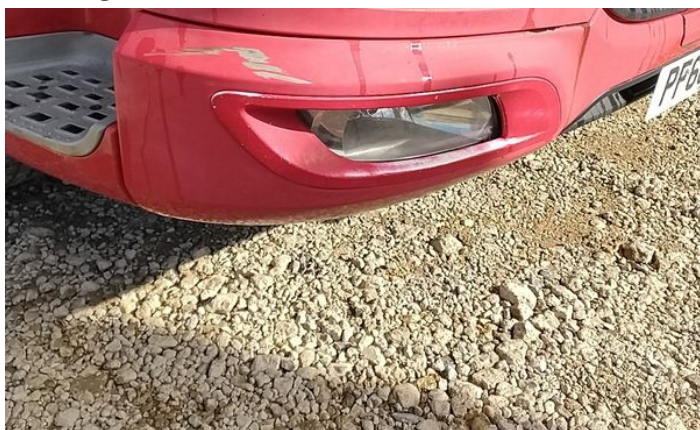
1: Bumper Front  
Scratched  
25 to 100mm Thru Paint

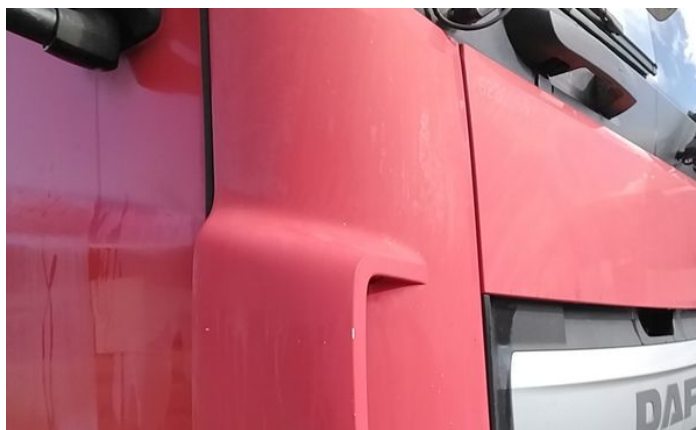
2: Wing osf  
Chipped  
Multiple Chips

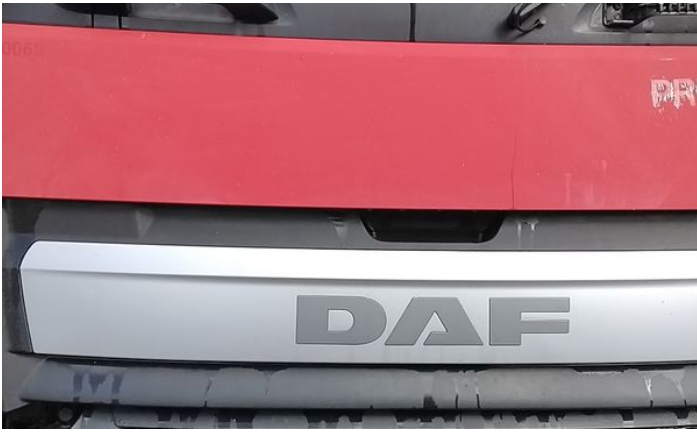
3: Bonnet  
Chipped  
Multiple Chips

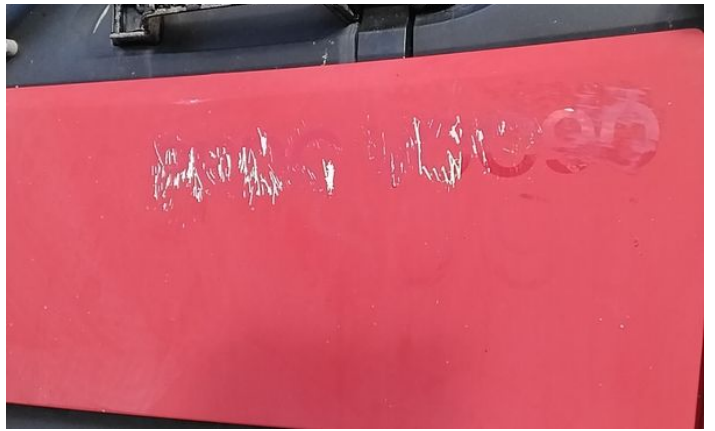
5: Wing nsf  
Scratched  
Over 25mm Thru Paint

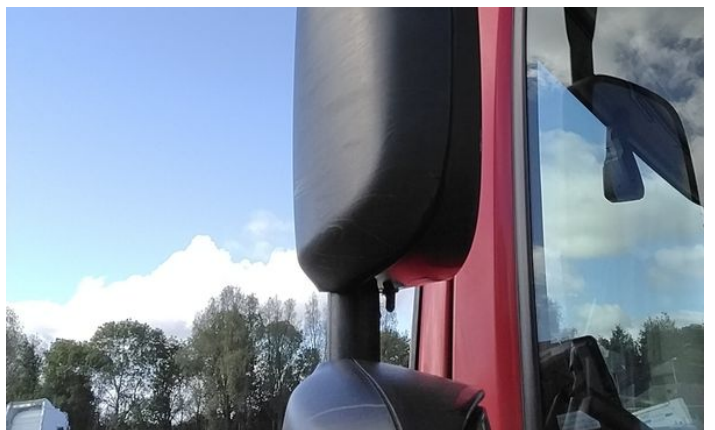
7: Door Mirror Assy nsf  
Scuffed (Unpainted)  
Over 100mm

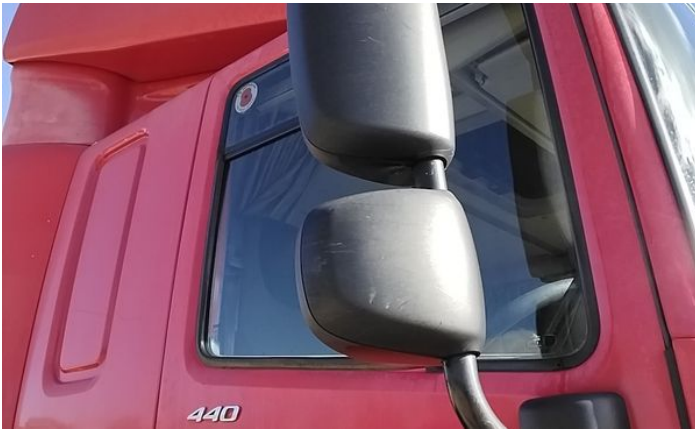
8: Door Mirror Assy nsf  
Broken  
Replace
