# VEHICLE INSPECTION REPORT

**BN21AHU**

## Iveco Daily 35-120

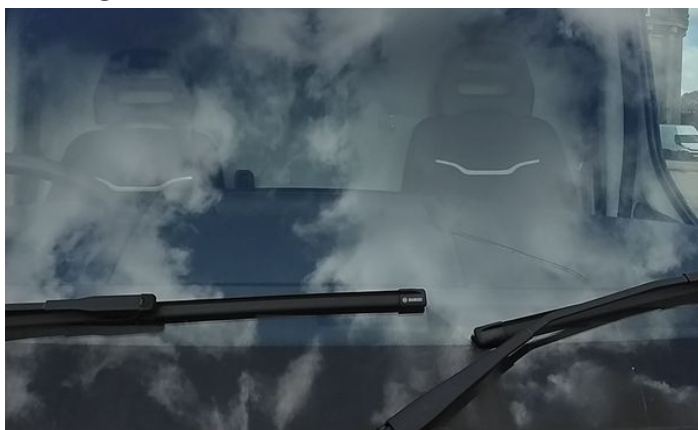
1: Screen Front  
Cracked  
Replace

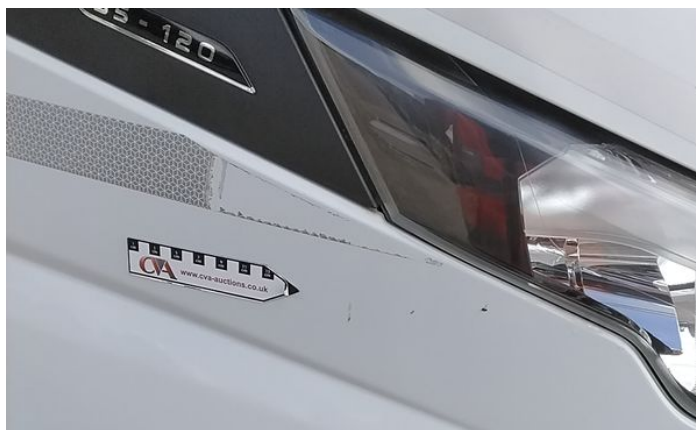
2: Wing osf  
Chipped  
1 To 5

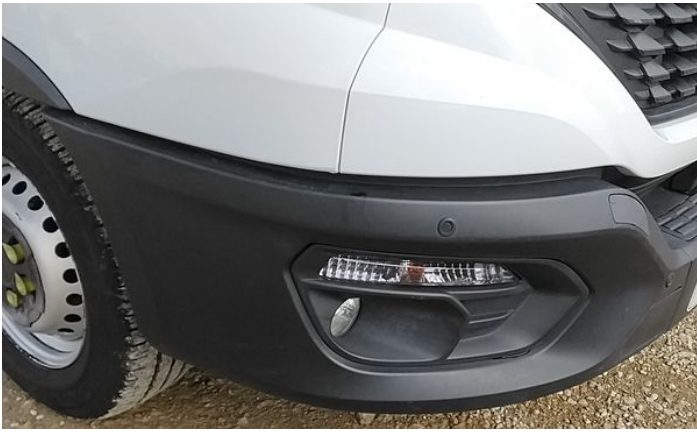
3: Bumper Front Moulding  
Scuffed (Unpainted)  
UpTo 100mm

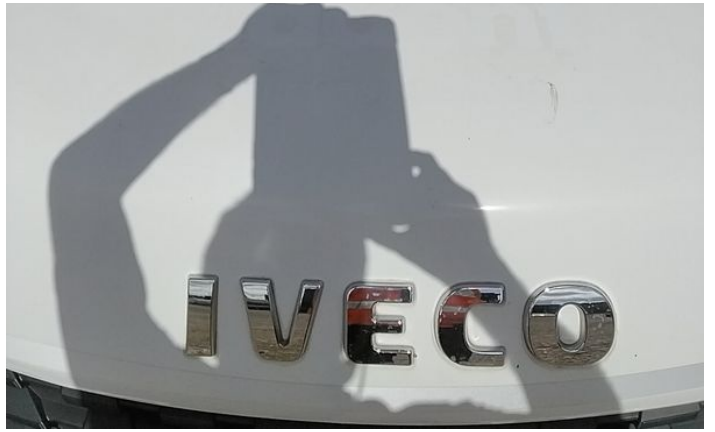
4: Bonnet  
Chipped  
Multiple Chips

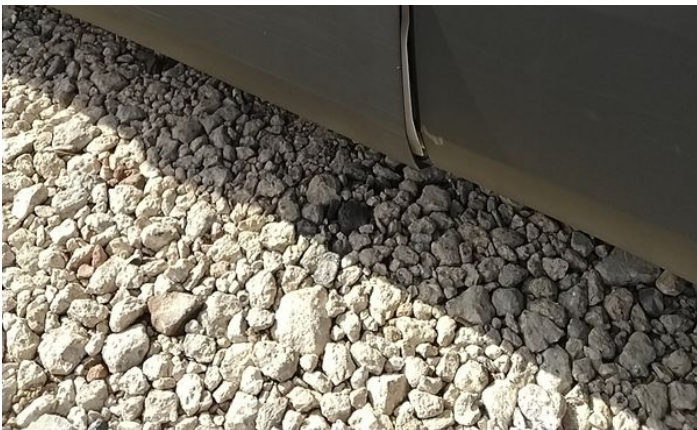
7: Door Moulding nsr  
Broken  
Replace

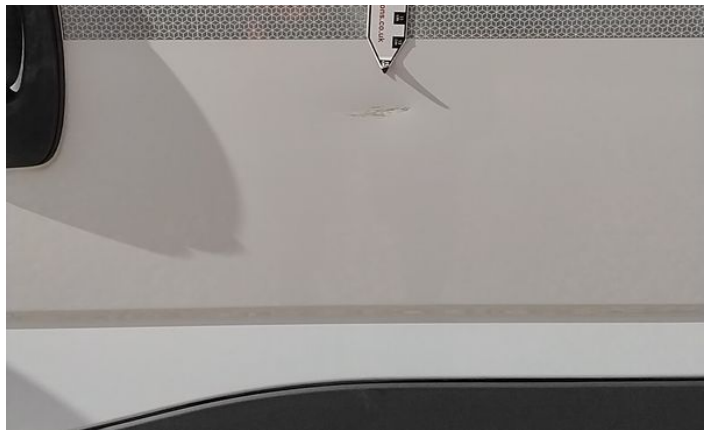
8: Door nsr  
Dented  
With Paint Damage

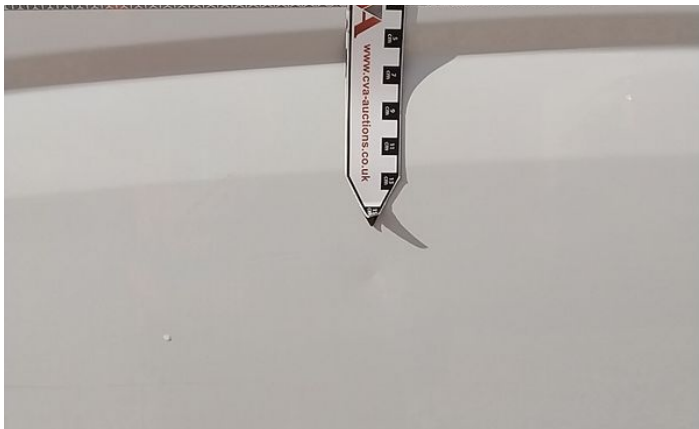
9: Qtr Panel nsr  
Dented  
Over 2 UpTo 10mm

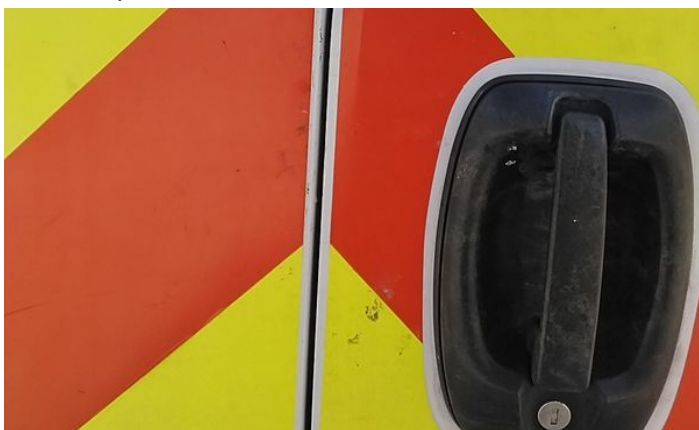
11: Door osr  
Dented  
With Paint Damage

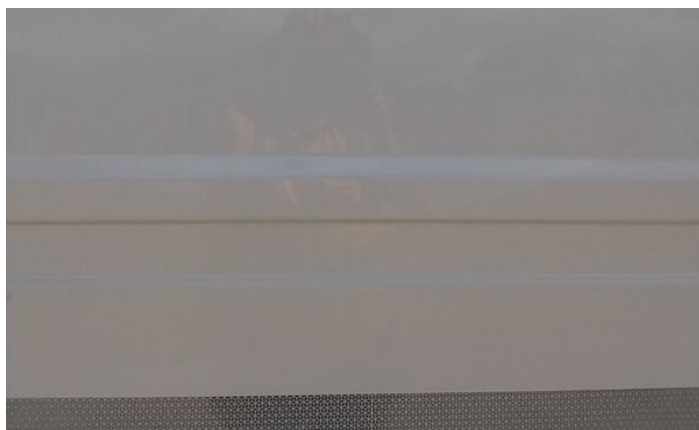
12: Qtr Panel osr  
Dented  
Between 10mm + 30mm

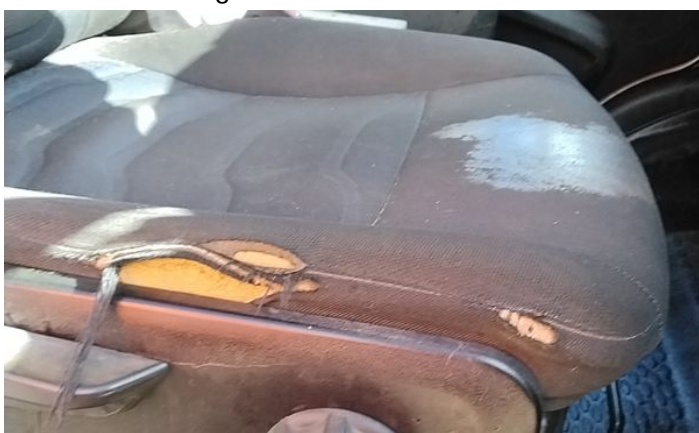
13: Seat Base Cover osf  
Holed  
Over 3mm
