# VEHICLE INSPECTION REPORT

**AV70VPY**

## Fuso Canter 7C18

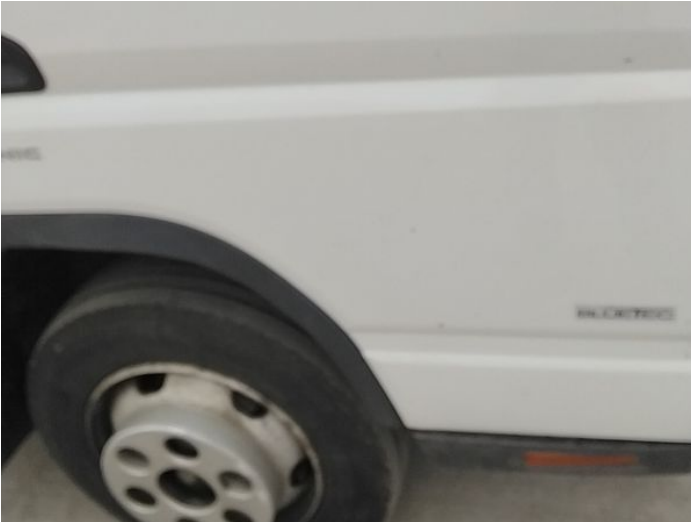
1: Door osf  
Chipped  
Multiple Chips

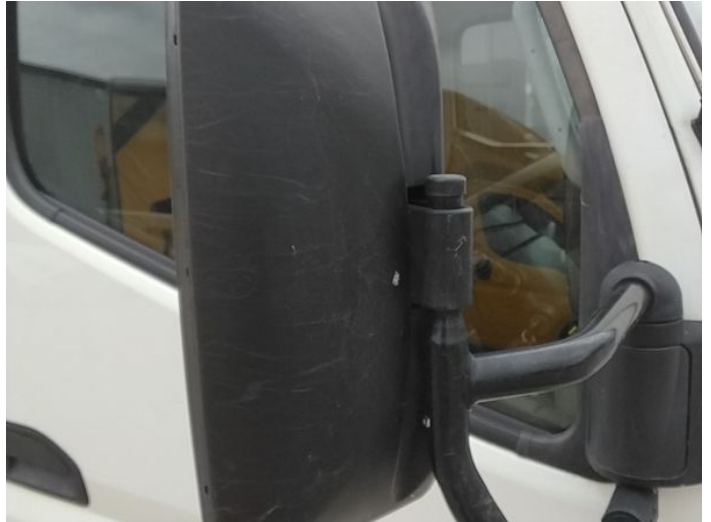
2: Door Mirror Assy osf  
Scuffed (Unpainted)  
Over 100mm

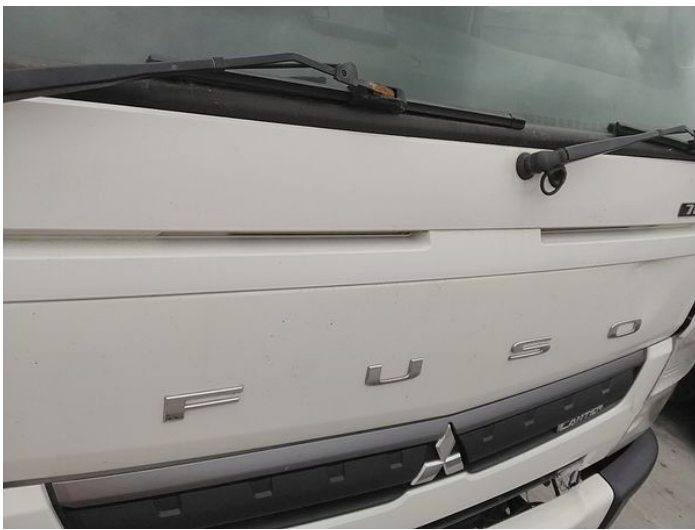
3: Bonnet  
Chipped  
Multiple Chips

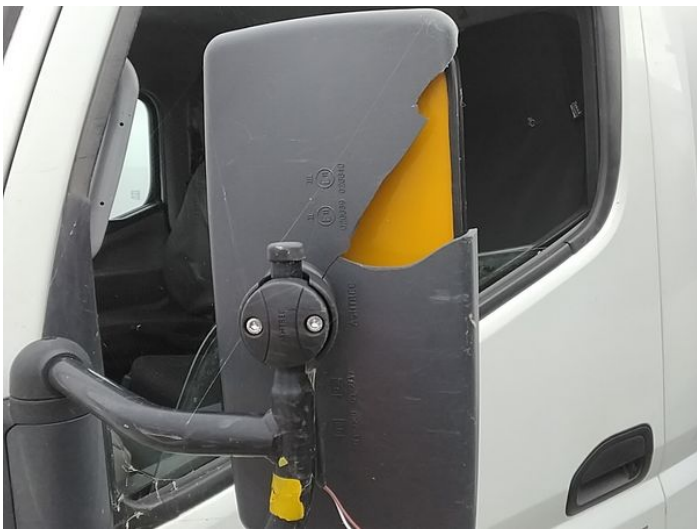
4: Door Mirror Assy nsf  
Broken  
Replace

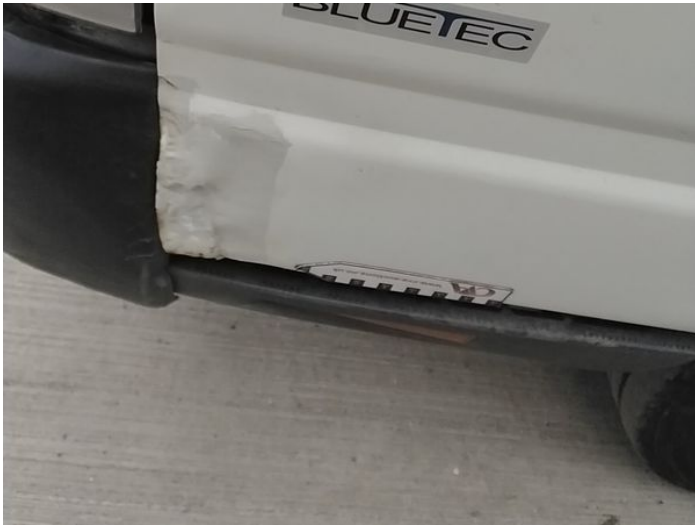
5: Door nsf  
Dented  
With Paint Damage

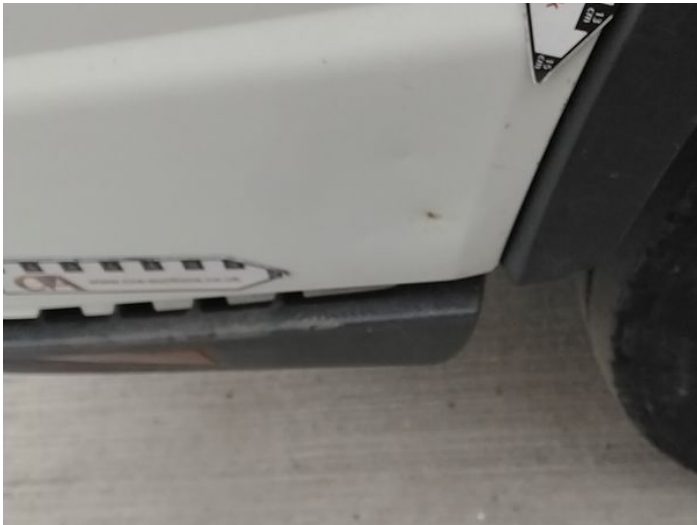
6: Door nsf  
Dented  
With Paint Damage

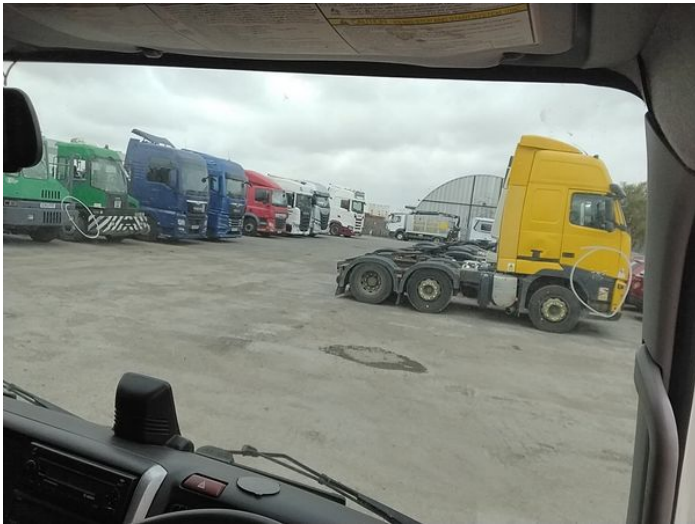
7: Screen Front  
Cracked  
Replace

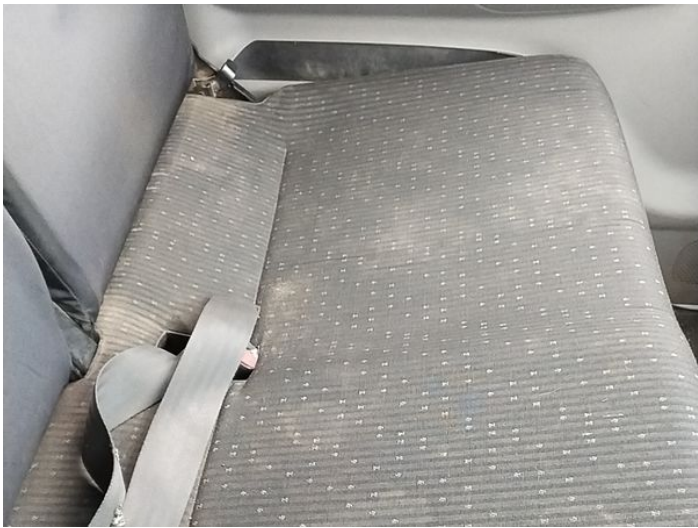
9: Seat Base Cover nsf  
Soiled  
Heavy

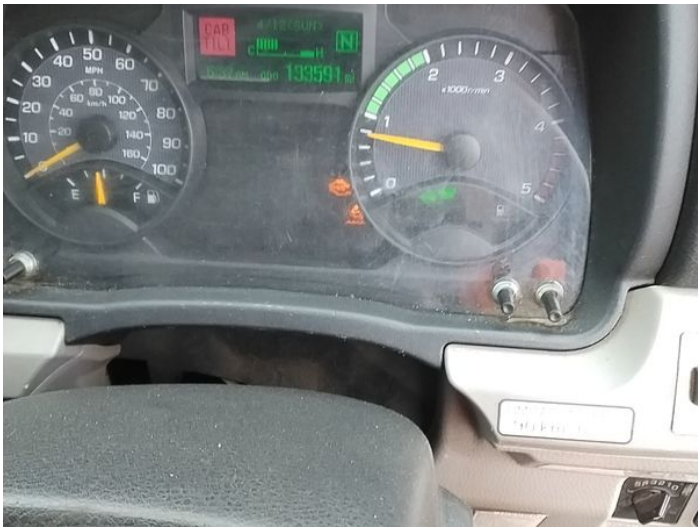
\*WARNING LIGHTS ON DASH, VENDOR STATES GEAR BOX NEEDS FUSHING\* INSURANCE LOSS MAY OR MAY NOT APPEAR ON VCAR

10: Dash Warning Lights  
Displayed  
No Action
