## VEHICLE INSPECTION REPORT

**GK19AWU**

### Man TGS 24.460

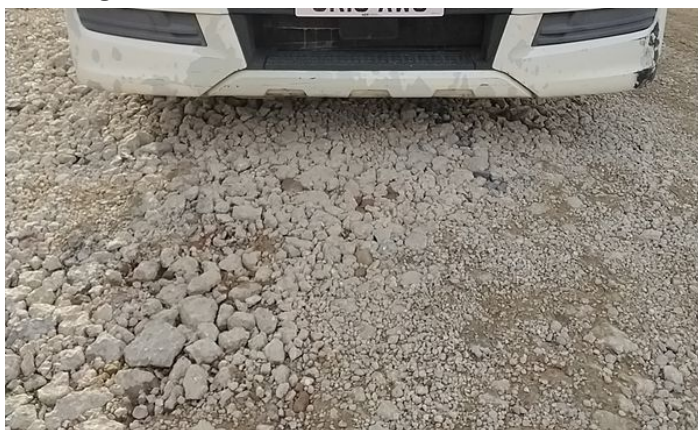
1: Bumper Front  
Scratched  
Over 100mm Thru Paint

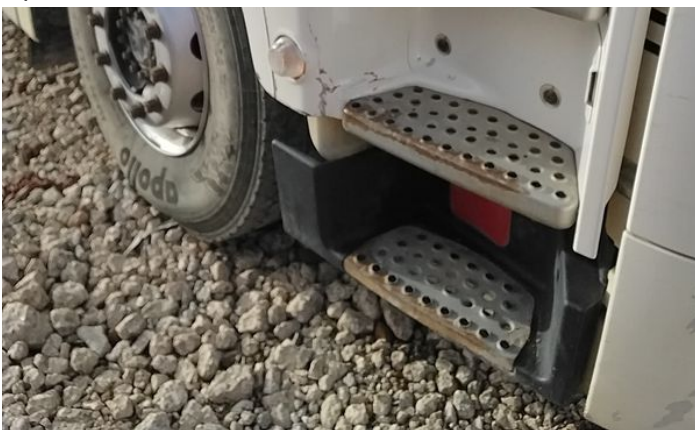
6: Wing Front Arch Extension ns  
Scratched (Painted)  
Over 25mm Thru Paint

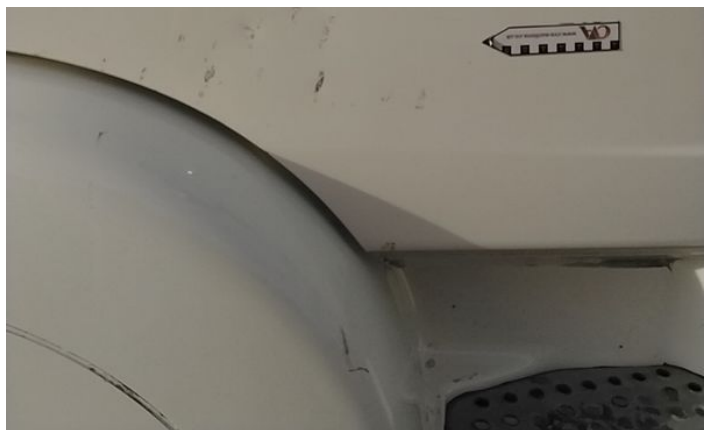
7: Wing Front Arch Extension os  
Broken  
Replace

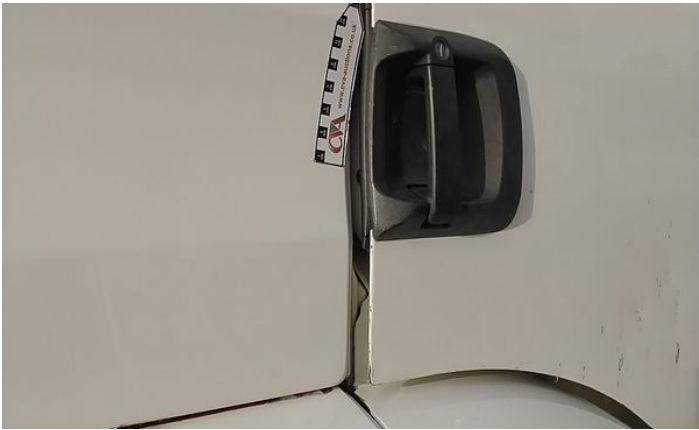
9: Door osf  
Chipped  
Edge Chip

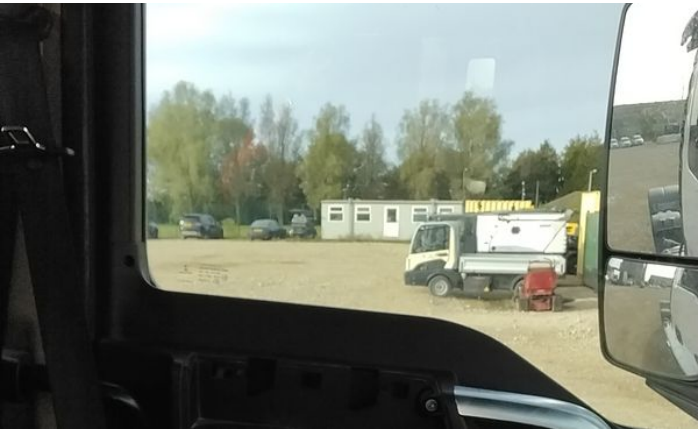
10: Door Pad nsf  
Missing  
Replace

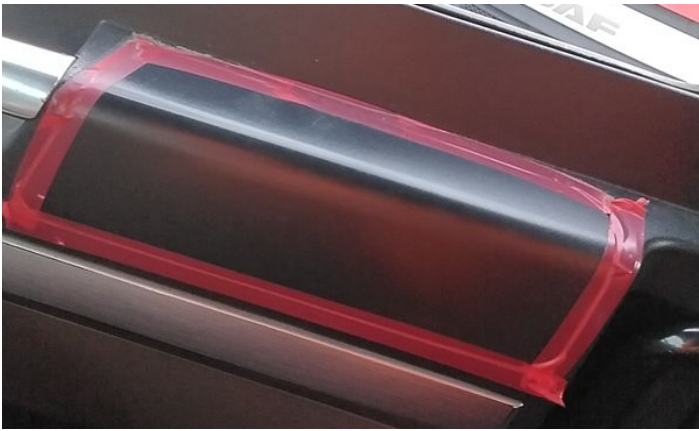
11: Door Pad osf  
Broken  
Replace
