# VEHICLE INSPECTION REPORT

**GL19FXA**

## Volvo FM 460

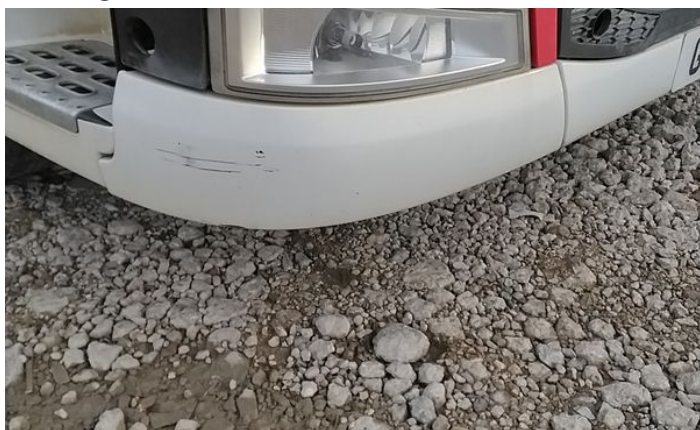
1: Bumper Front  
Scratched  
25 to 100mm Thru Paint

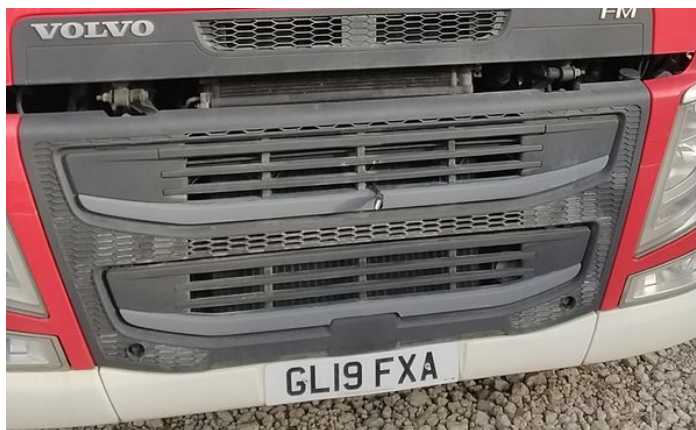
2: Bonnet  
Chipped  
Multiple Chips

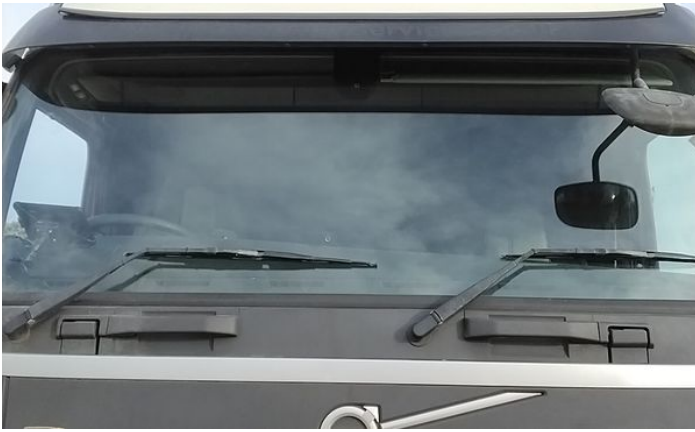
3: Screen Front  
Chipped  
UpTo 10mm

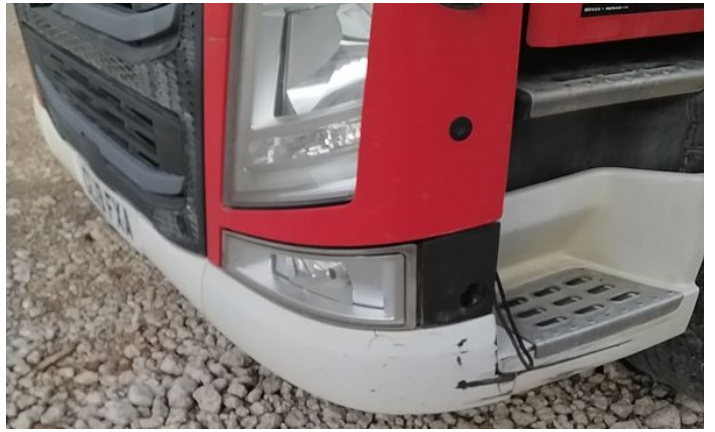
4: Bumper Front  
Scratched  
25 to 100mm Thru Paint

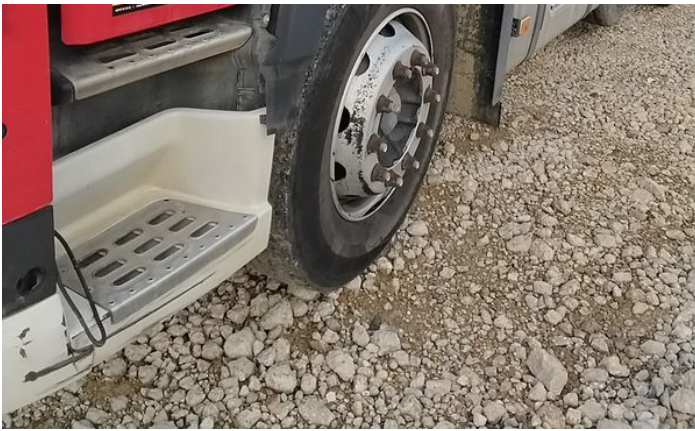
5: Wing Front Arch Extension ns  
Broken  
Replace

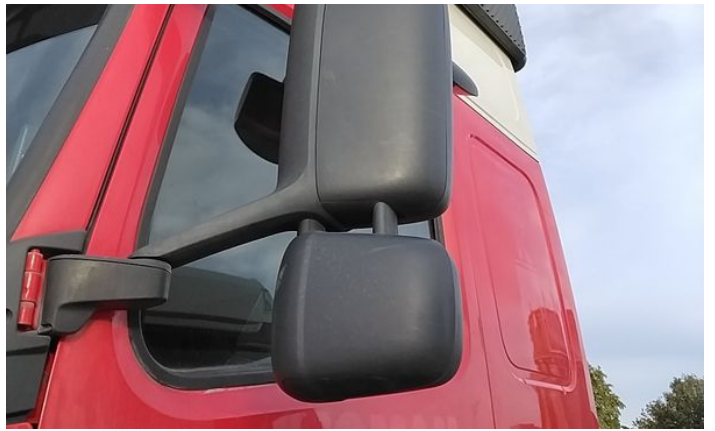
6: Door Mirror Assy nsf  
Scuffed (Unpainted)  
UpTo 100mm

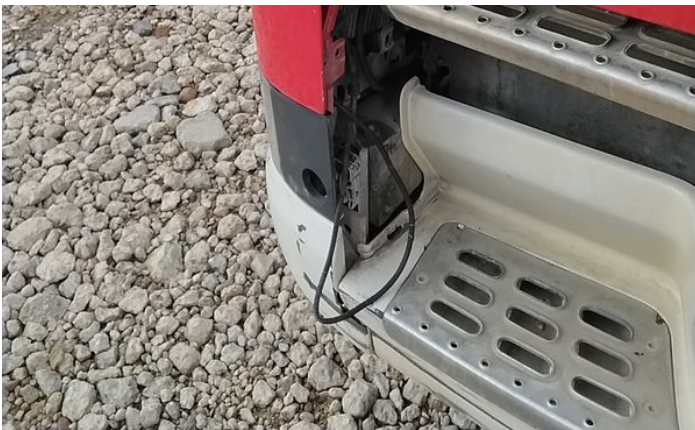
7: Wing nsf  
Missing  
Replace

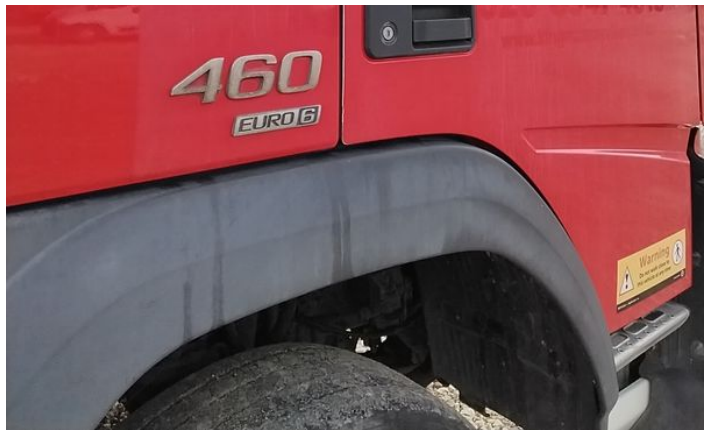
8: Door osf  
Chipped  
Edge Chip
