# VEHICLE INSPECTION REPORT

**GL19FXB**

## Volvo FM 460

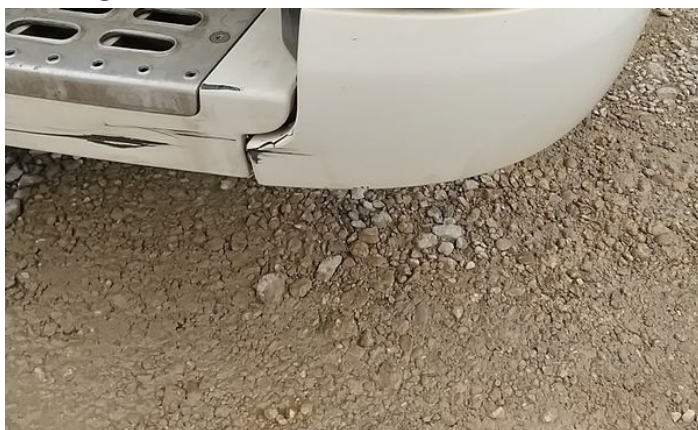
1: Bumper Front  
Cracked  
UpTo 25mm

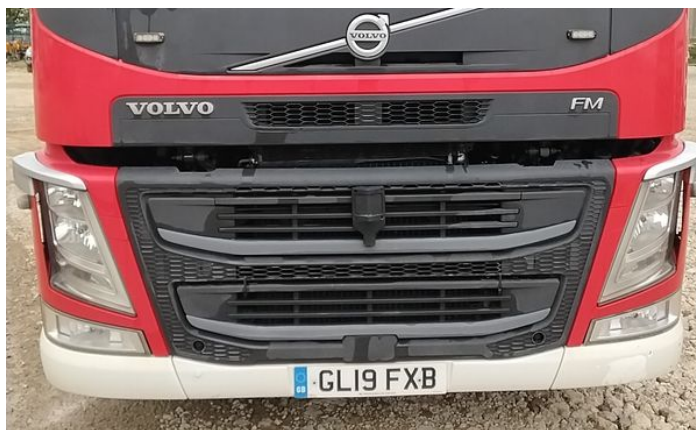
2: Bonnet  
Chipped  
Multiple Chips

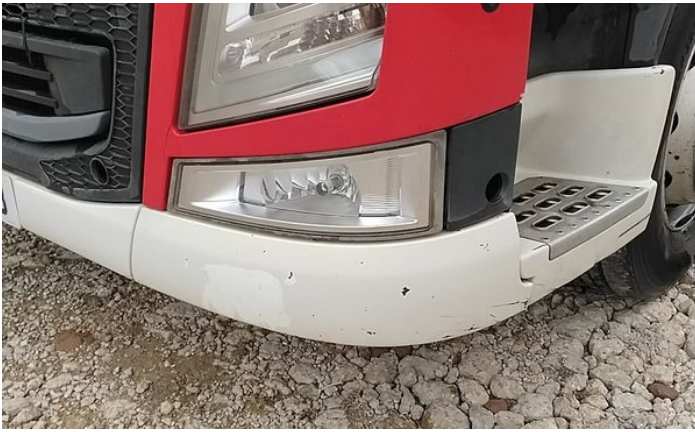
3: Bumper Front  
Scratched  
25 to 100mm Thru Paint

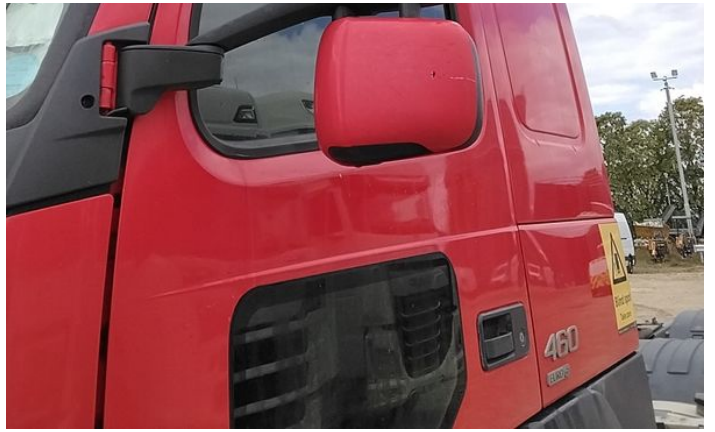
4: Door Mirror Assy nsf  
Scratched (Painted)  
UpTo 25mm Thru Paint

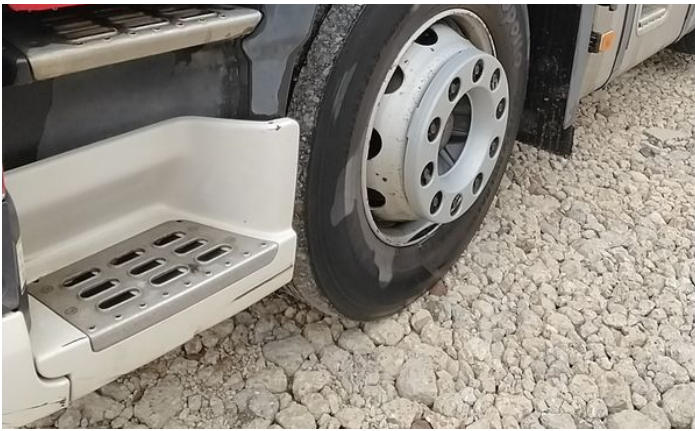
5: Wing Front Arch Extension ns  
Scratched (Painted)  
Over 25mm Thru Paint

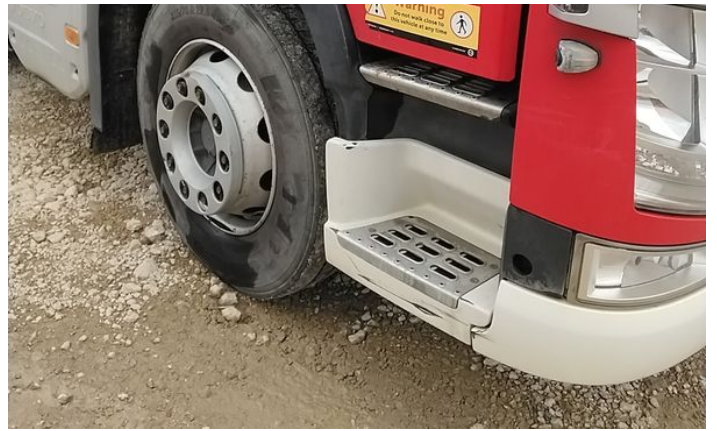
6: Wing Front Arch Extension os  
Scratched (Painted)  
Over 25mm Thru Paint

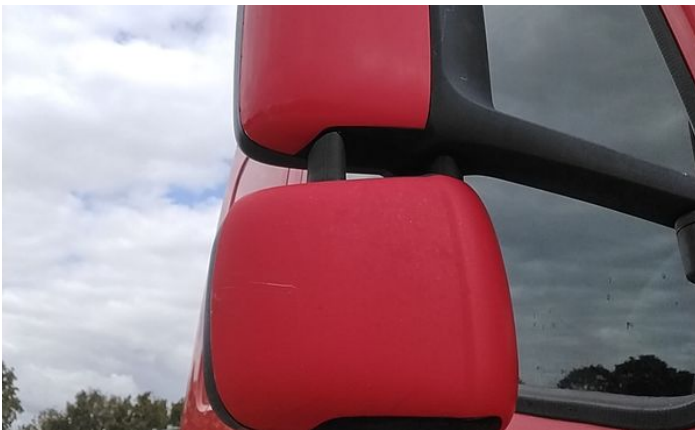
7: Door Mirror Assy osf  
Scratched (Painted)  
UpTo 25mm Thru Paint
