# VEHICLE INSPECTION REPORT

**HK17XXU**

## Daf LF 230

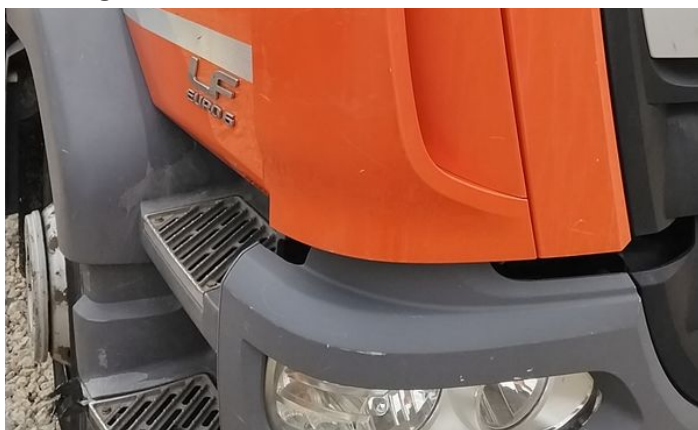
1: Wing osf  
Scratched  
UpTo 25mm Thru Paint

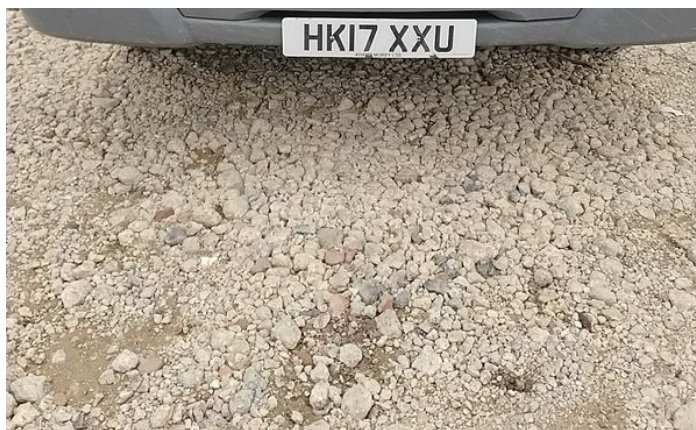
2: Bumper Front  
Scratched  
Over 100mm Thru Paint

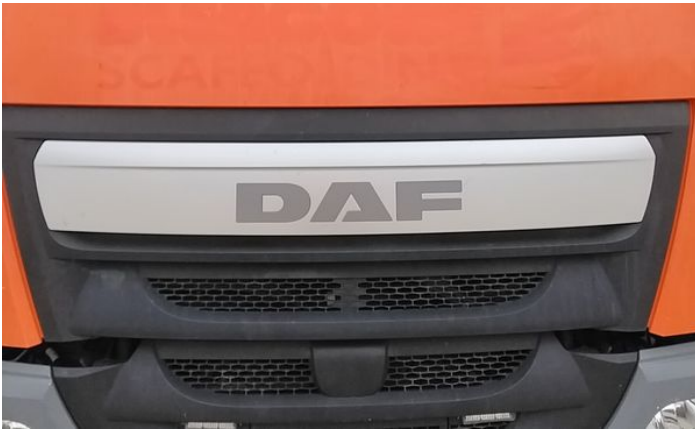
3: Bonnet  
Chipped  
Multiple Chips

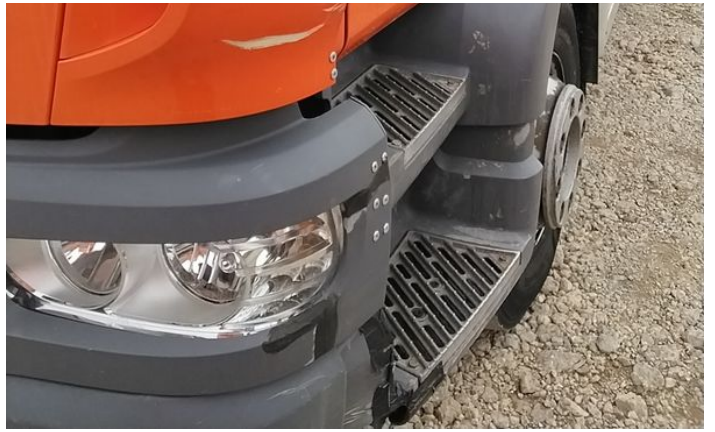
4: Wing nsf  
Scratched  
Over 25mm Thru Paint

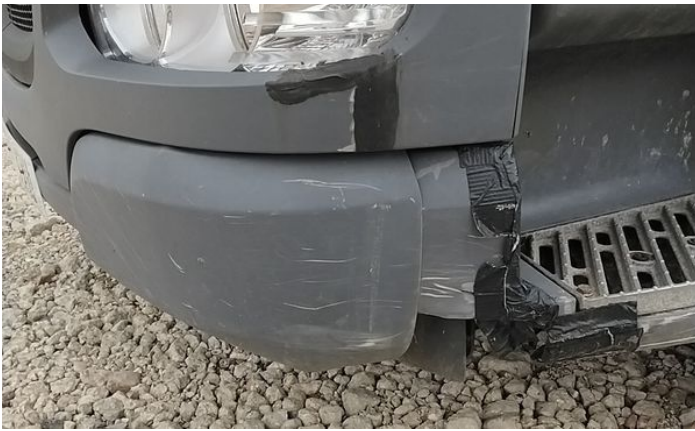
5: Bumper Front  
Dented  
With Paint Damage

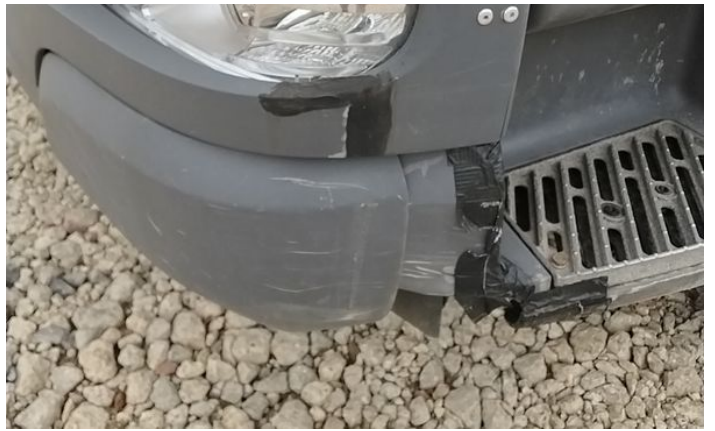
6: Fog Lamp Surround ns  
Broken  
Replace

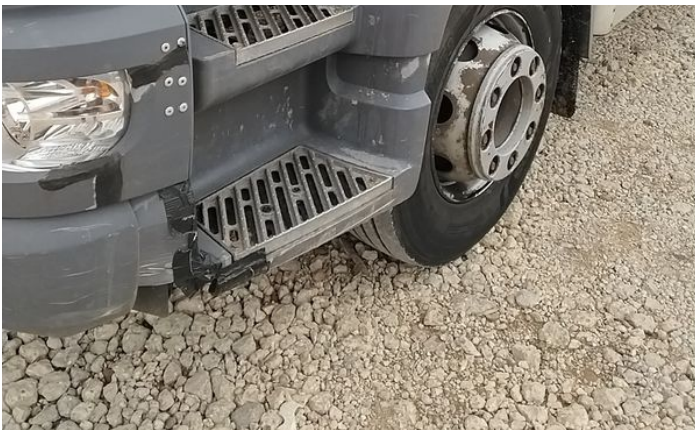
7: Wing Front Arch Extension ns  
Broken  
Replace

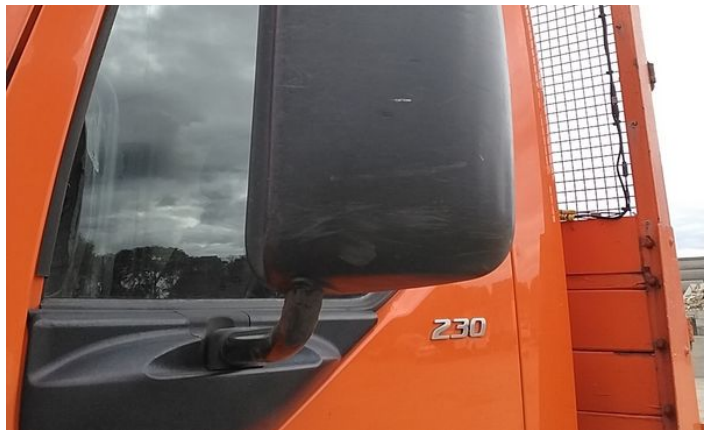
8: Door Mirror Assy nsf  
Scuffed (Unpainted)  
Over 100mm

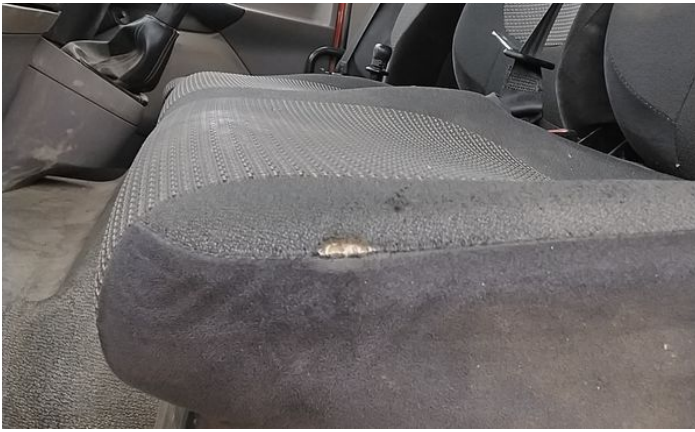
9: Seat Base Cover nsf  
Holed  
Over 3mm

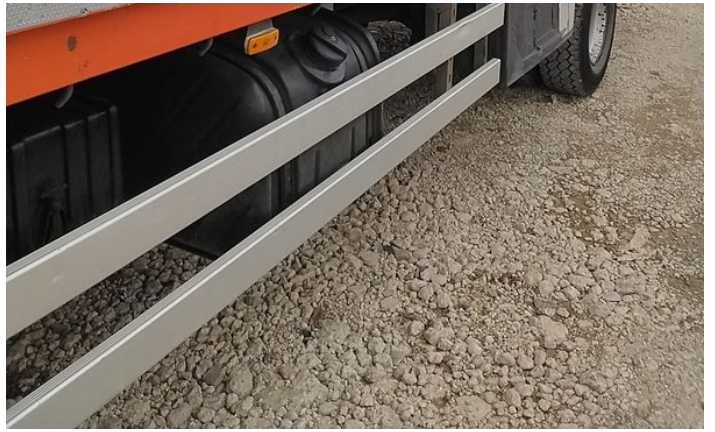
10: Qtr Panel nsr  
Scratched  
Over 25mm Thru Paint

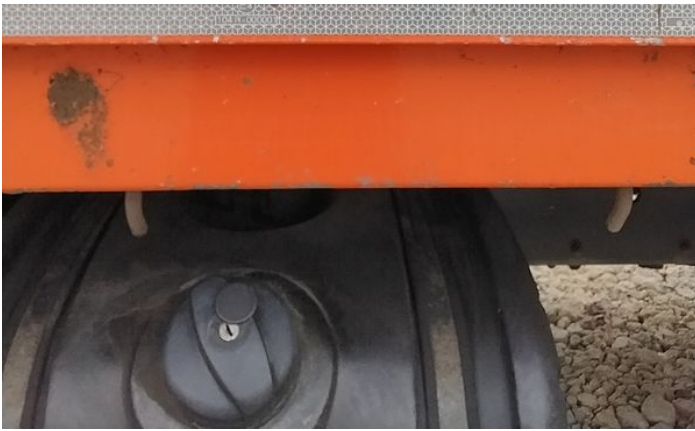
11: Qtr Panel nsr  
Hole  
Over 10mm

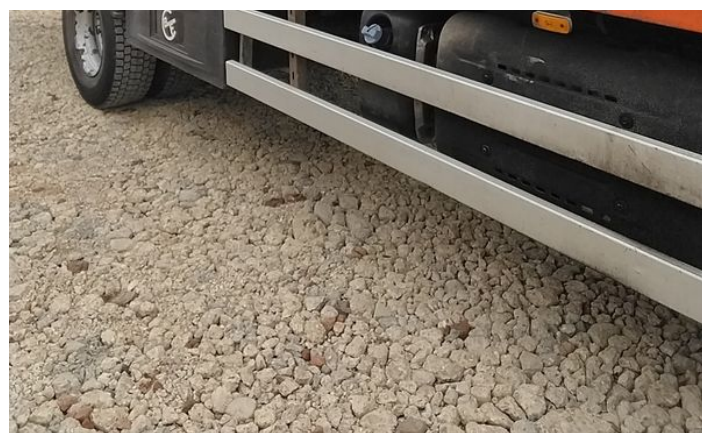
13: Qtr Panel osr  
Scratched  
Over 25mm Thru Paint

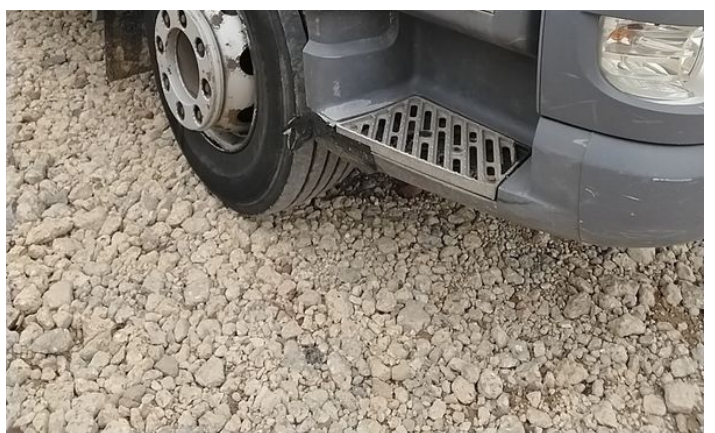
14: Wing Front Arch Extension os  
Broken  
Replace

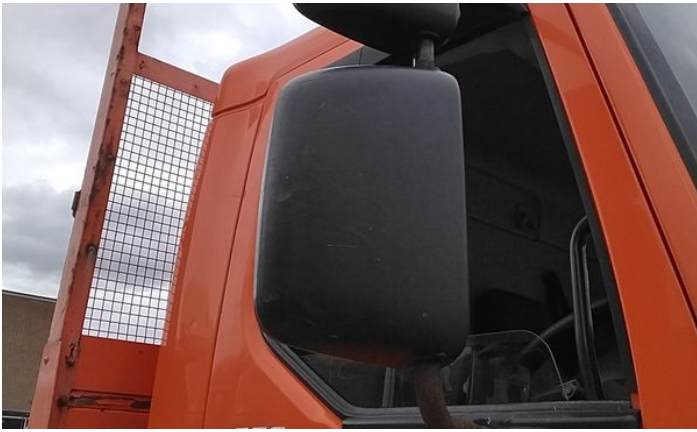
15: Door Mirror Assy osf  
Scuffed (Unpainted)  
Over 100mm

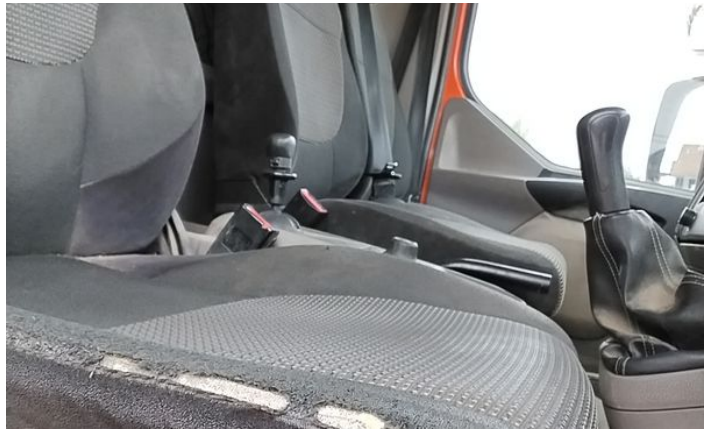
16: Seat Base Cover osf  
Holed  
Over 3mm
