# VEHICLE INSPECTION REPORT

**HN67NVG**

## Daf LF 230

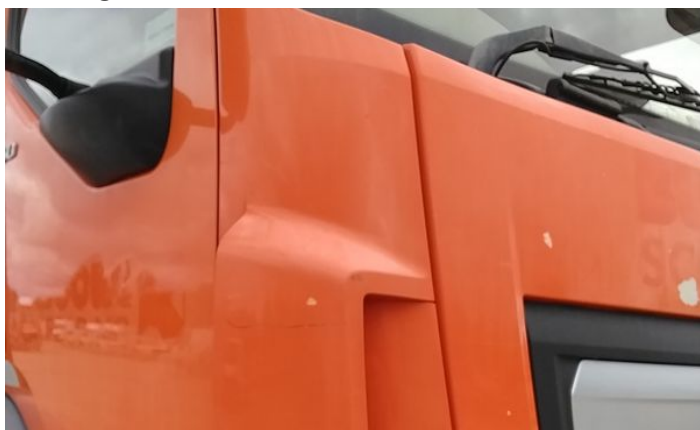
1: Wing osf  
Scratched  
Over 25mm Thru Paint

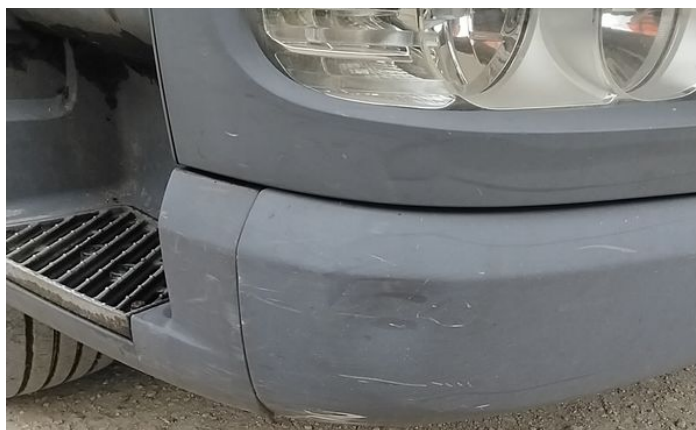
2: Bumper Front  
Dented  
With Paint Damage

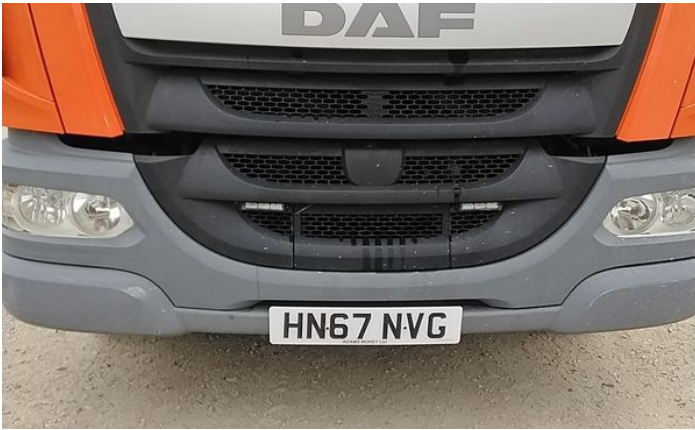
3: Bumper Front  
Scratched  
Over 100mm Thru Paint

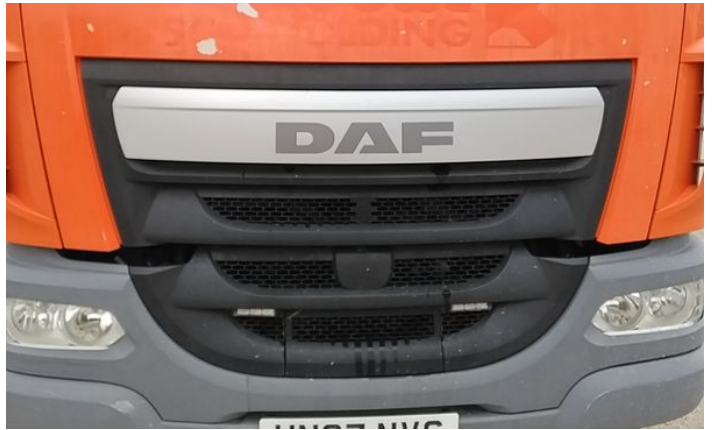
4: Bonnet  
Scratched  
Over 25mm Thru Paint

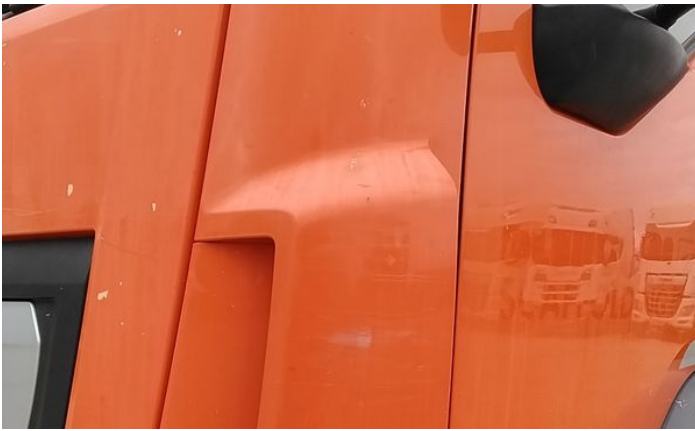
5: Wing nsf  
Scratched  
UpTo 25mm Thru Paint

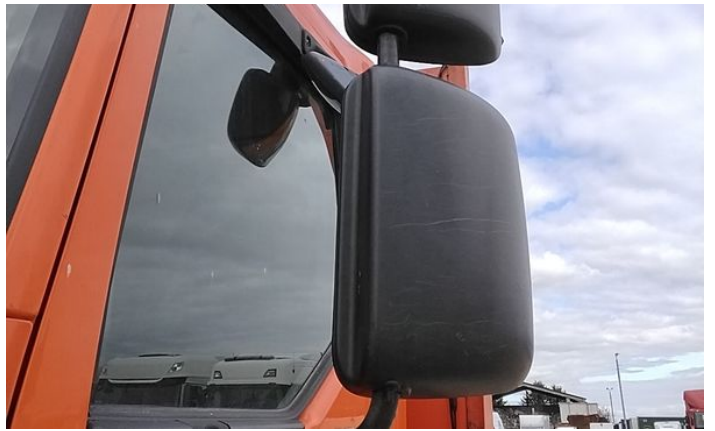
6: Door Mirror Assy nsf  
Scuffed (Unpainted)  
Over 100mm

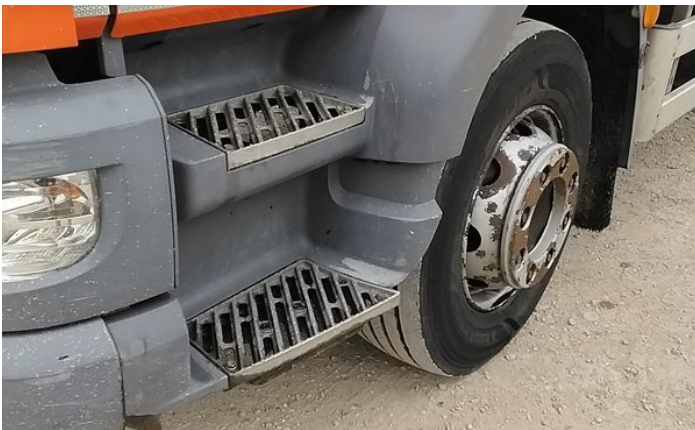
7: Wing Front Arch Extension ns  
Broken  
Replace

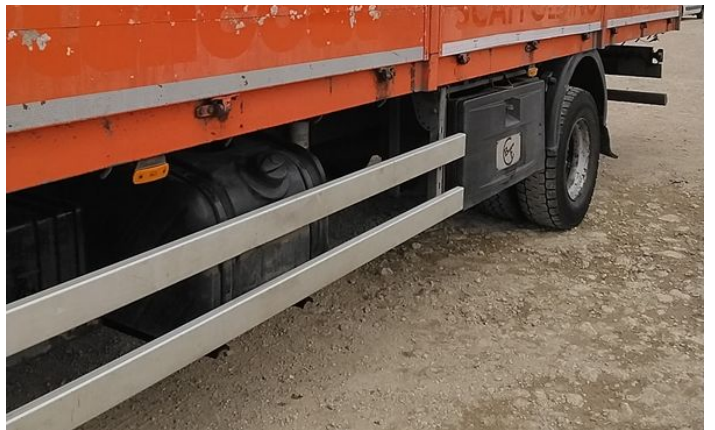
8: Qtr Panel nsr  
Scratched  
Over 25mm Thru Paint

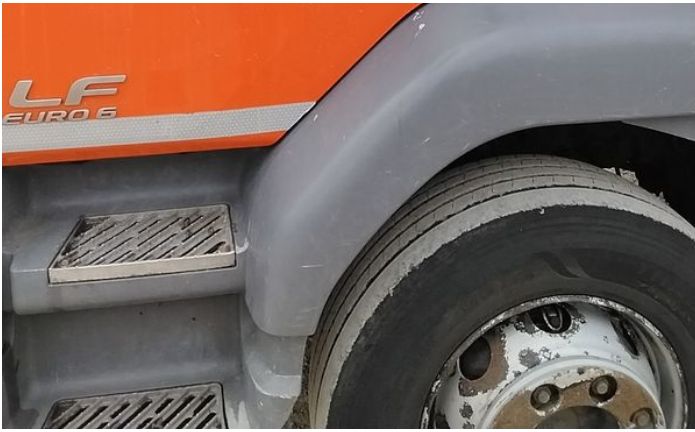
9: Door nsf  
Scratched  
Over 25mm Thru Paint

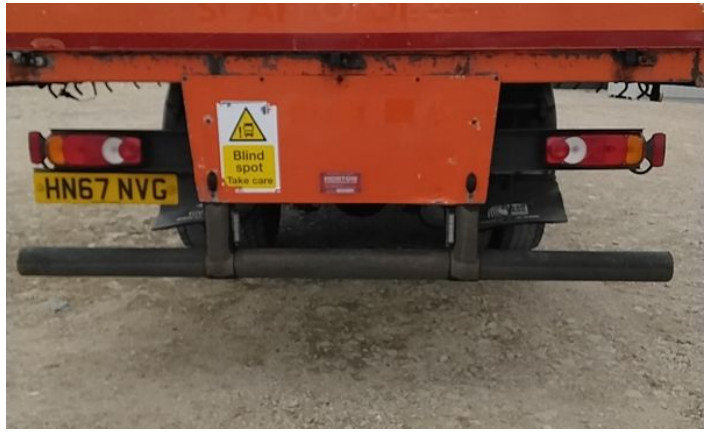
10: Bumper Rear  
Rusted  
Over 5mm

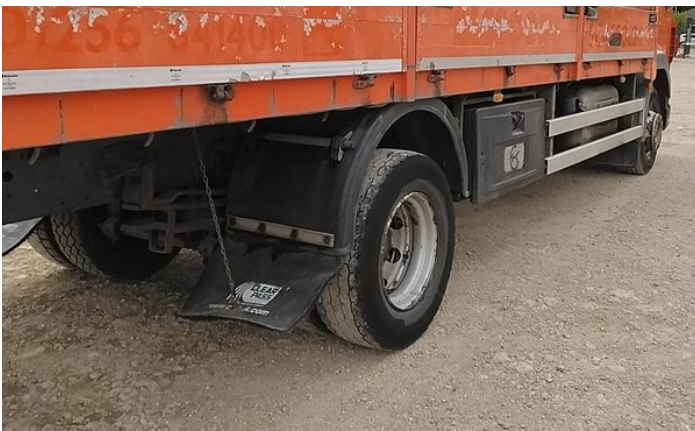
11: Qtr Panel osr  
Scratched  
Over 25mm Thru Paint

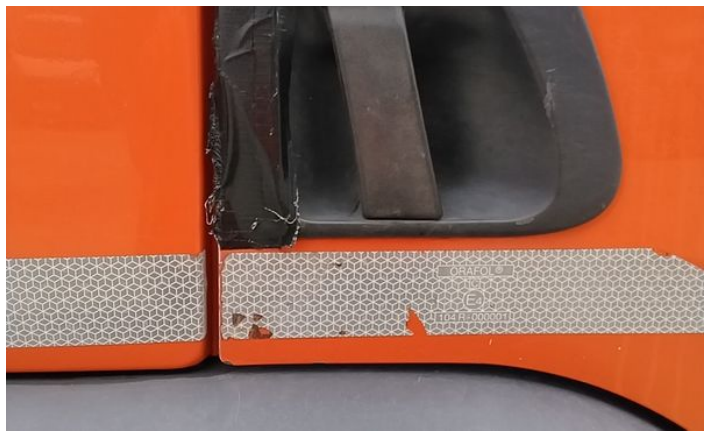
12: Handle Outer osf  
Broken  
Replace

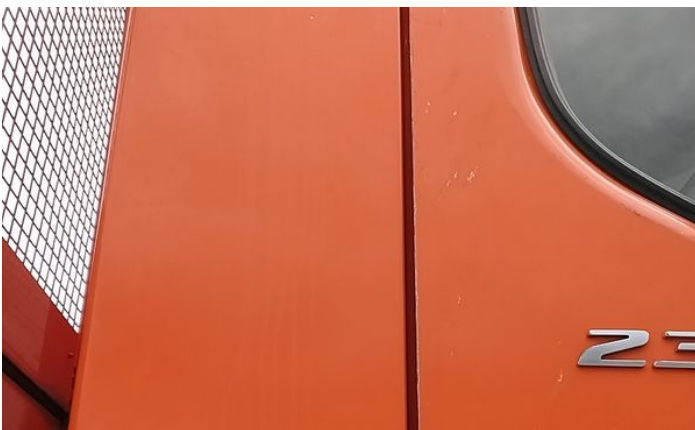
13: Door osf  
Chipped  
Edge Chip

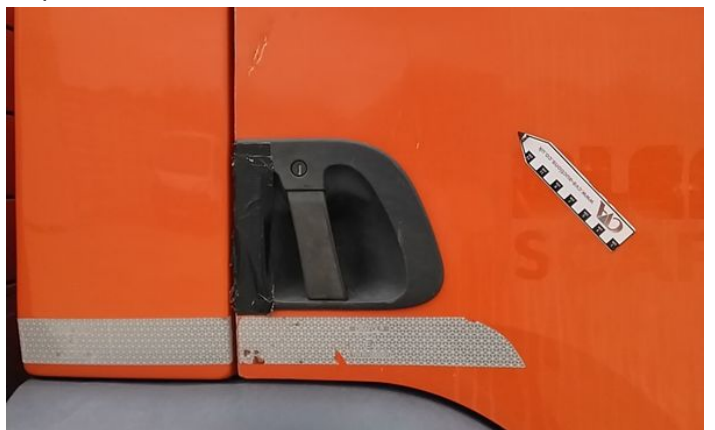
14: Door osf  
Scratched  
Over 25mm Thru Paint

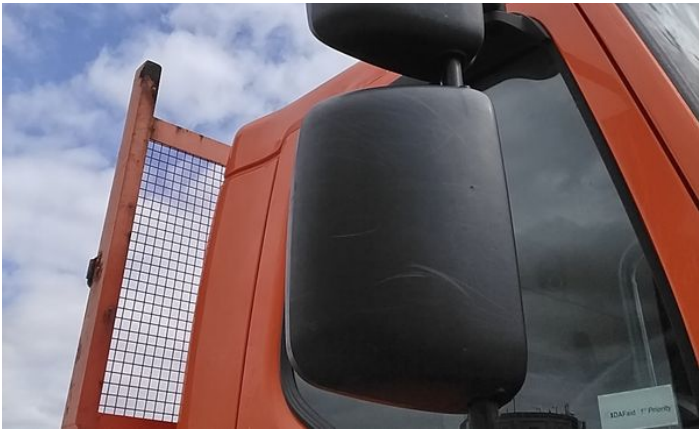
15: Door Mirror Assy osf  
Scuffed (Unpainted)  
Over 100mm

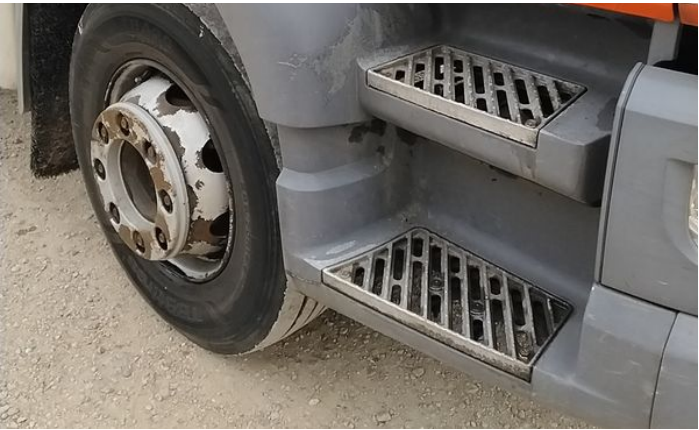
16: Wing Front Arch Extension os  
Scuffed (Unpainted)  
Over 100mm
