# VEHICLE INSPECTION REPORT

**FP70GJZ**

## Daf CF 430

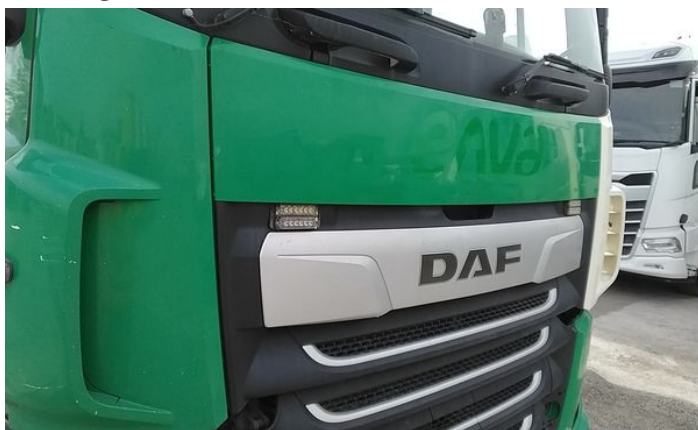
1: Bonnet  
Chipped  
Multiple Chips

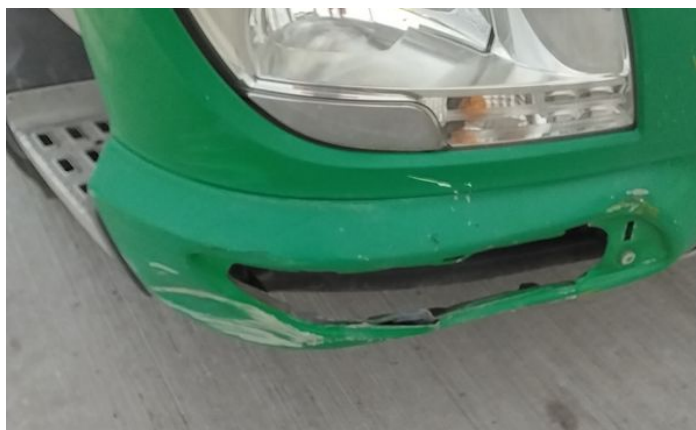
2: Bumper Front  
Dented  
With Paint Damage

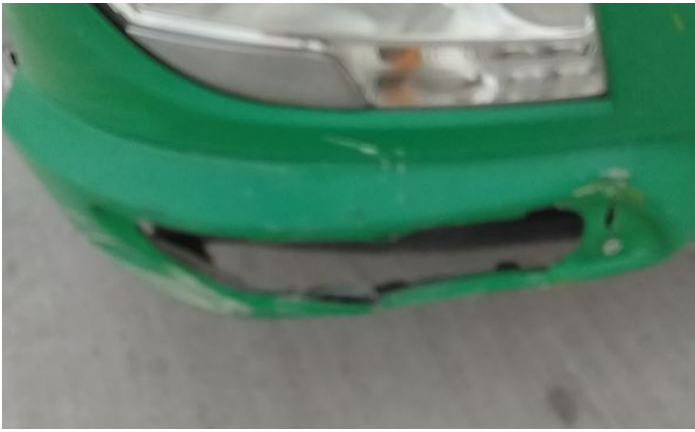
3: Bumper Front Moulding  
Missing  
Replace

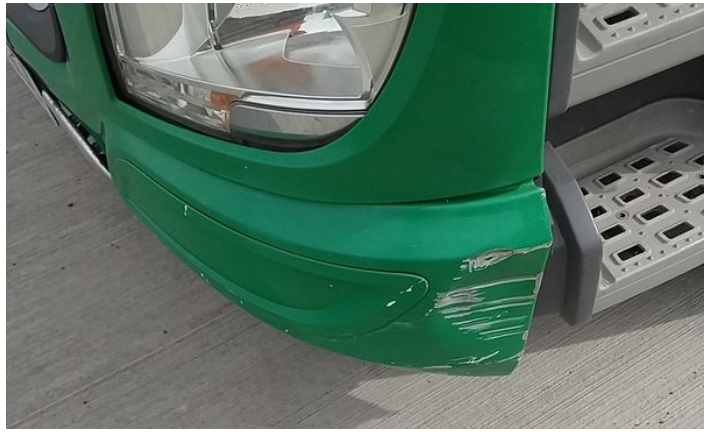
4: Bumper Front  
Dented  
With Paint Damage

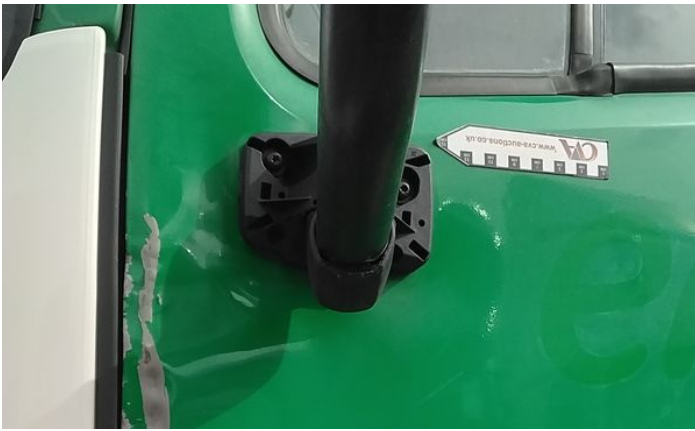
5: Door nsf  
Dented  
With Paint Damage

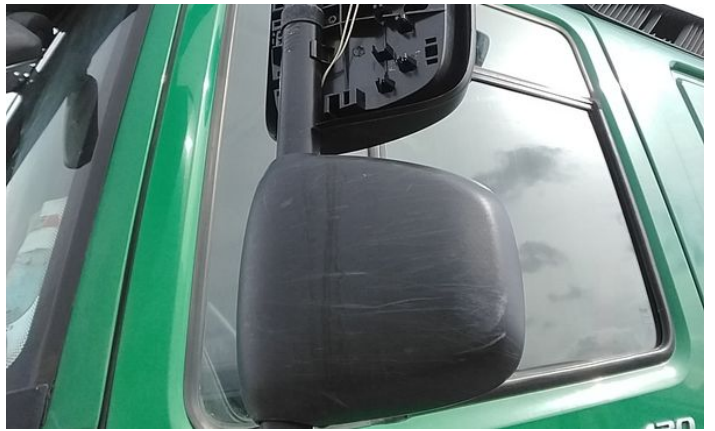
6: Door Mirror Assy nsf  
Broken  
Replace

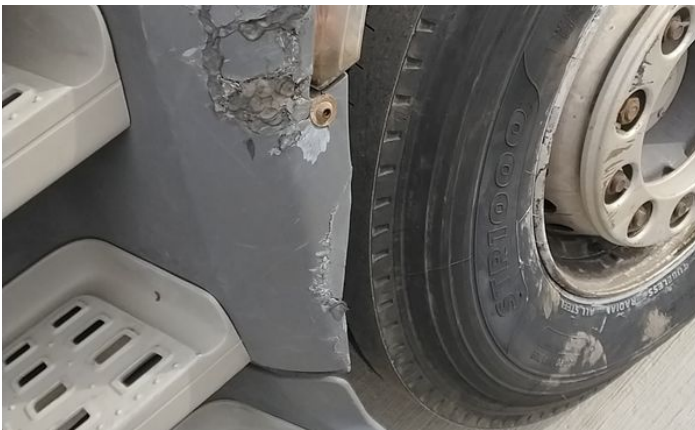
7: Wing nsf  
Poor Previous Repair  
Rippled UpTo 30%

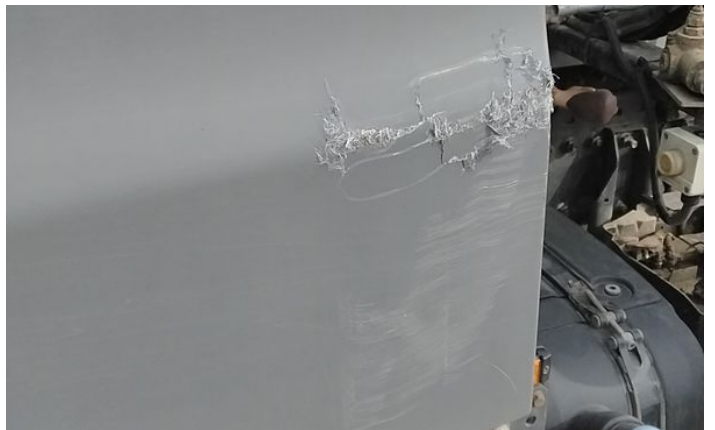
8: Qtr Panel Moulding ns  
Broken  
Replace

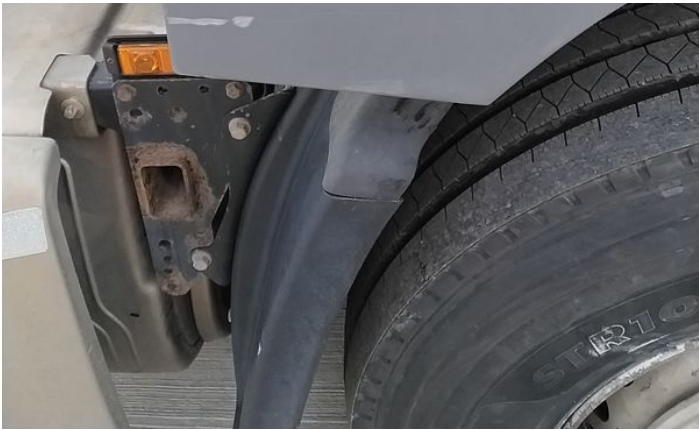
9: Qtr Panel Moulding os  
Scuffed (Unpainted)  
UpTo 100mm

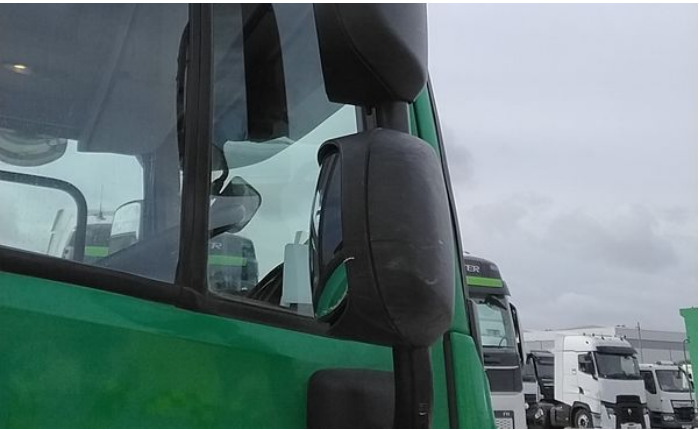
10: Door Mirror Assy osf  
Broken  
Replace

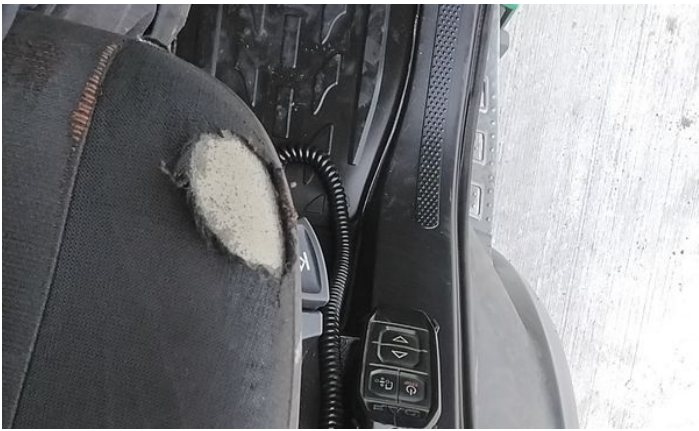
11: Seat Base Cover osf  
Holed  
Over 3mm
