# VEHICLE INSPECTION REPORT

**WD73CBX**

## NISSAN INTERSTAR F35 2.3 dci 135ps

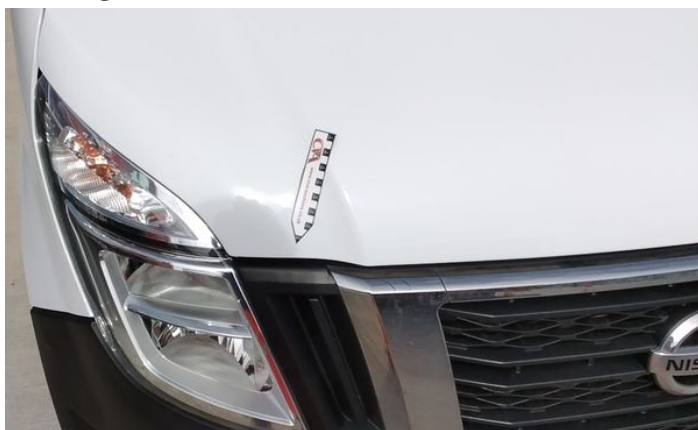
1: Bonnet  
Chipped  
Multiple Chips

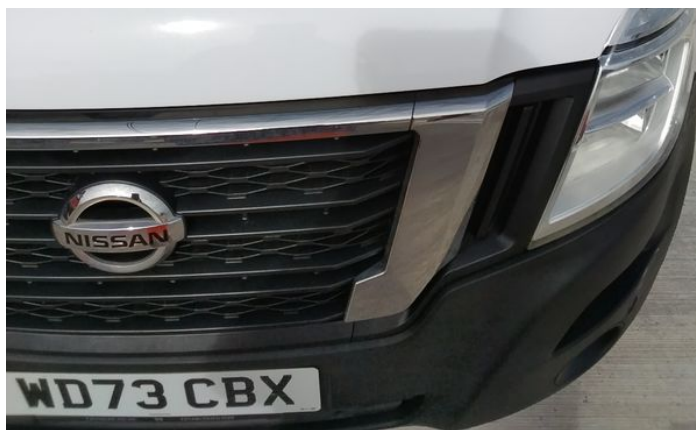
2: Bonnet  
Chipped  
Multiple Chips

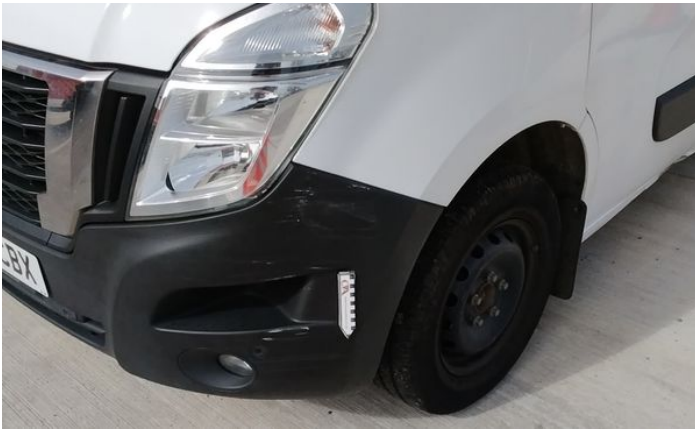
3: Bumper Front  
Scratched  
Over 25mm Not Thru Paint

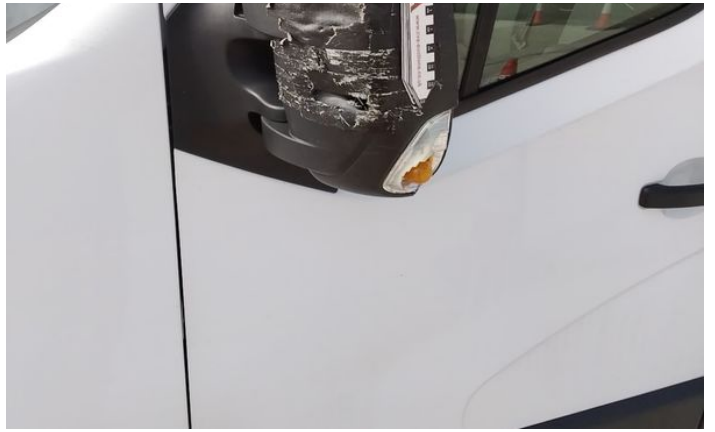
4: Door Mirror Assy nsf  
Broken  
Replace

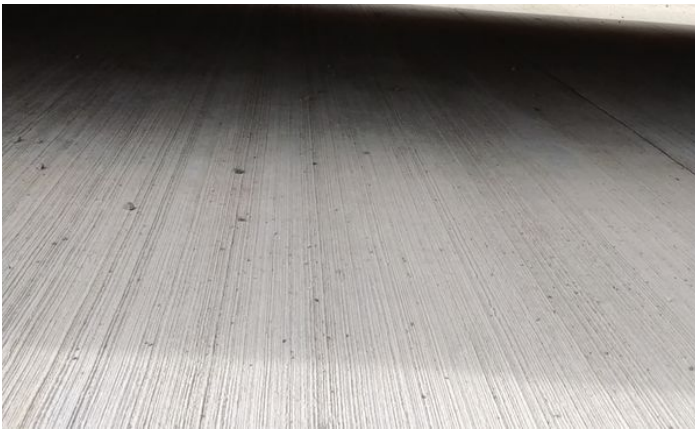
5: Sill ns  
Dented  
Over 30mm

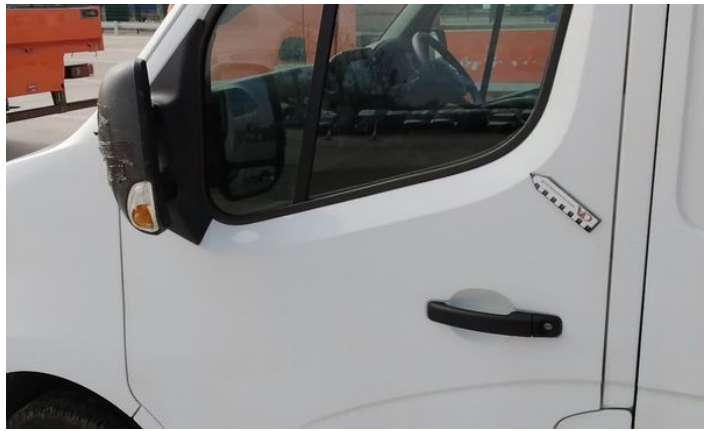
6: Door nsf  
Scratched  
Over 25mm Not Thru Paint

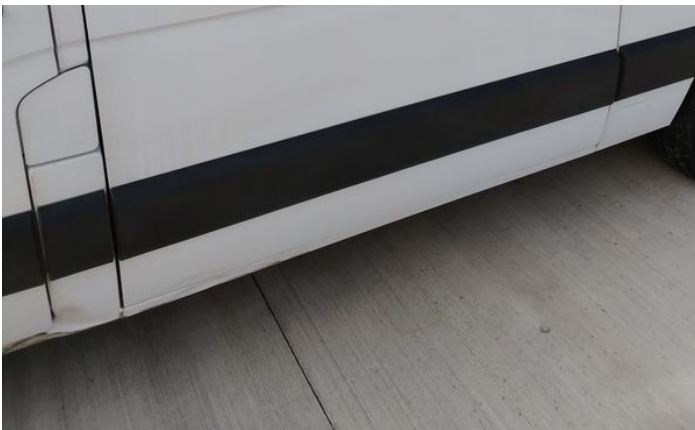
7: Door nsr  
Scratched  
Over 25mm Not Thru Paint

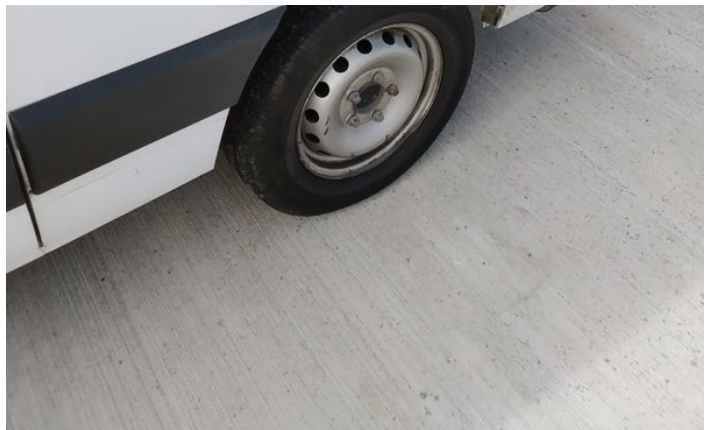
8: Qtr Panel Arch Extension ns  
Scratched (Painted)  
Over 25mm Thru Paint

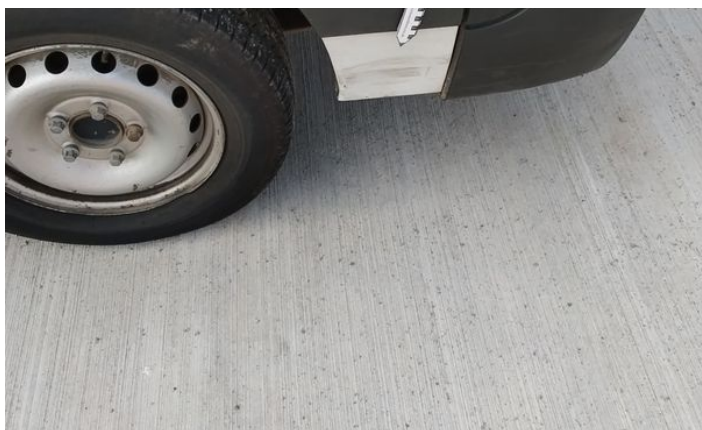
9: Qtr Panel nsr  
Dented  
Over 30mm

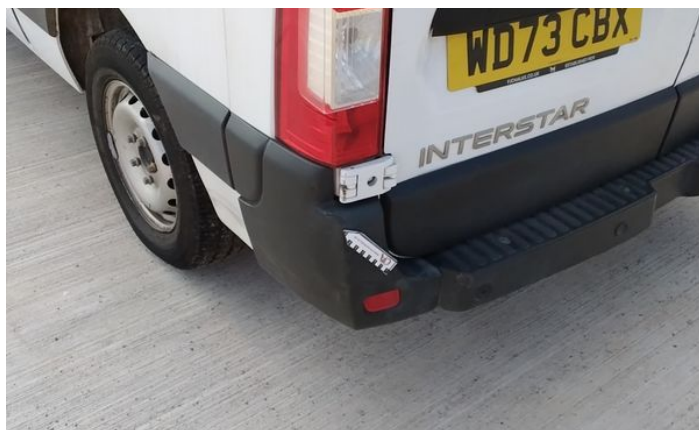
10: Bumper Rear Moulding  
Scuffed (Unpainted)  
Over 100mm

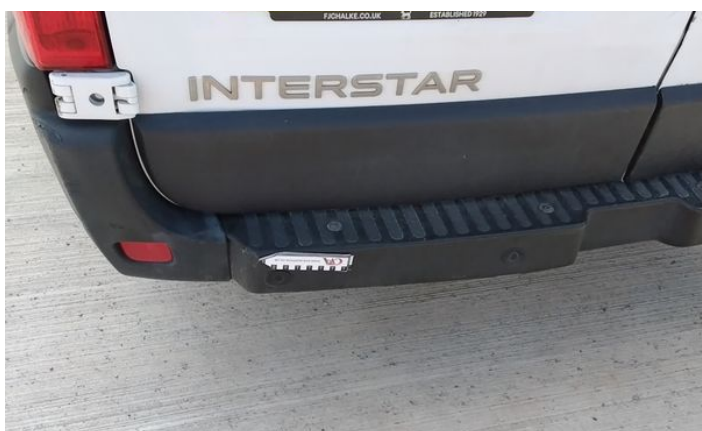
11: Bumper Rear  
Scratched  
Over 25mm Not Thru Paint

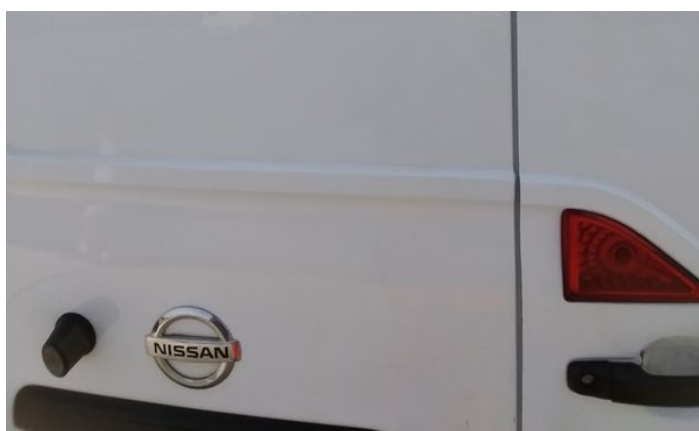
12: Door osr  
Chipped  
Multiple Chips

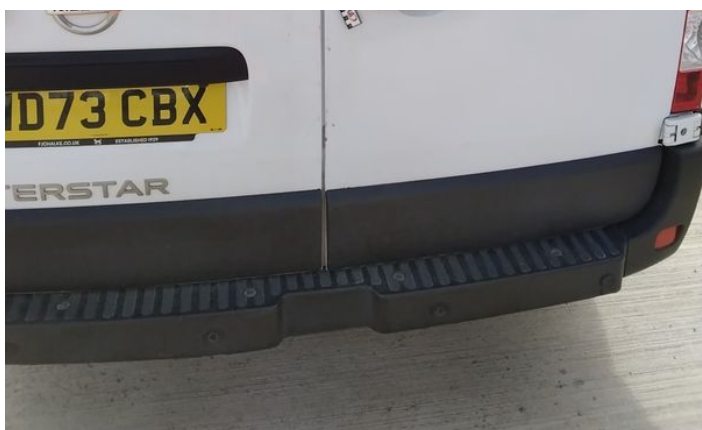
13: Door osr  
Chipped  
Edge Chip

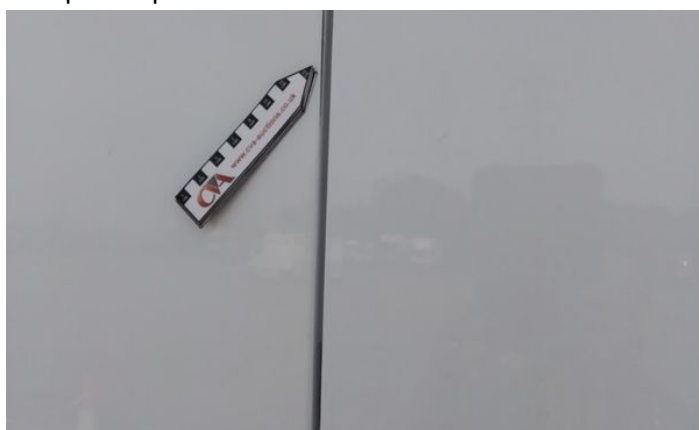
14: Door nsr  
Chipped  
Edge Chip

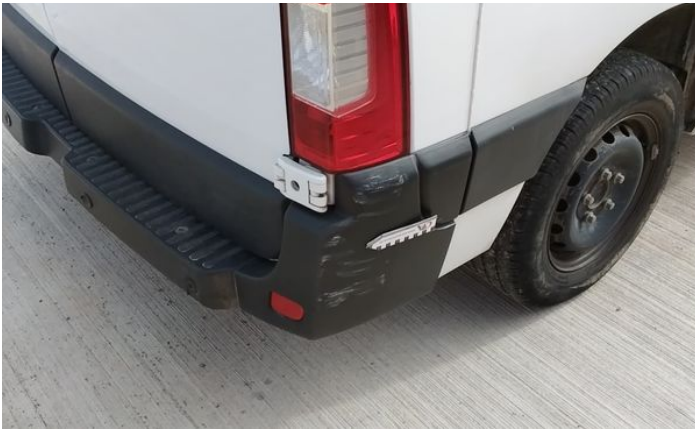
15: Bumper Rear Moulding  
Scuffed (Unpainted)  
Over 100mm

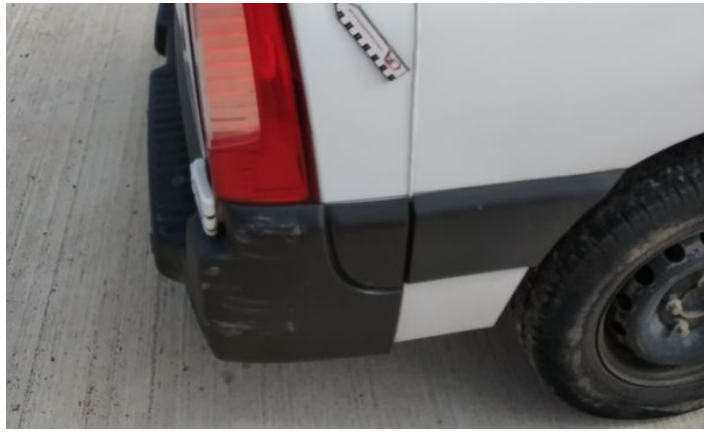
16: Qtr Panel osr  
Dented  
Over 30mm

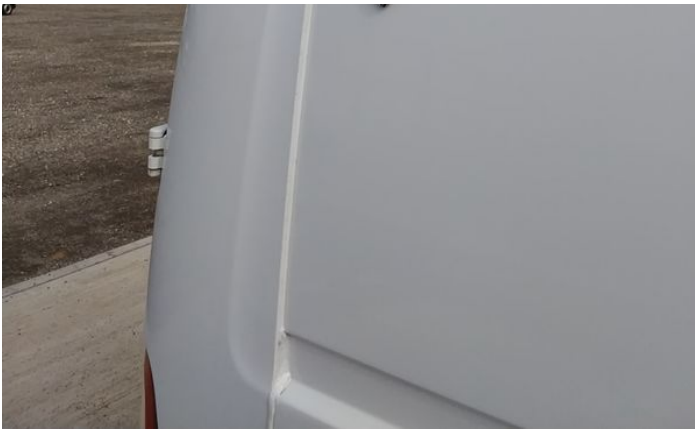
17: Qtr Panel osr  
Chipped  
Over 5mm

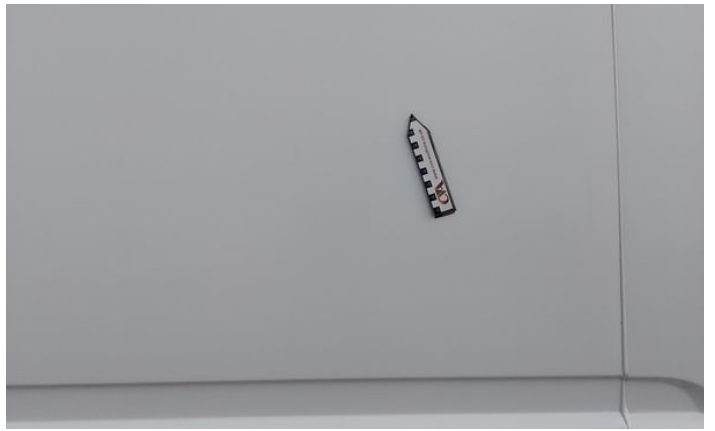
18: Qtr Panel osr  
Scratched  
Over 25mm Not Thru Paint

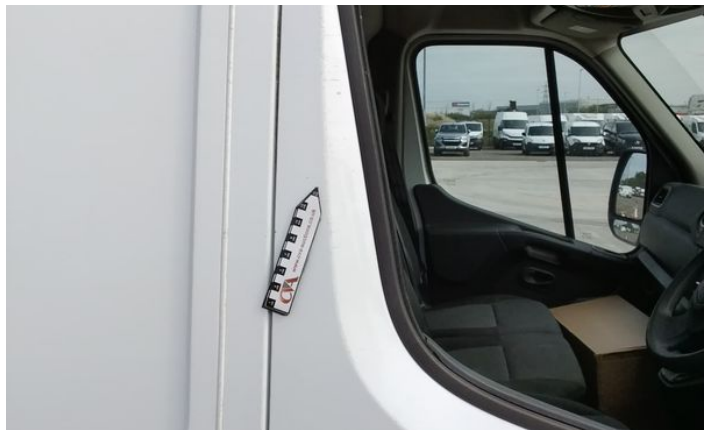
20: Door osf  
Scratched  
Over 25mm Not Thru Paint

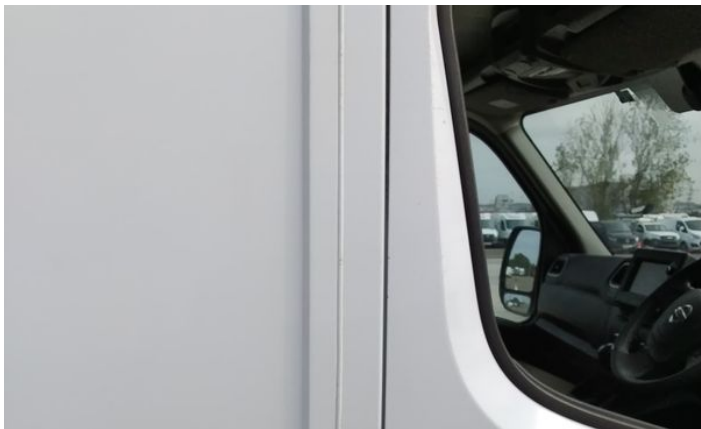
21: Door osf  
Chipped  
Multiple Chips

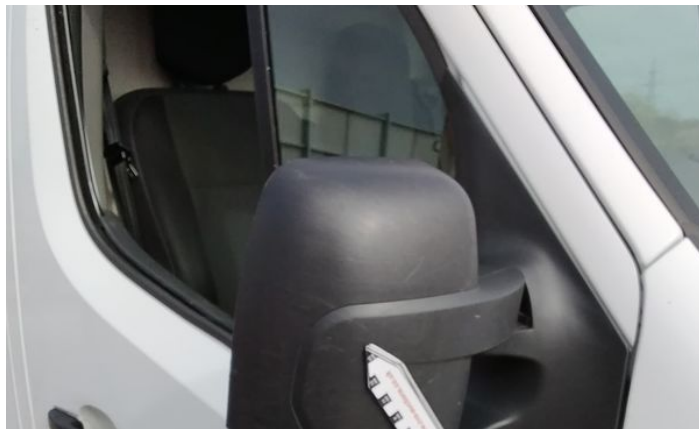
22: Door Mirror Assy osf  
Scuffed (Unpainted)  
Over 100mm

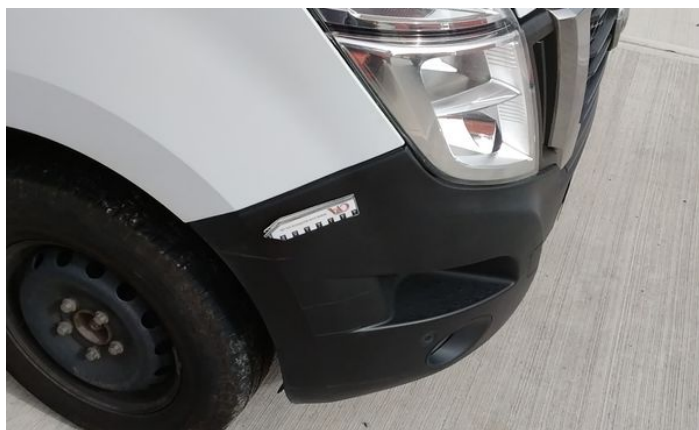
24: Bumper Front Moulding  
Scuffed (Unpainted)  
Over 100mm

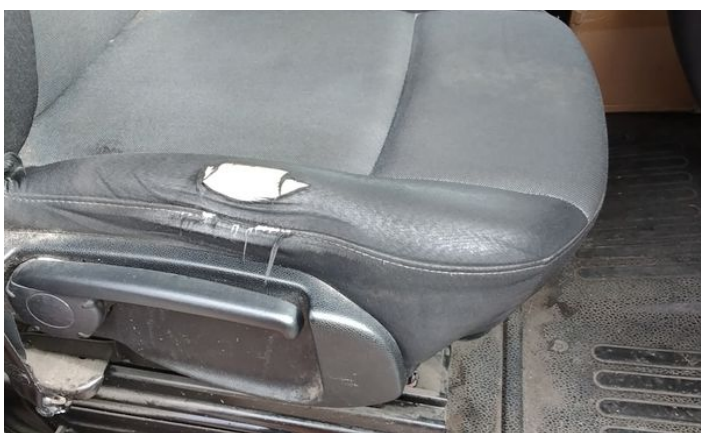
25: Seat Base Cover osf  
Holed  
Over 3mm

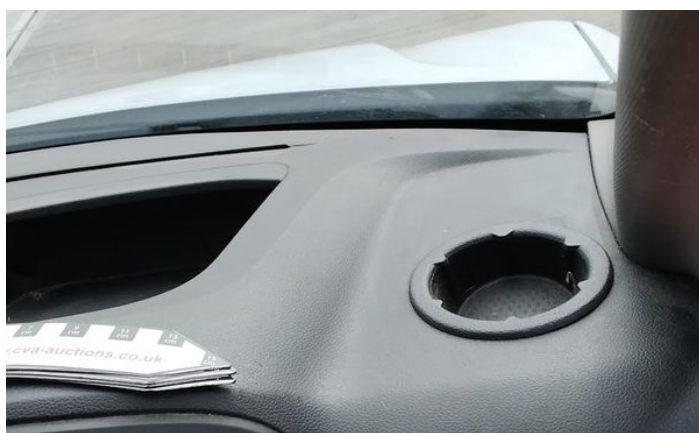
26: Centre Console Front  
Scuffed  
Over 25mm
