# VEHICLE INSPECTION REPORT

**LL18WRJ**

## Toyota Hilux 2.4 D-4D

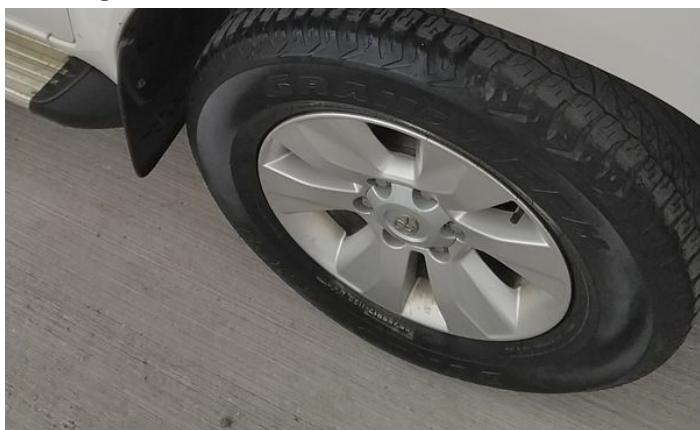
1: Wing osf  
Chipped  
Multiple Chips

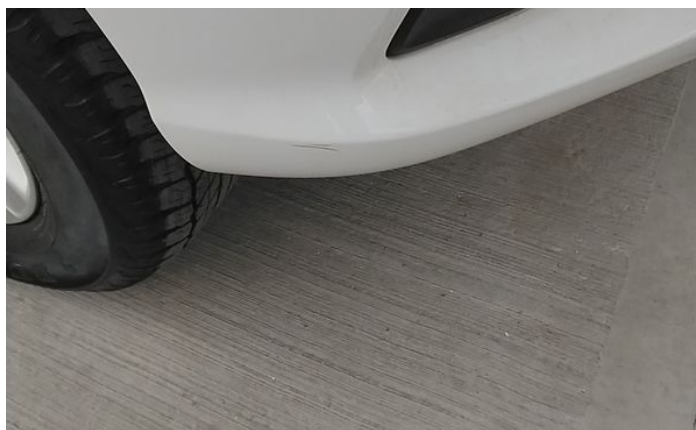
2: Bumper Front  
Scratched  
25 to 100mm Thru Paint

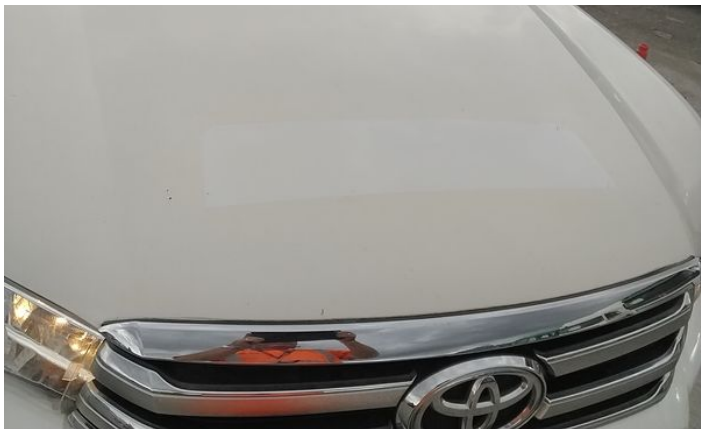
3: Bonnet  
Chipped  
Multiple Chips

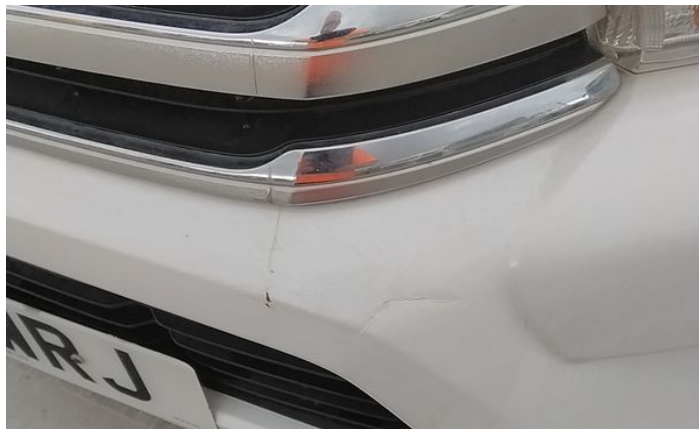
4: Bumper Front  
Dented  
With Paint Damage

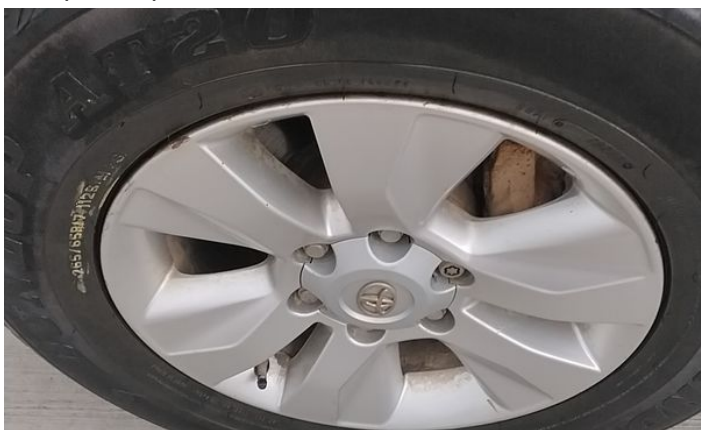
5: Wheel nsf  
Scratched  
Over 50mm

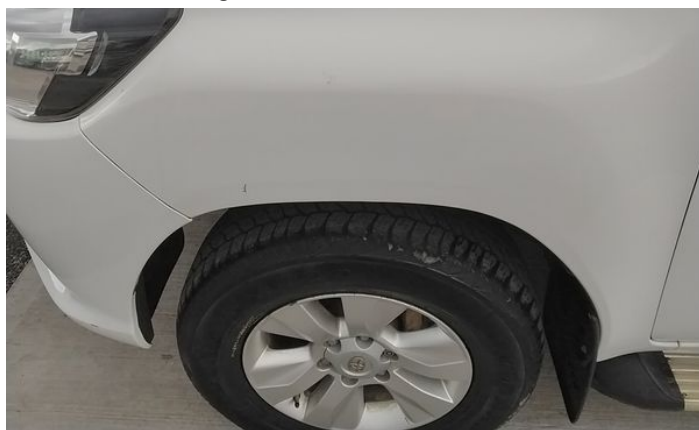
6: Wing nsf  
Chipped  
Multiple Chips

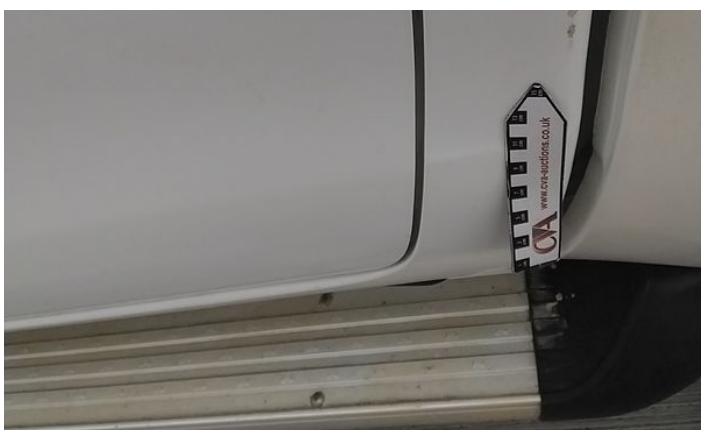
7: C Post ns  
Dented  
With Paint Damage

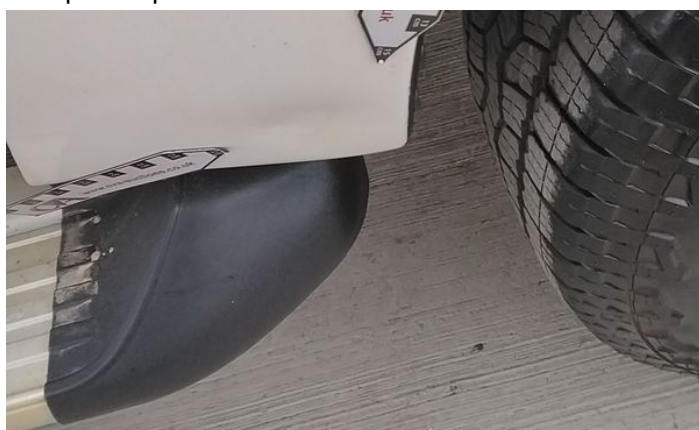
8: Qtr Panel nsr  
Dented  
Over 30mm

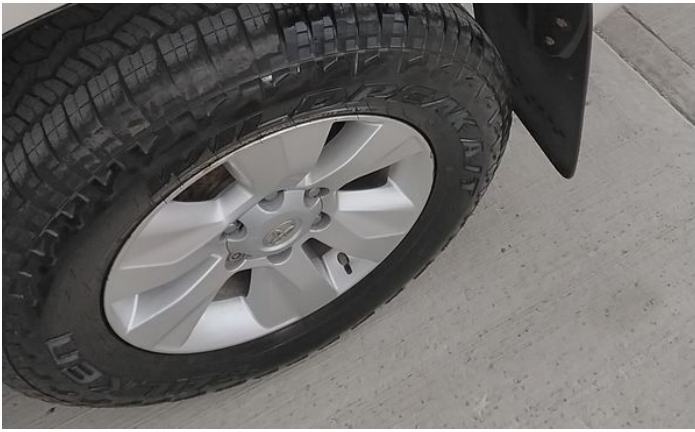
9: Qtr Panel nsr  
Rusted  
Over 5mm

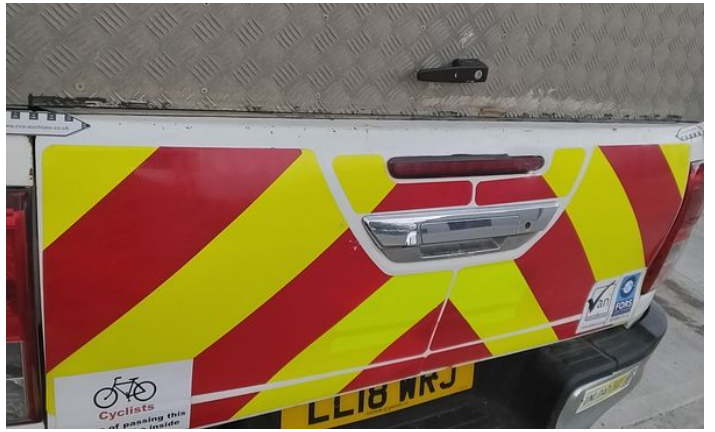
10: Tailgate  
Dented  
With Paint Damage

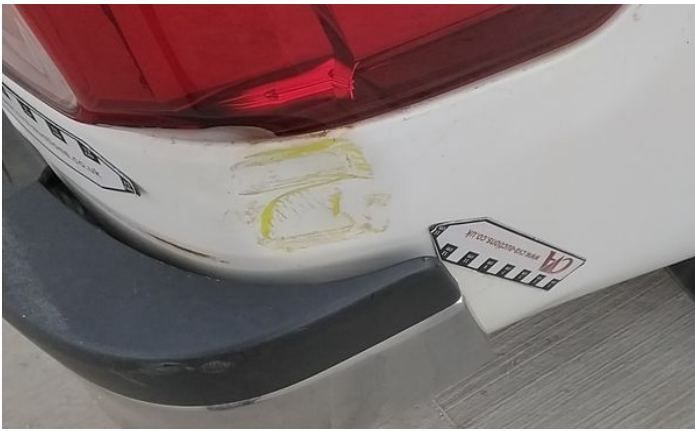
11: Qtr Panel osr  
Dented  
With Paint Damage

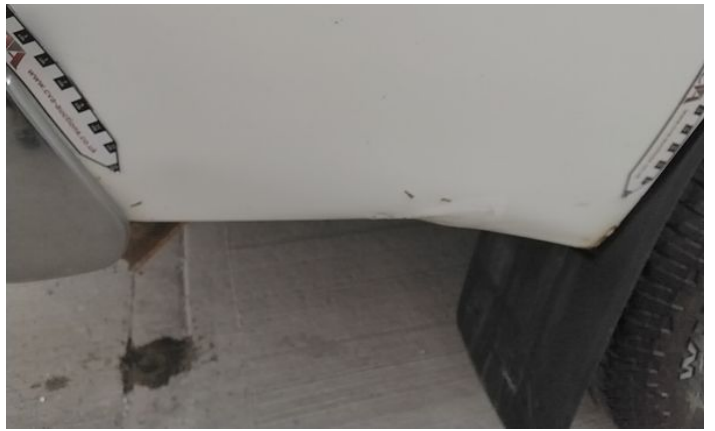
12: Qtr Panel osr  
Dented  
With Paint Damage

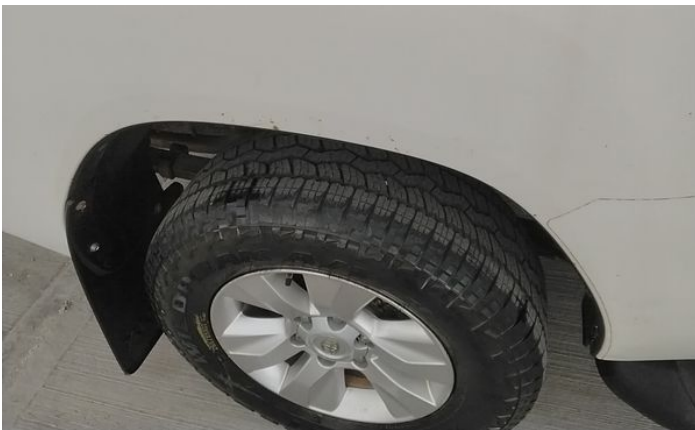
13: Qtr Panel osr  
Rusted  
Over 5mm

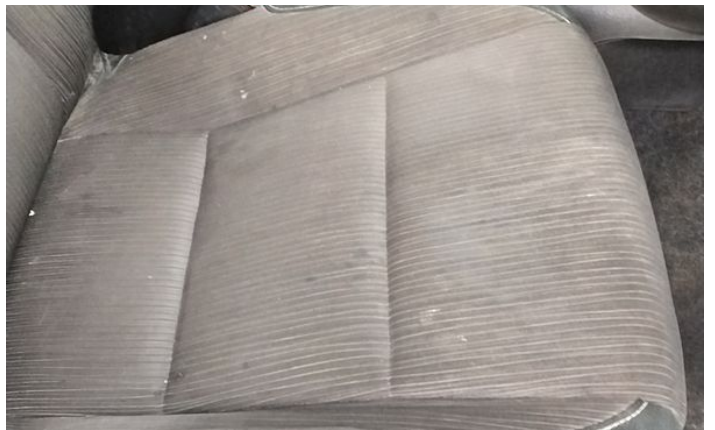
14: Seat Base Cover osf  
Torn  
Over 3mm

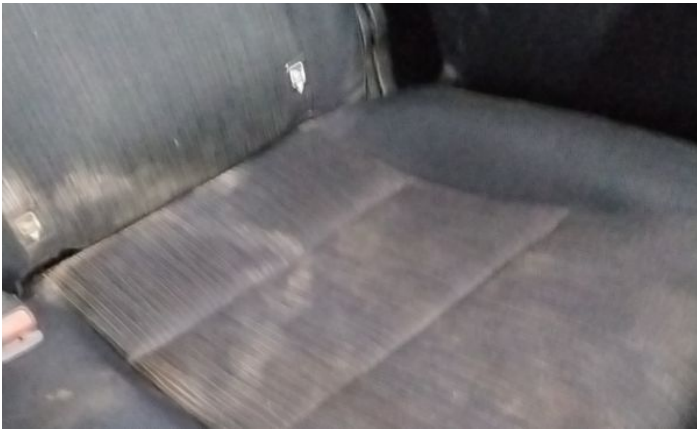
15: Seat Base Cover nsr  
Soiled  
Heavy

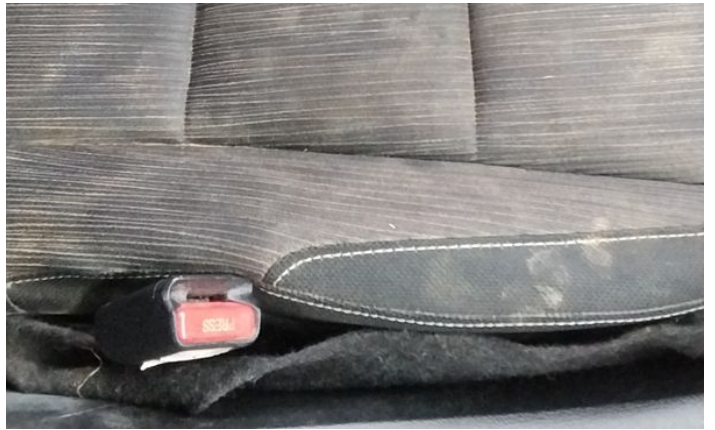
16: Seat Base Cover nsf  
Soiled  
Heavy

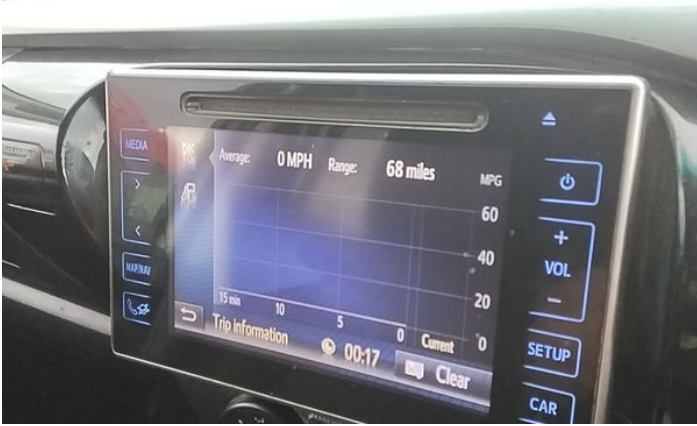
17: In Car Entertainment  
Broken  
Replace
